Joint Committee on
Ways and Means
Subcommittee on Capital Construction
Oregon State Capitol
Public testimony
Date: Time: April 19, 2019 12:00 P.M. HR E
900 Court Street NE, Room H-178, Salem, Oregon 97301
Phone: 503-986-1828
Email: jwmcc.exhibits@oregonlegislature.gov

Willamette Falls Canal and Locks
Independent Condition Assessment and Recommendations for
Recommissioning

Prepared for:
Willamette Falls Locks Commission (WFLC)

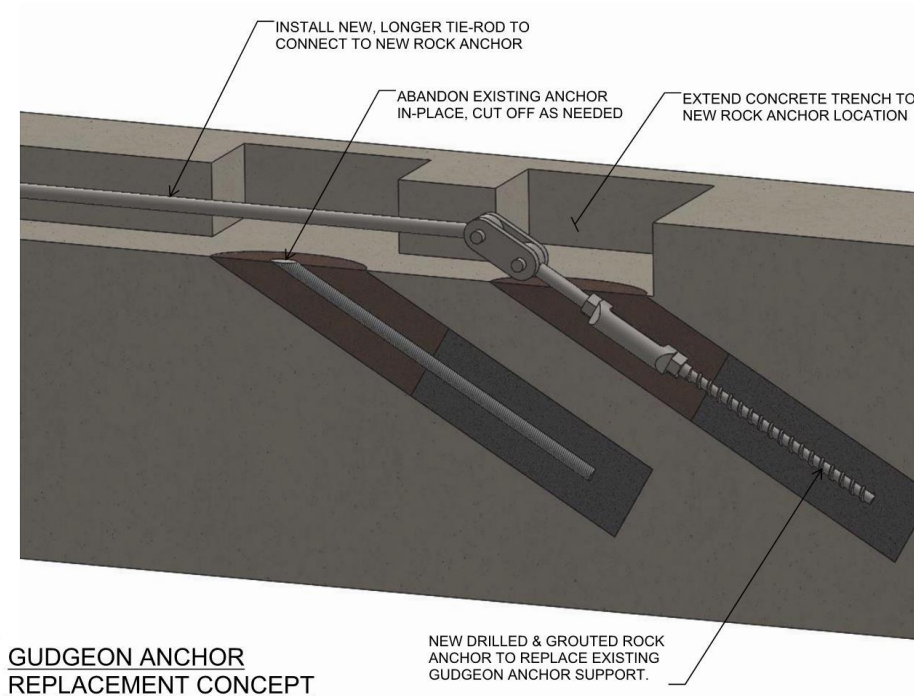
The gudgeon anchorage system for the miter gates was observed to be in poor condition and to be consistent with conditions described by previous inspection reports. The gudgeon anchorage system consists of anchor rods either buried in the lock wall structure for the rods parallel with the lock or buried a significant distance below grade for the rods perpendicular to the lock. The exposed linkage components connect these anchor rods to the gudgeon pin. The true condition of the buried anchor rods cannot be assessed without substantial excavation. Based on the anchorage movements observed at gate 3 and on corrosion issues noted in previous reports, these anchor rods should be replaced to support reliable and safe operation of the miter gates in the future. Portions of the exposed linkage components appear to be in relatively good condition and can be refurbished to provide safe and reliable operation.

9. Replace Corroded Gudgeon Anchorages (\$540K) : This isn't one of the highest cost items, however it is heavily discussed in previous reports. This estimate assumes all gudgeon anchorages need to be replaced for gates #2, #3, #4, #5, #6, and #7 to mitigate any concerns regarding the safety of these anchorages. For the anchor rods that are parallel to the lock, these rods are assumed to be replaced in kind. For the anchor rods that are perpendicular to the lock, the approach is to abandon the existing anchor rod in place, and install new drilled in and grouted rock anchors a few feet further back from the gate and then installing longer tie rods to connect to the gate. This is true for all perpendicular gudgeon anchorages except at Gates 4 & 5 Mill side, where they are replaced in kind. This recommendation for repair and scope of work is different from the 2011 USACE evaluation, which recommended abatement of existing corrosion and replacing only a handful of pieces of hardware, which did not address the potential for corroded and buried anchorages which are not accessible for inspection. See the figure below for a conceptual sketch of the replacement gudgeon anchor.

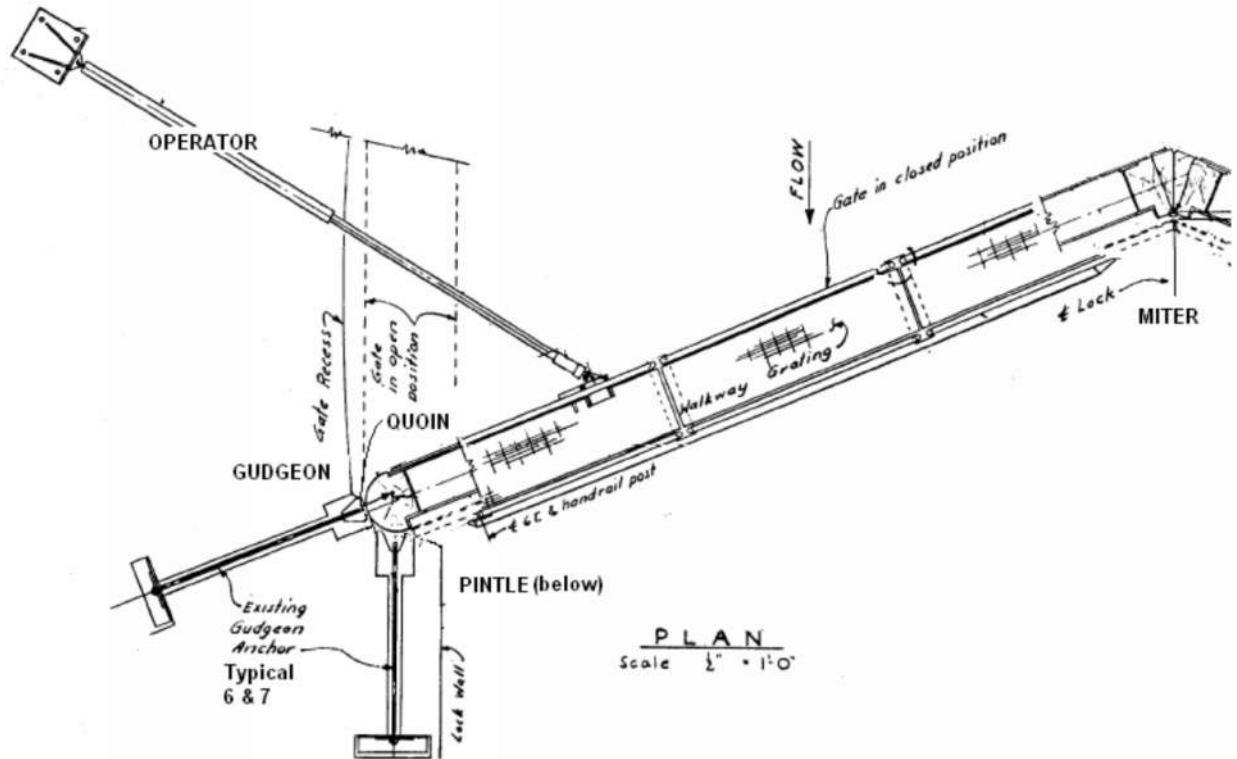
Figure 1 - Typical Miter Gate Plan

All lock gates are miter style, consisting of two leaf structures supported by timber quoin blocks at the lock wall and by timber miter blocks at the lock centerline. When open, each gate leaf swings on a pintle bearing located under the quoin block and is held in place by two gudgeon anchors, one parallel to the lock to support the gate in the open position, and one lateral to the lock, in line with the gate when in the closed position. Each miter gate leaf is constructed from a steel frame with a steel face skin on the upstream surface and a timber facing on the downstream face. Each gate leaf is operated by a hydraulic cylinder located just upstream of the quoin block and anchored to the top of the lock wall. Figure 1 provides a typical plan view of the miter gates (note that the lock centerline is coincident with the miter block and only one of the two gate leaves is shown).

The gudgeon anchors are comprised of steel rods that are connected to a link plate that is then attached to a ground anchor rod. Gudgeon anchor configuration varies from gate to gate due to

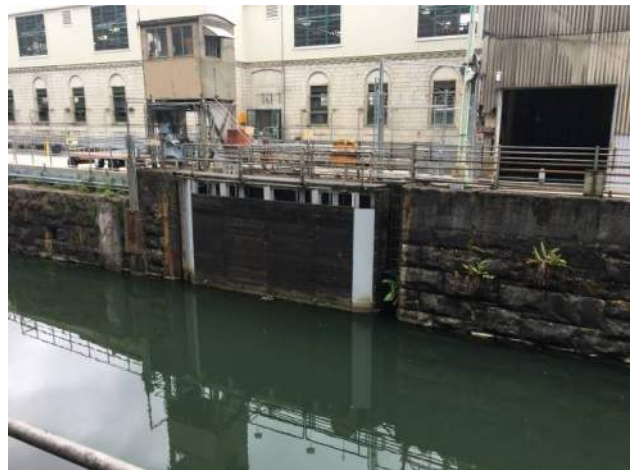
Photo #23

Note that LCS3 located on an elevated structure adjacent to Miter Gate 6 is in very poor condition. Project staff indicated that this structure has been condemned and is no longer used. Operation of

Miter Gate 6 and 7 is accomplished using the local control stations on the HPU or from LCS2 adjacent to Miter Gate 4. (See Photo #23)

Analyze Lock Control Stand at Gate 6 (Mill Side): The structure of the lock control stand has been condemned. At this point, there is no need to analyze the structure since it has already been deemed unsafe structurally. If the control stand is needed, the structure would need to be replaced. This activity would have added complexity with all of the utilities routed around, underneath and into the control stand. With the recommended operational methodology, the control stand is no longer needed.
