Willamette Falls Canal and Locks

Independent Condition Assessment and Recommendations for Recommissioning

Prepared for:
Willamette Falls Locks Commission (WFLC)

Prepared by:
KPFF Consulting Engineers
1601 Fifth Avenue, Suite 1300
Seattle, WA 98101
(206) 382-0600

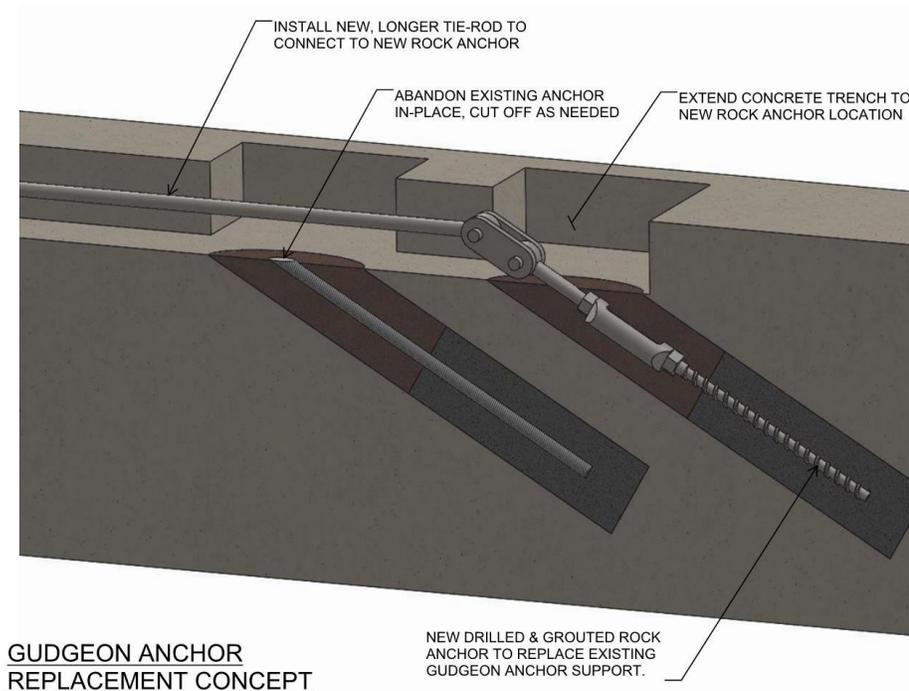
9. Replace Corroded Gudgeon Anchorages (\$540K) : This isn't one of the highest cost items, however it is heavily discussed in previous reports. This estimate assumes all gudgeon anchorages need to be replaced for gates #2, #3, #4, #5, #6, and #7 to mitigate any concerns regarding the safety of these anchorages. For the anchor rods that are parallel to the lock, these rods are assumed to be replaced in kind. For the anchor rods that are perpendicular to the lock, the approach is to abandon the existing anchor rod in place, and install new drilled in and grouted rock anchors a few feet further back from the gate and then installing longer tie rods to connect to the gate. This is true for all perpendicular gudgeon anchorages except at Gates 4 & 5 Mill side, where they are replaced in kind. This recommendation for repair and scope of work is different from the 2011 USACE evaluation, which recommended abatement of existing corrosion and replacing only a handful of pieces of hardware, which did not address the potential for corroded and buried anchorages which are not accessible for inspection. See the figure below for a conceptual sketch of the replacement gudgeon anchor.

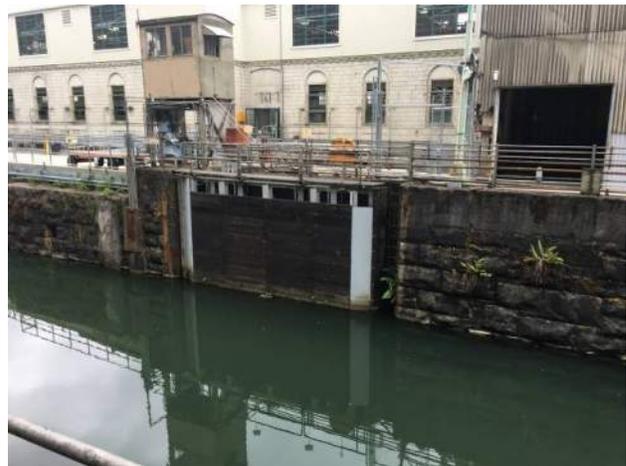
Photo #23

Note that LCS3 located on an elevated structure adjacent to Miter Gate 6 is in very poor condition. Project staff indicated that this structure has been condemned and is no longer used. Operation of

Miter Gate 6 and 7 is accomplished using the local control stations on the HPU or from LCS2 adjacent to Miter Gate 4. (See Photo #23)
