**Willamette River Newberg Pool
Towed Water Sport Zone and
Wake Surfing and Water Skiing Zone
River Bank Erosion Documentation and Evaluation**

Oregon Marine Board Towed Water Sport Regulated Zones Within the Willamette River Newberg Pool

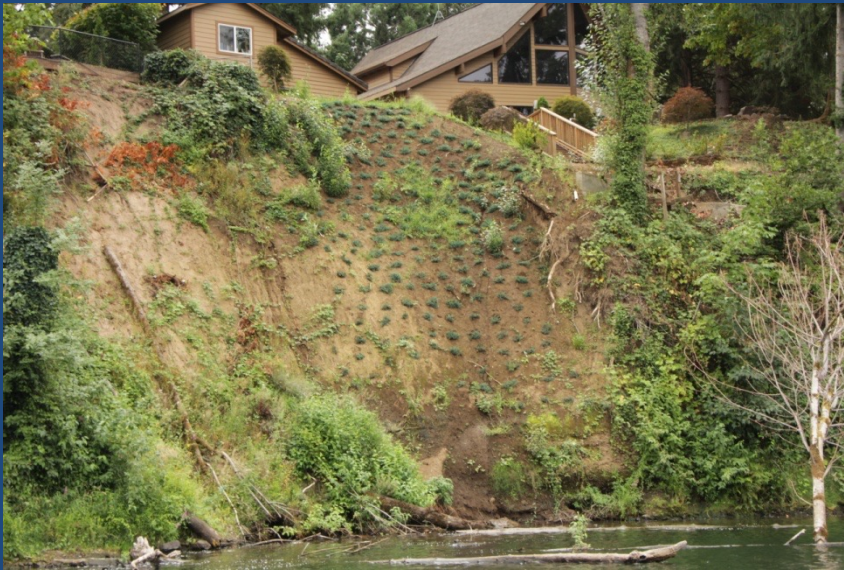
Outside of Wake Surfing Zone

Massive Bank Failure

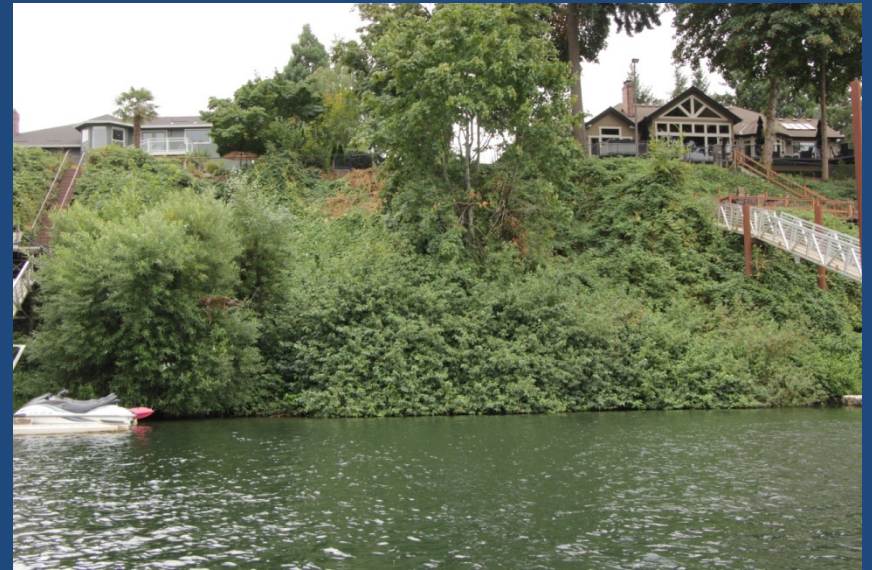
Neighboring Property

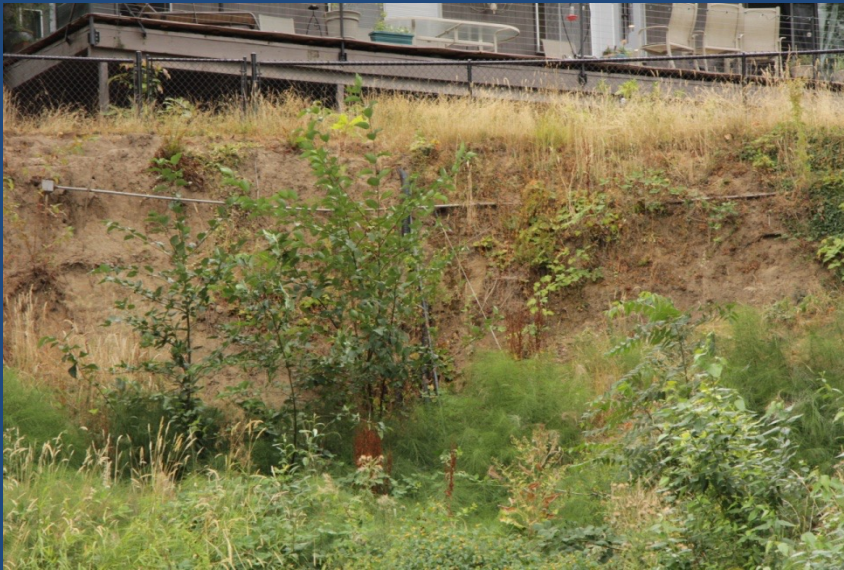
Outside of Wake Surfing Zone

Utility & Drainage Caused Failure

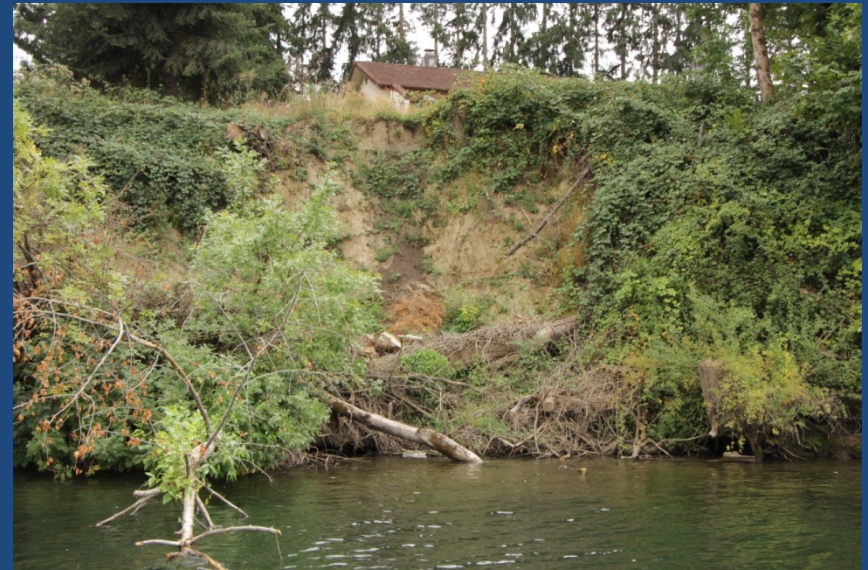
Water Caused Bank Failure

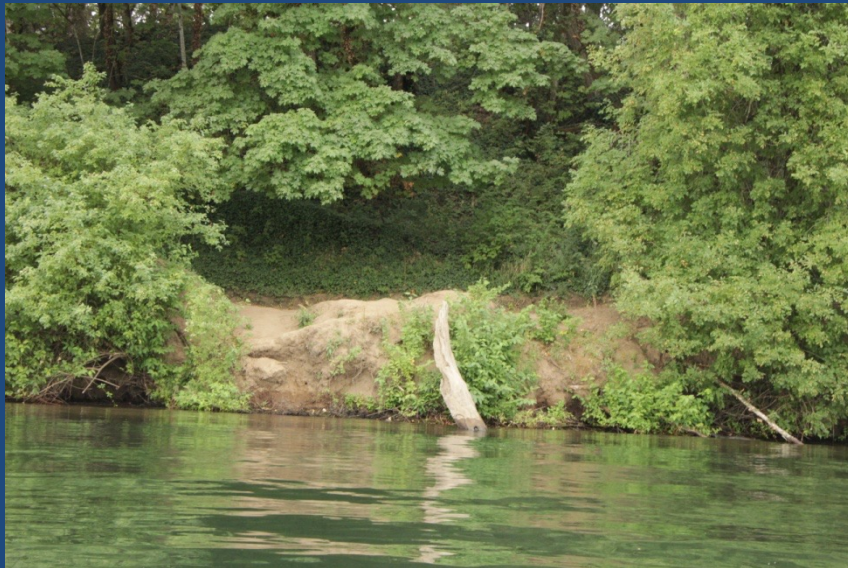
Inside Upper Wake Surfing Zone

Champoeg State Park

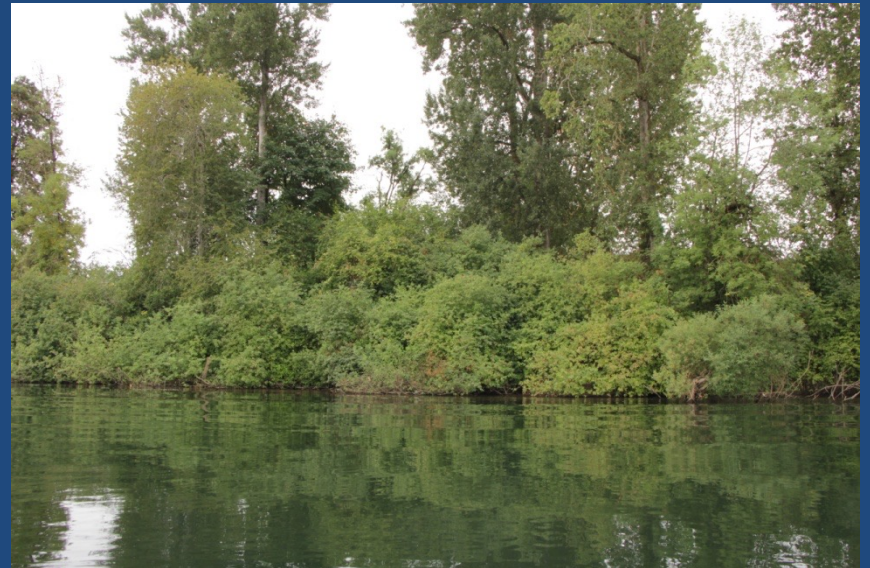
Agricultural Landuse

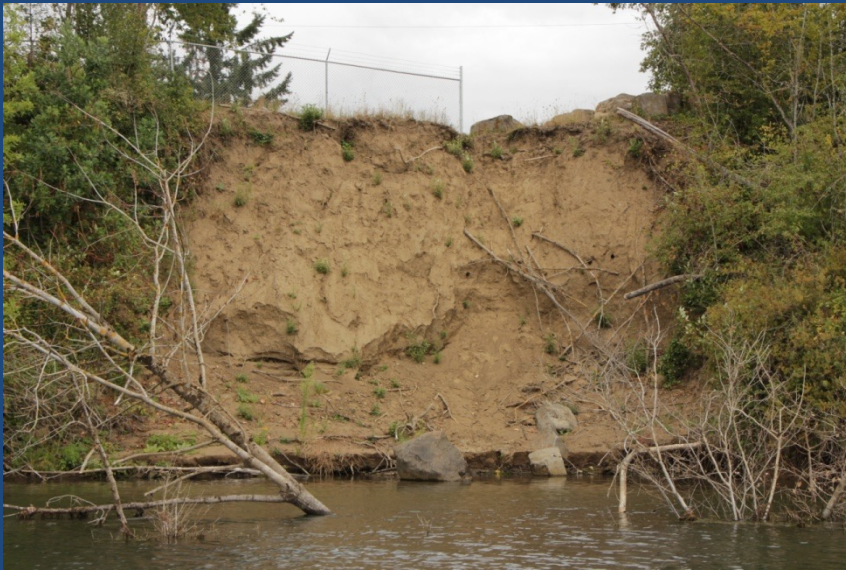
Inside Lower Wake Surf Zone

Residential Construction

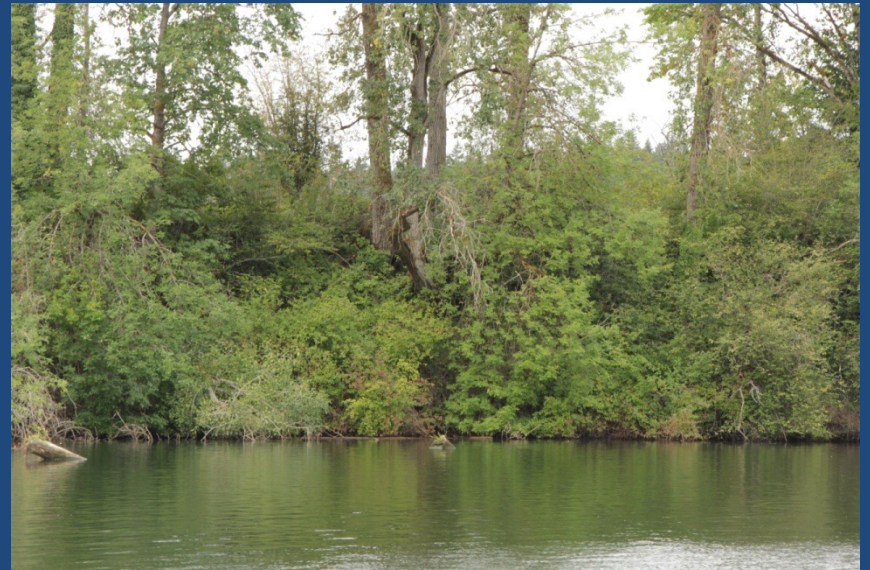
Agricultural Landuse
