Rebuttal Report of Bert Krages to
Willamette River Newberg Pool Towed Water Sport Zone and Wake Surfing and
Water Skiing Zone River Bank Erosion Documentation and Evaluation
(David Gorman, PE, Ecological Engineering, LLC)

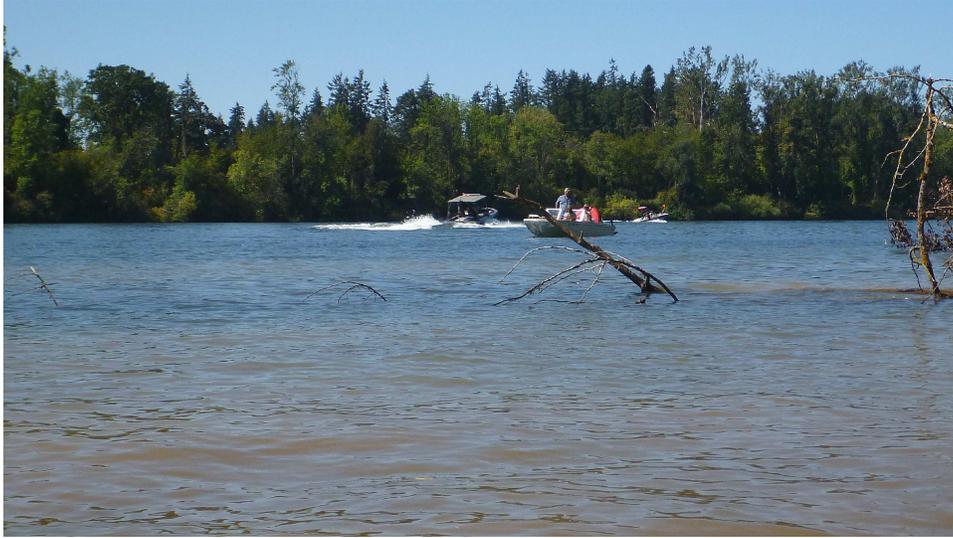
When wake boats are active, the scour caused by the wakes releases soil from the river bank which forms a turbid zone that can extend past the edge of the nearshore sediment zone. The following photograph shows an area in the wakesurfing zone delineated by Buoys B and C where the turbidity extended over 70 feet into the river.²

² Note also that a Clackamas County Marine Patrol boat is in the background, chasing down a wake boat that was violating boating laws.

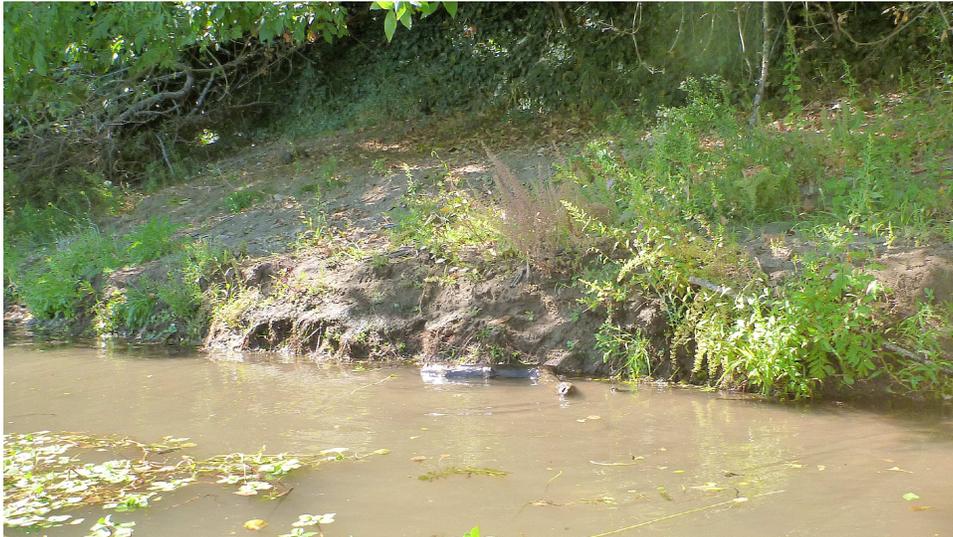
The following photograph shows a wave scarp on undeveloped Willow Island in the same wakesurfing zone. This is an example of a scarp that would likely go unnoticed when viewed from a distance away from the shoreline during a period of relatively calm water. Notably, the Gorman report does not include observations of Willow Island.

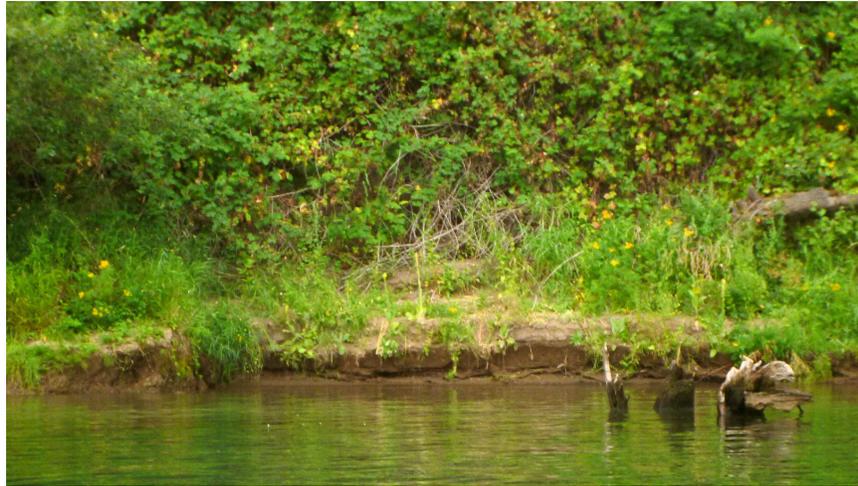
The photographs mostly focus on areas with upper bank issues and fail to look at the Newberg Pool as a whole. At the beginning of the section with photographs, the report shows “baseline” photographs taken at RM 46–49 in the area to the west of the buoy D-E wakesurfing zone, but fails to show any photographs of the substantial wave scarps that are present adjacent to the agricultural areas between the public boat ramp at Newberg and the St. Paul Bridge. An example of one of these scarps in this area is depicted below.
