**Willamette River Newberg Pool
Towed Water Sport Zone and
Wake Surfing and Water Skiing Zone
River Bank Erosion Documentation and Evaluation**

David Gorman, PE
Ecological Engineering, LLC
2016 SE Henkle Road
Corbett, Oregon 97019

September 10, 2021

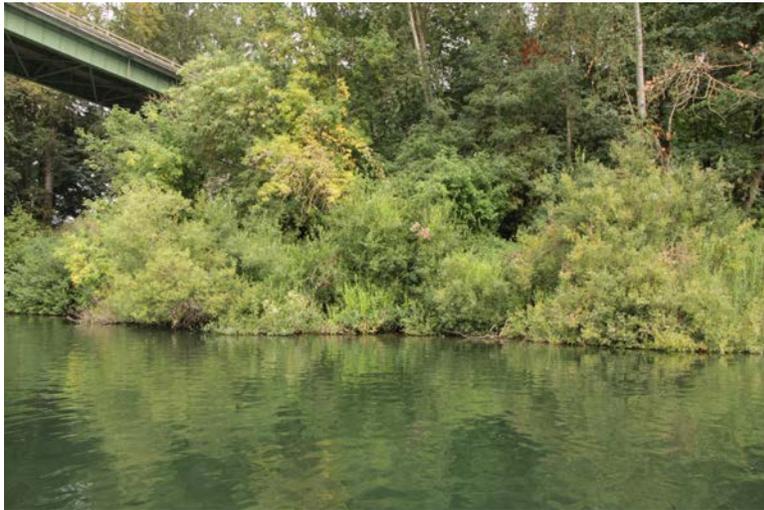
Photo WR-1A

Photos WR-1A through WR-1D were taken at Photo Point WR-1 (see map above) just downstream of the Newberg Bridge within the Oregon Marine Board designated Towed Water Sport Zone (Towed Zone) and approximately one river mile upstream of the upper limit of the Oregon Marine Board designated Wake Surfing and Water Skiing Zone #1 (Surf Zone 1). The river bank in this area was used as a reference for bank conditions inside of the Towed Zone but outside of Surf Zone 1.

There is a thick growth of willows (*Salix* sp.) along the lower and wetter portion of the bank with native trees higher up on the bank. There is no sign of bank erosion or failure.

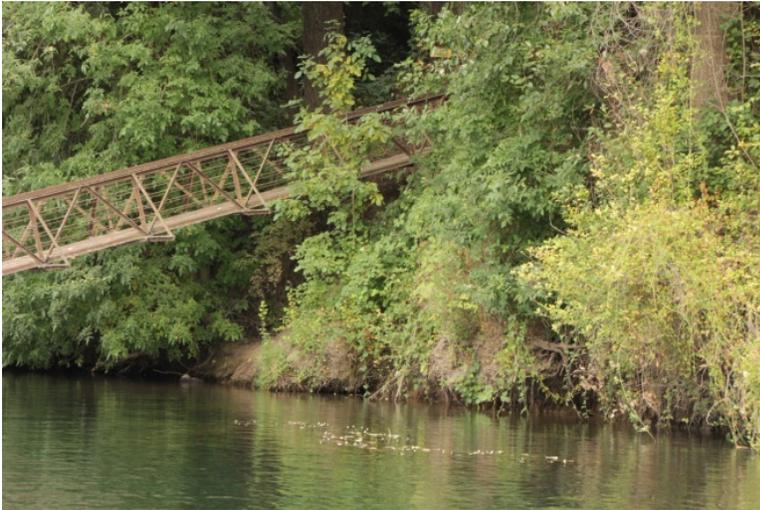
Photo WR-2A

Photos WR-2A through WR-2C were taken at Photo Point WR-2 (see map above) just downstream of the Newberg Bridge within the Oregon Marine Board designated Towed Water Sport Zone (Towed Zone) and approximately 0.1 river mile upstream of the upper limit of the Oregon Marine Board designated Wake Surfing and Water Skiing Zone #1 (Surf Zone 1). The photos are of a boat dock and ramp within the Towed Zone but with no associated urban

development. The dock and ramp are on agricultural land with no housing nearby. The river bank has some areas with non-native invasive Himalayan blackberry (*Rubus ameniacus*) and some areas that have sparse vegetation, but there is little or no erosion or bank failure.

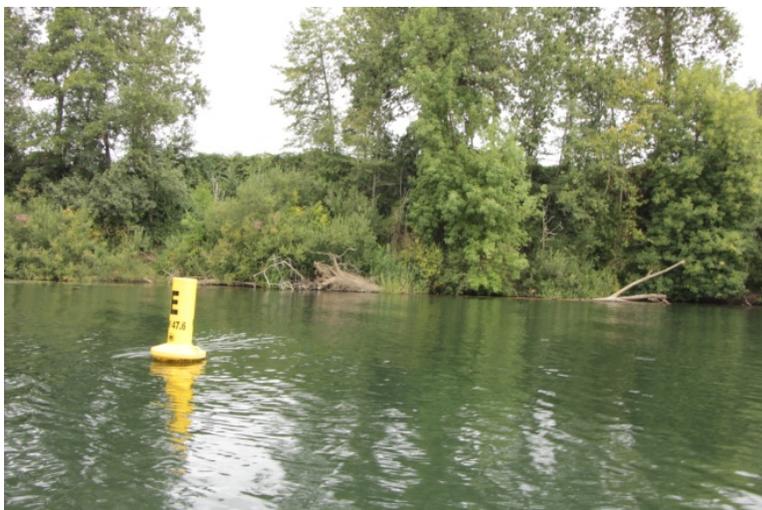
Photo WR-3A

Photos WR-3A through WR-3D were taken at Photo Point WR-3 located at the upper end of Surf Zone 1 located at RM 47.6 (see map above and zone marking bouys in photos). These photos represent bank conditions at the upper end of the Surf Zone. The river bank is well vegetated with willow and native dogwood (*Cornus sericea*) lower on the bank with no sign of erosion or

bank failure. The upper end of Surf Zone 1 is located in an agricultural area with no urban development of land uses.

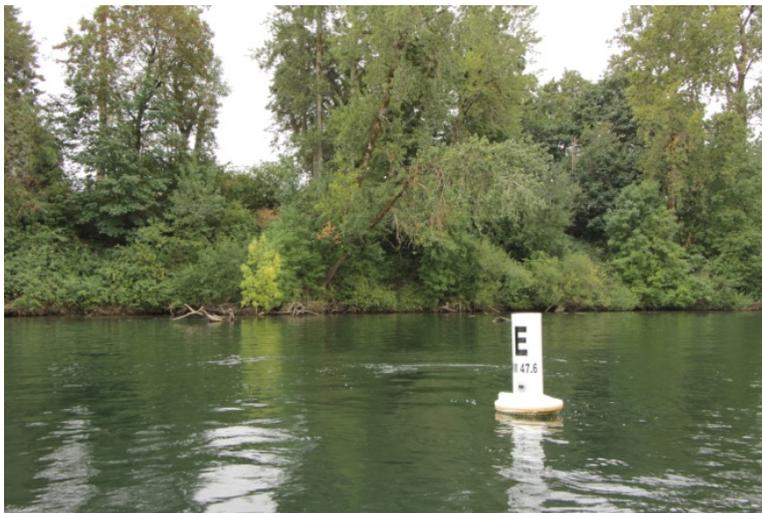
Photo WR-4A was taken at Photo Point WR-4 located at the upper end of Surf Zone 1 located at RM 47.6 (see map above and zone marking buoys in photos). This photo represents bank conditions at the upper end of the Surf Zone. The river bank is well vegetated with willow and native dogwood (*Cornus sericea*) lower on the bank with no sign of erosion or bank failure. The upper end of Surf Zone 1 is located in an agricultural area with no urban

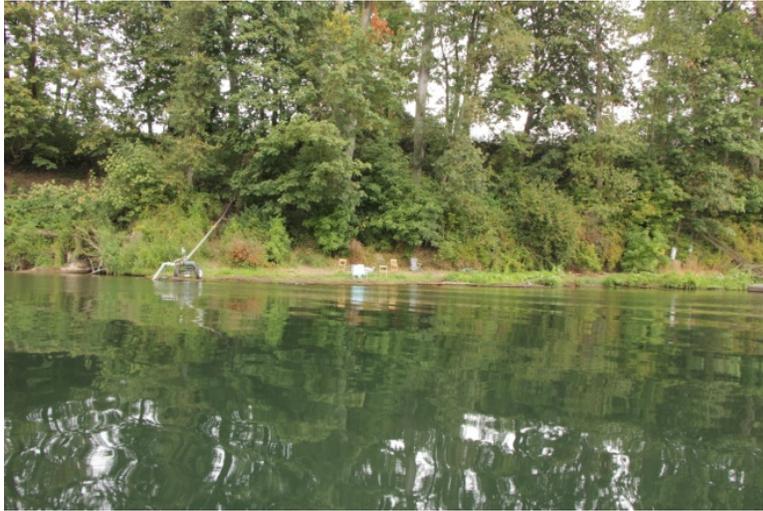
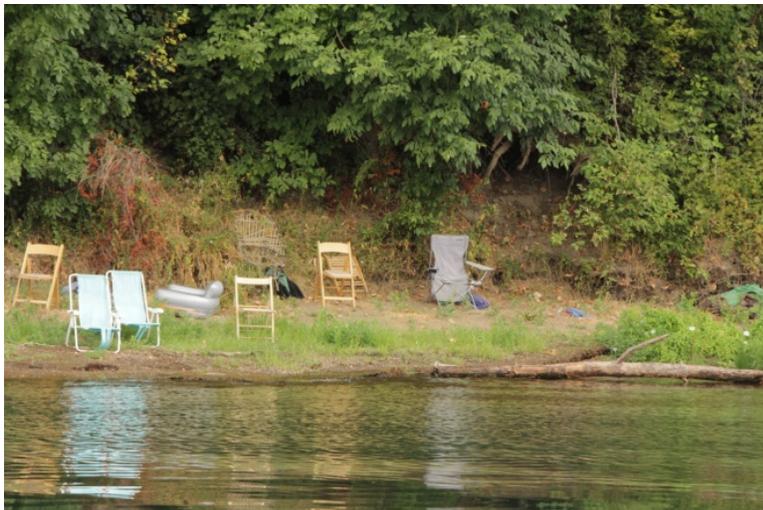
Photo WR-5A

Photos WR-5A and WR-5B were taken at Photo Point WR-5 (see map above) inside of Surf Zone 1 where land use is agricultural. The area is used recreationally by the nearby landowner with the house, barn, and other more intensive land uses a significant distance from the river bank. Impacts to riparian vegetation can be seen with some minor bank erosion where the vegetation is lacking. However, there is no significant bank erosion and no bank failures.

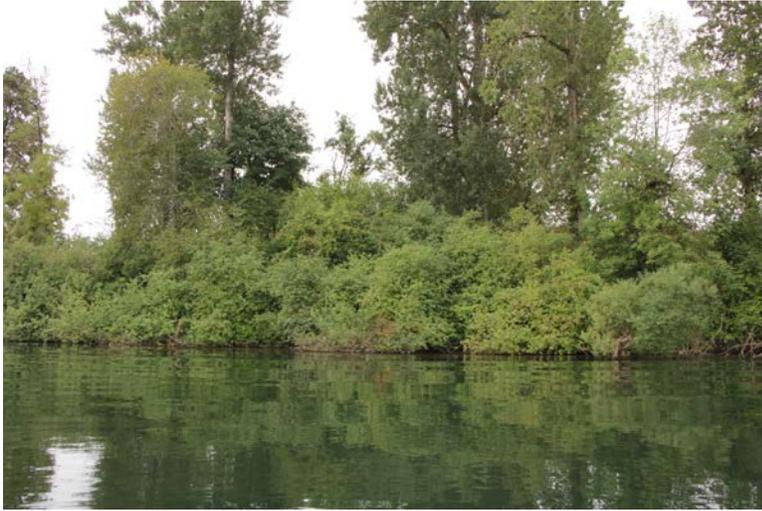
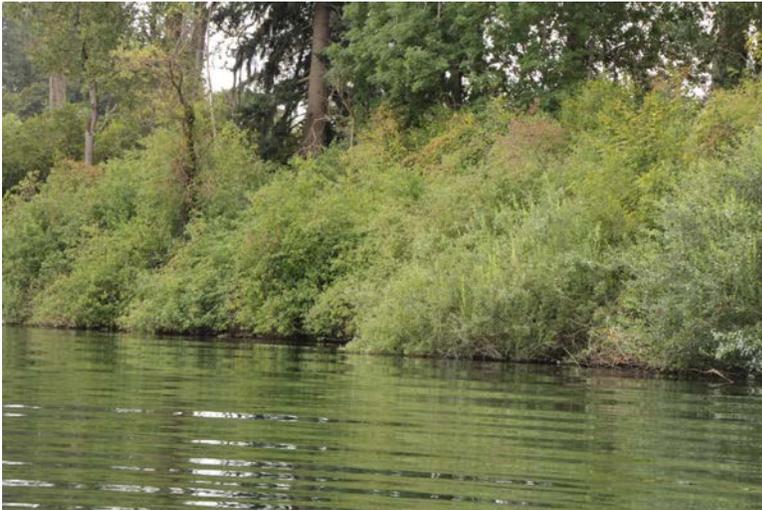
Photo WR-6A

Photos WR-A through WR-6D were taken at Photo Point WR-6 (see map above) which is approximately in the middle of Surf Zone 1 in an area that is exclusively agricultural with no development or intensive landuses along the river banks. The river bank in this portion of Surf Zone 1 is very stable with good vegetation cover of native willows and dogwood. Due to its location within the central portion of the Surf Zone the river banks at WR-6

are subjected to the largest boat wakes generated from wake surfing and water skiing. Despite the intense wave activity in this area, there is no sign of erosion or bank failure.

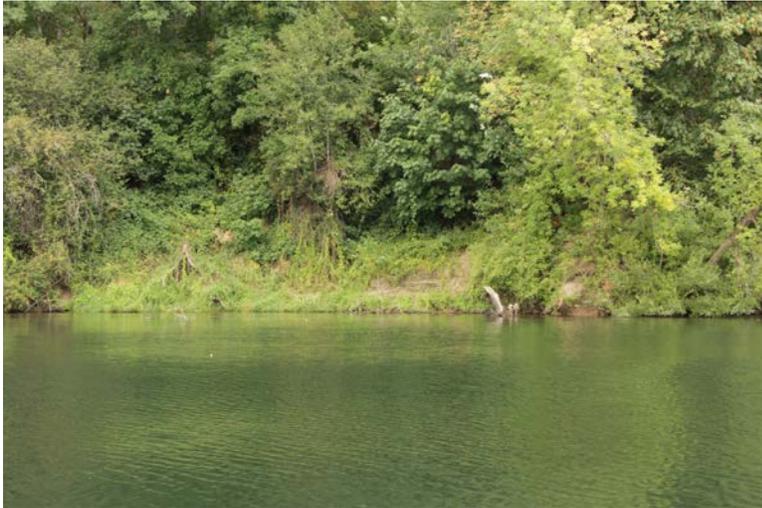
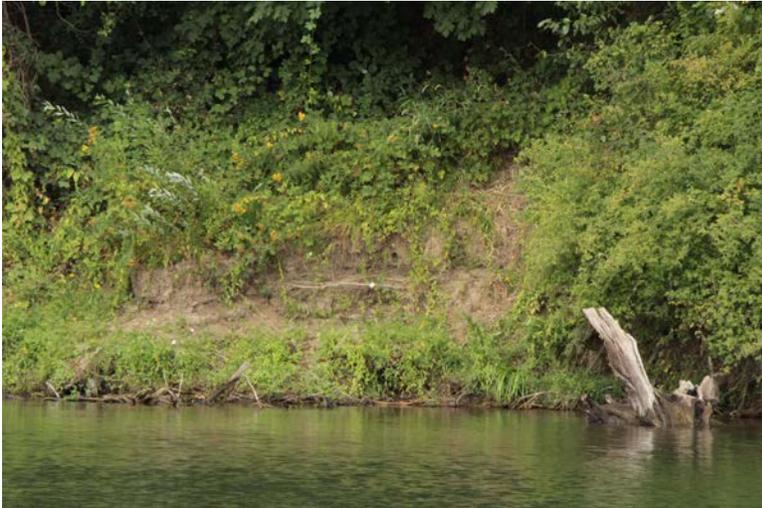
Photo WR-7A

Photos WR-7a through WR-7C were taken from Photo Point WR-7 in the lower one third of Surf Zone 1 (see map above). Land use in this portion of the Surf Zone is exclusively agricultural. The river bank has a minor amount of erosion in an area where willow and dogwood shrubs are lacking and vegetation is sparse. The predominant vegetation lower on the bank is non-native invasive Himalayan Blackberry. The cause of the erosion may be boat wakes

in the absence of other human activity, but there is no obvious cause.

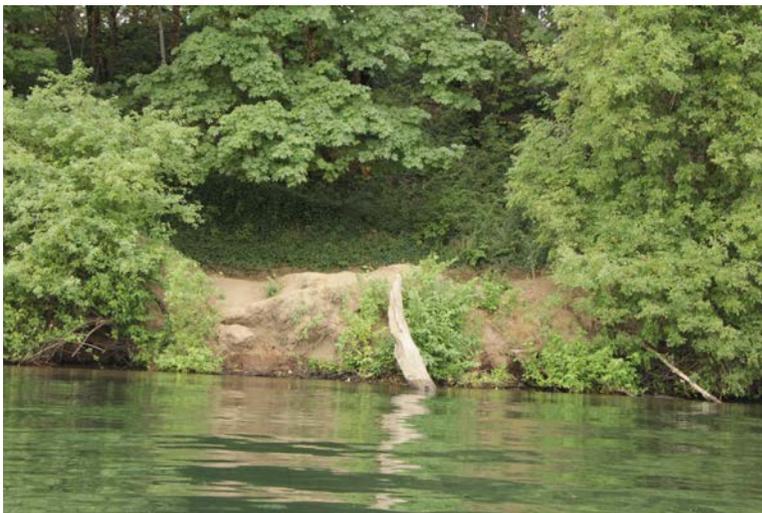
Photo WR-8A was taken at Photo Point WR-8 (see map above) at the lower end of Surf Zone 1 and adjacent to Champoeg State Park. Shortly before this photograph was taken a group of people were observed hiking and playing along this section of the bank. The bank erosion in this location is the result of frequent human access to the bank and land based recreation on the bank that has resulted in the elimination of the native riparian shrubs that are characteristic of

the bank both upstream and downstream of this location.

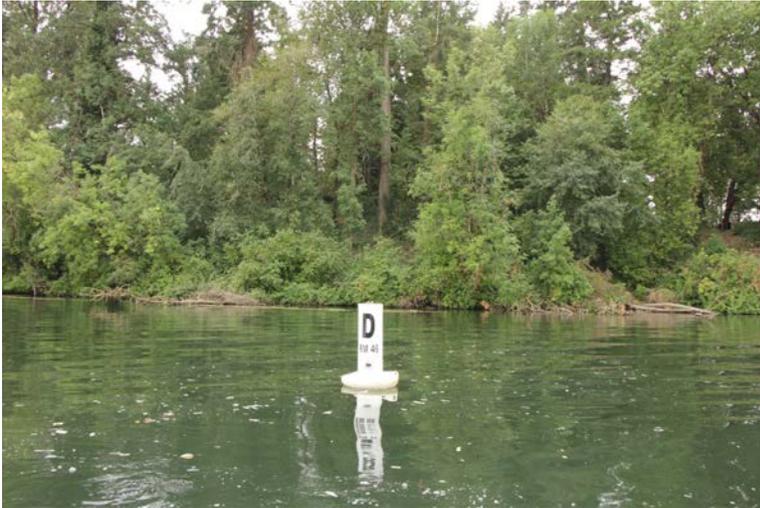
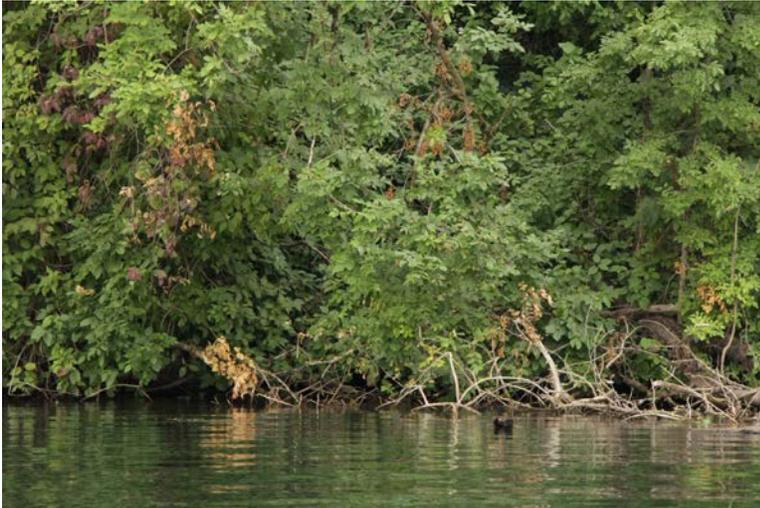
Photo WR-9A

Photos WR-9A through WR-9C were taken at Photo Point WR-9 and Photo WR-10A was taken at Photo Point WR-10 (see map above). Both photo points are located at the lower boundary of Surf Zone 1 at RM 46. Land use on the right bank at this location is Champoeg State Park, and land use on the left bank is agricultural. Riparian vegetation is generally healthy on both banks but appears more dense on the left bank where the agricultural land use

likely has less of an impact than the right bank with the state park. No erosion or bank failures are evident in this location.

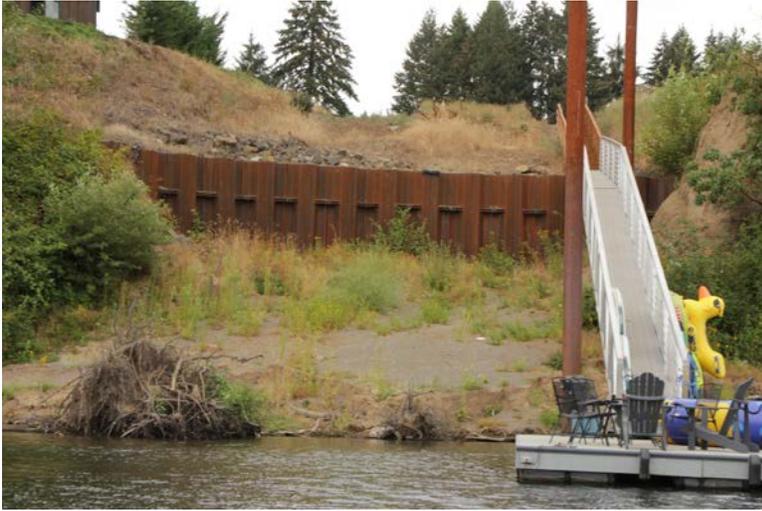
Photo WR-11B

Photos WR-11A and WR-11B were taken at Photo Point 11 (see map above) approximately RM 45, 1 river mile downstream from the lower end of the Wake Surfing and Water Skiing Zone 1 (Surf Zone 1) and within the Towed Water Sport Zone (Towed Zone). These photos were taken of the left bank in an area where the land use is residential. All, or nearly all, of the river bank residential properties in this reach of the river have boat docks and ramps. At this location

the property owner has placed steel sheet pile with riprap behind it in an apparent attempt to stabilize the land behind the sheet pile. It appears that the bank has been excavated in this location based on the steep slope to the right of the sheet pile. The lack of vegetation and the presence an “alcove” or indentation in the bank may result in the formation of flow eddies at higher flows that will increase the erosional pressure on the steep bank.

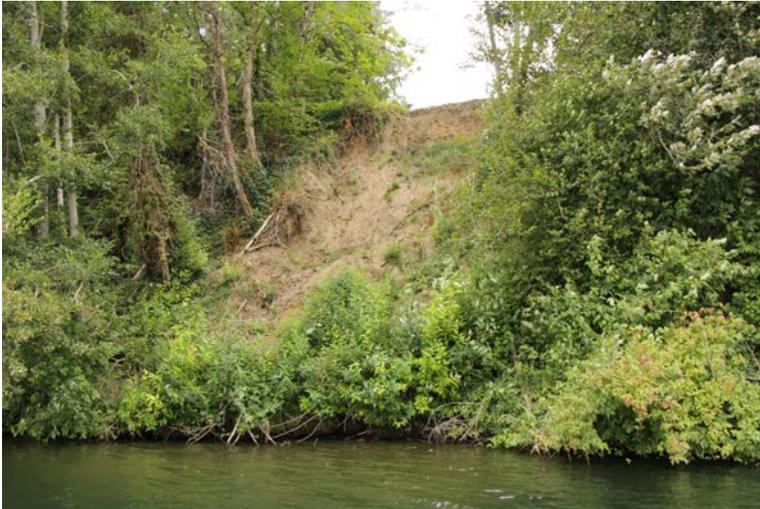
Photo WR-12A was taken at Photo Point 12 (see map above). The photo shows a significant bank failure located on the left bank in an area where the land use is agricultural. A local citizen noted that a tree fell at this location during a recent ice storm. It is possible that bank scour or hydraulic failure followed that event during high winter flow events. Note that the boat wake zone is vegetated and relatively stable, indicating that boat wakes

were not the cause of this failure.

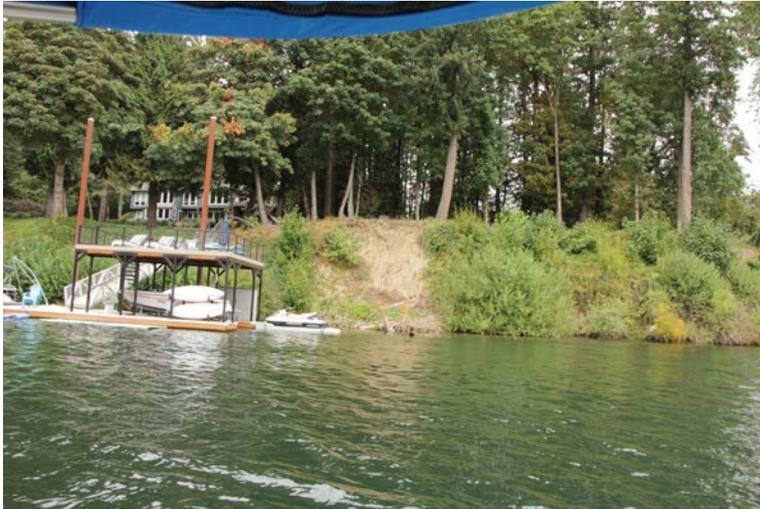
Photo WR-13A

Photos WR-13A through WR-13C were taken at Photo Point 13 within the Towed Water Sport Zone but not within the Wake Surfing and Water Skiing Zone (see map above). The portion of the river bank in the photo has undergone a mass failure as a result of a combination of saturated soils from winter rains and high river water plus excess weight at the top of the slope from trees. The lower riparian vegetation appears healthy and

intact and there is no indication of slope undercutting resulting from waves. Photo WR-13C shows the presence of ivy on the slope. Ivy does not provide the same level of bank protection and stabilization as native willows and dogwood.

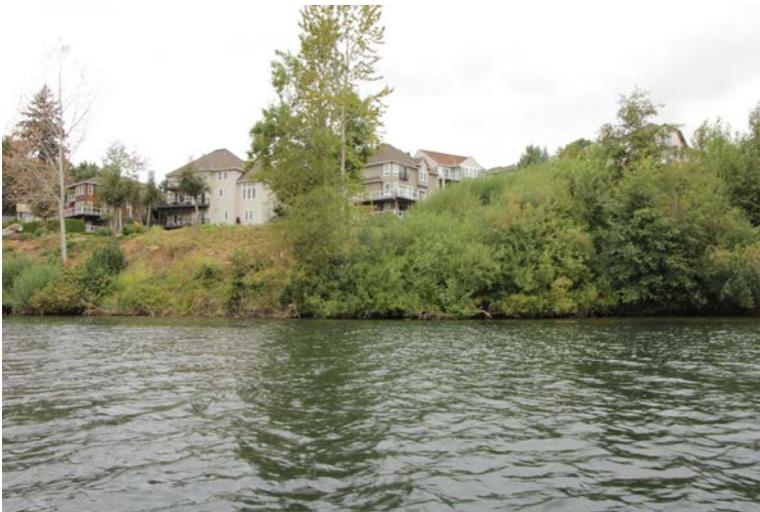
Photo WR-15A

Photos WR-15A and WR-15-B were taken at Photo Point WR-15 within the Towed Water Sports Zone but not within the Wake Surfing and Water Skiing Zone (see map above). Conditions on the river bank suggest that the property owners have conducted either vegetation clearing and/or maintenance practices that prevent the growth of native riparian vegetation. There is healthy native riparian vegetation on the right side of the photo but

on the left side of the photo there is mostly only grass cover on the upper bank and Himalayan blackberry on the lower bank. The river bank appears to be stable but will be more susceptible to bank scour and boat wakes.

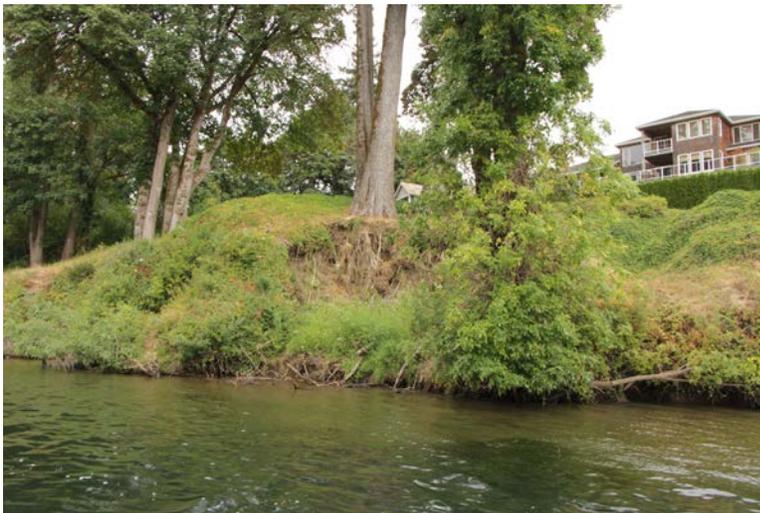
Photo WR-16A

Photos WR-16A and WR-16B were taken at Photo Point 16 within the Towed Water Sport Zone but outside of the Wake Surfing and Water Skiing Zone (see map above). There is some minor bank undercutting near the water level, but the soil loss at the base of the large tree appears to be the result of bank scour during high river flows. The larger recessed area to the right of the scour likely caused the formation of an eddy during high flows that resulted in the

scour. The lower bank is vegetated with Reed Canary Grass (*Phalaris arundinacea*) that has less bank stabilization ability than willows and dogwood. The scour has undermined the tree which will fall eventually due to high winds or additional scour from high river flows. When the tree does fall over it will exacerbate the erosion at this location.

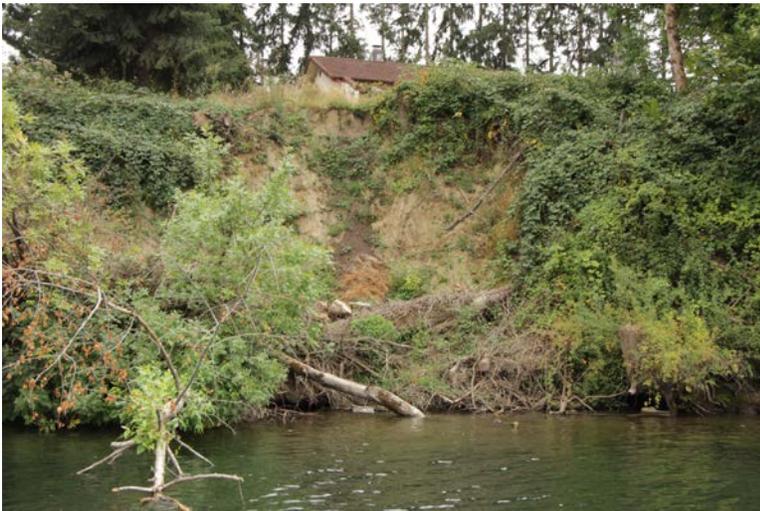
Photo WR-34A and WR-34B were taken from Photo Point 34 within the Towed Water Sport Zone but outside of the Wake Surfing and Water Skiing Zone (see map above). This mass failure was likely caused by a discharge of water at the top of the slope which adds weight to the soil and reduces the internal soil particle friction thereby reducing the slope's ability to support itself. This photo was taken on August 17, 2021 during a very dry time of year. However,

there is a wet soil down the center of the mass failure, indicating that there is a steady source of water being discharged to the top of the slope. At this time of year the source of the water is likely a broken irrigation line or over watering of the landscaping vegetation.

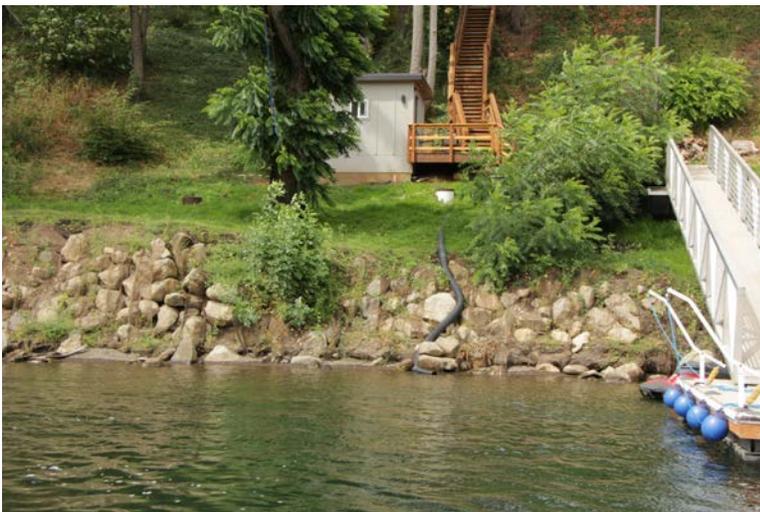
Photo WR-35A

Photos WR-35A through WR-35D was taken at Photo Point 35 within the Towed Water Sport Zone but outside of the Wake Surfing and Water Skiing Zone (see map above). These photos show a stabilized river bank that was professionally designed and permitted by the regulatory agencies with jurisdiction. The plantings of willow and dogwood are sparse and young but will be added to during the next planting season. Photo WR-35C shows what

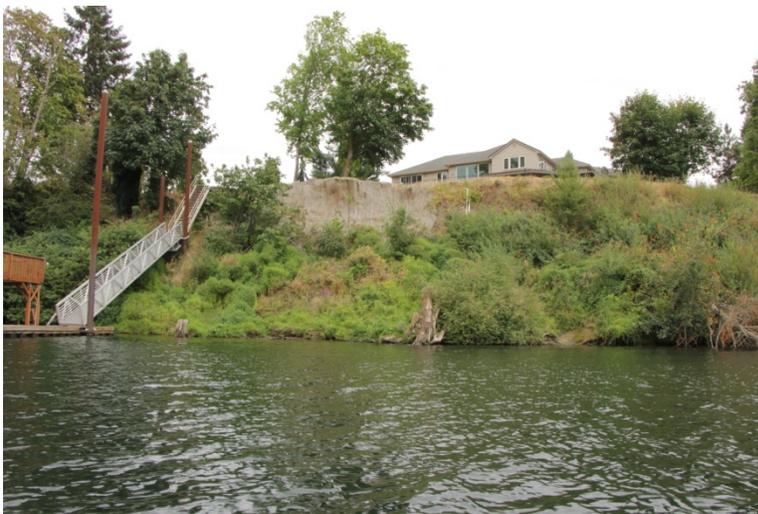
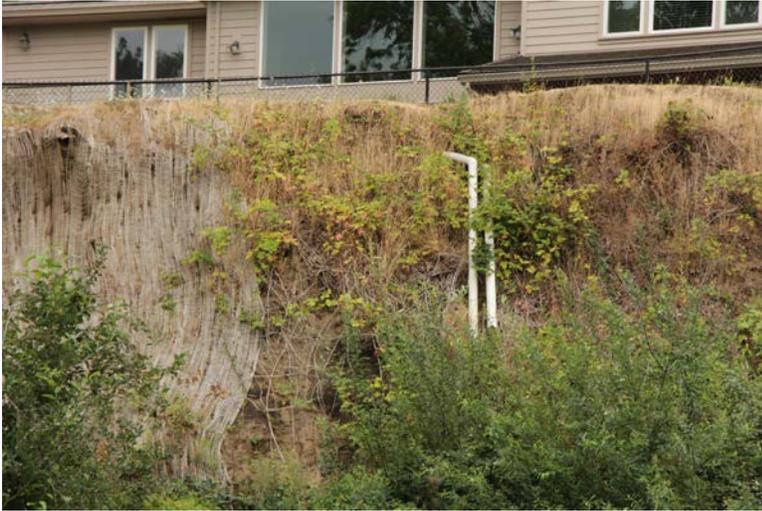
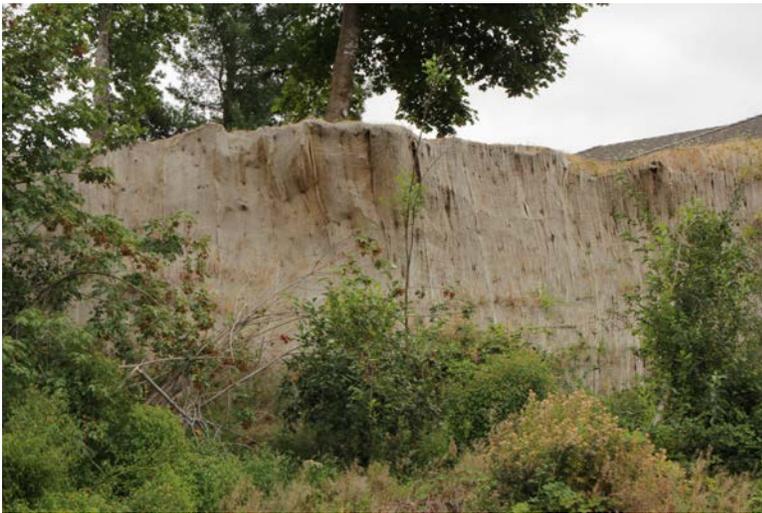
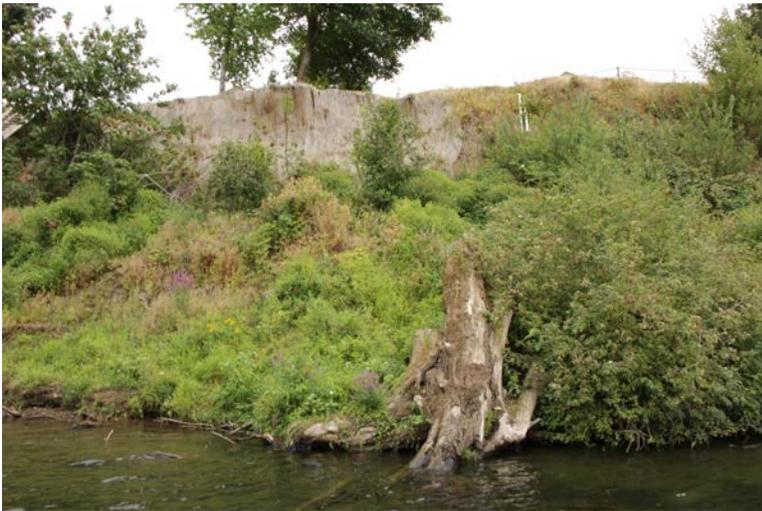
Photo WR-17A

Photos WR-17A through WR-17E were taken at Photo Point 17 within the Towed Water Sport Zone but outside of the Wake Surfing and Water Skiing Zone (see map above). The top of the bank is precipitously steep in the vicinity of the white PVC piping. A possible cause of the mass failure is the saturation of the soil at the top of the bank from stormwater discharge onto the slope.

Discharging stormwater runoff from roofs and other impervious

surfaces adds weight to the soil and reduces the internal soil particle friction thereby reducing the slope's ability to support itself. Another contributing factor may have been bank scour during high river flows midway up the slope. The lower slope appears stable but is lacking significant native woody vegetation below the over steepened slope. This mass failure does not appear to be caused by boat wakes.

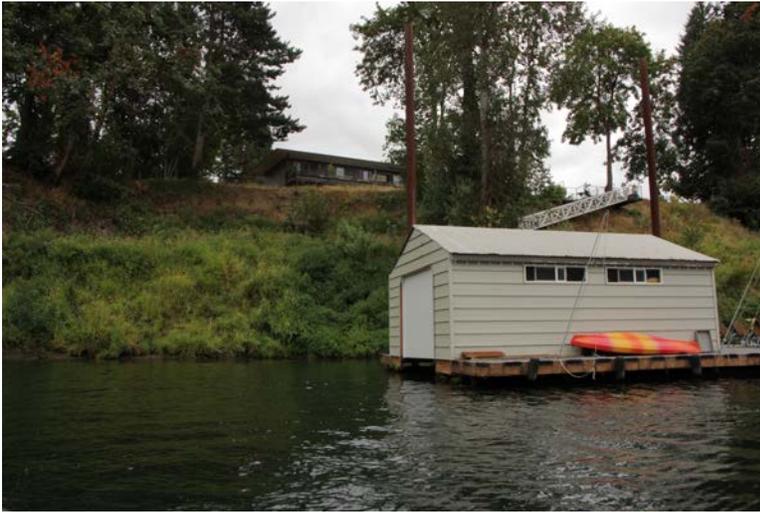
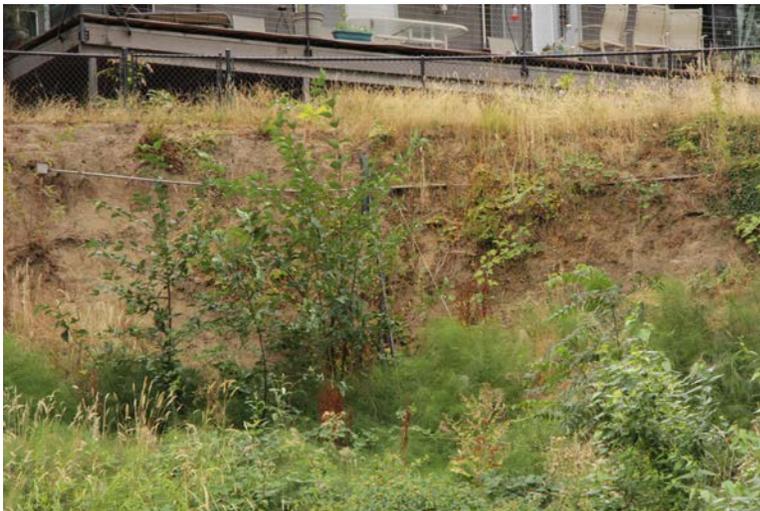
Photo WR-18A

Photos WR-18A and WR-18B were taken at Photo Point WR-18 within the Towed Water Sport Zone but outside of the Wake Surfing and Water Skiing Zone (see map above). The lower part of the river bank is vegetated with mostly Reed Canary Grass (*Phalaris arundinacea*), some young trees, and Scouring Rush (*Equisetum arvense*) and shows no sign of boat wake erosion. The upper bank has undergone significant mass failure. There is a black

plastic pipe located in the approximate center of the bank failure. It is probably that prior to placement of the pipe there was a stormwater discharge to the top of the slope that may have contributed to the failure. The over-steepened river bank is prone to further erosion and mass failure during future wet seasons.

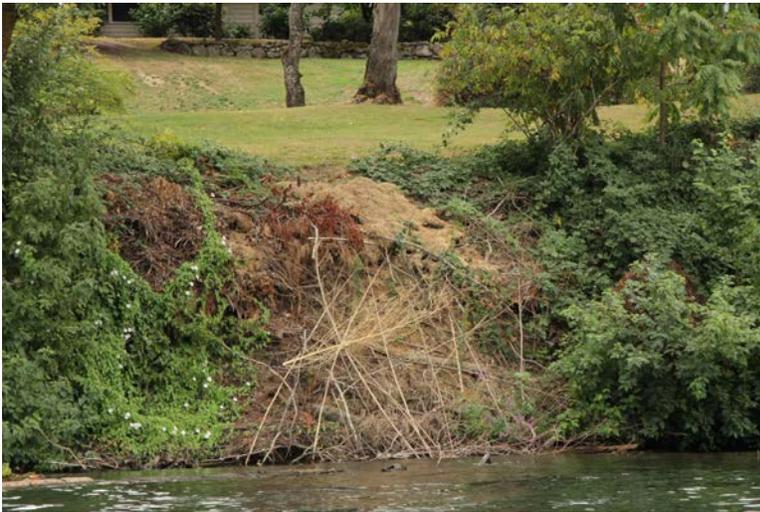
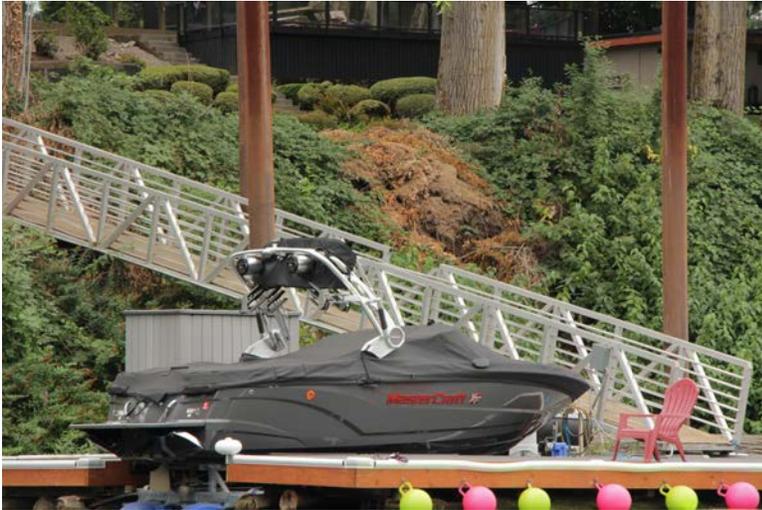
Photo WR-19A through WR-19C were taken at Photo Site 19 within the Towed Water Sport Zone but outside of the Wake Surfing and Water Skiing Zone (see map above). The property owner(s) at this location are dumping yard debris down the river bank. The yard debris is acting as a mulch to prevent native woody vegetation from growing from the dump location, thereby increasing the probability that a high flow event will scour out the area under the debris and

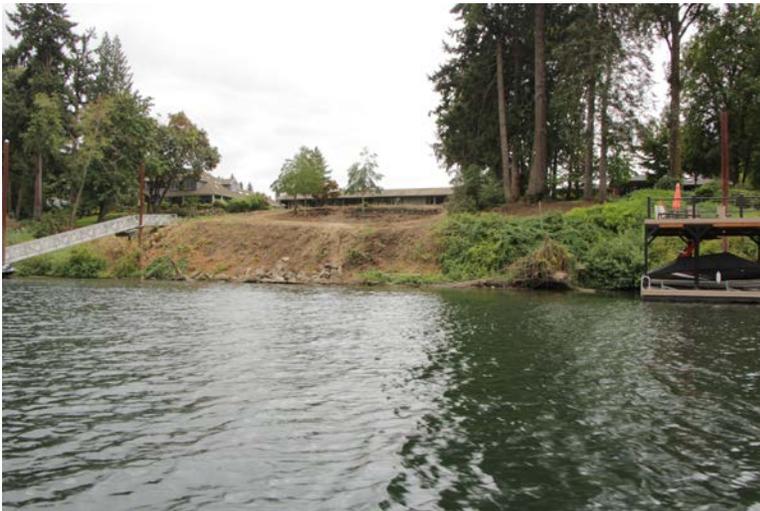
Photo WR-20A

Photos WR-20A through WR-20D were taken at Photo Point 20 within the Towed Water Sport Zone but outside of the Wake Surfing and Water Skiing Zone (see map above). The bare soil all along the river bank and what appears to be a material haul road suggests that fill was recently added to the bank. The rip rap at the toe of the slope appears to have been dumped over the bank rather than carefully placed, and may actually lead to bank scour at higher river

flows. The bank is essentially devoid of vegetation and is highly prone to scour. Despite the loose soil and the lack of vegetation, there is not evidence of boat wake caused erosion.

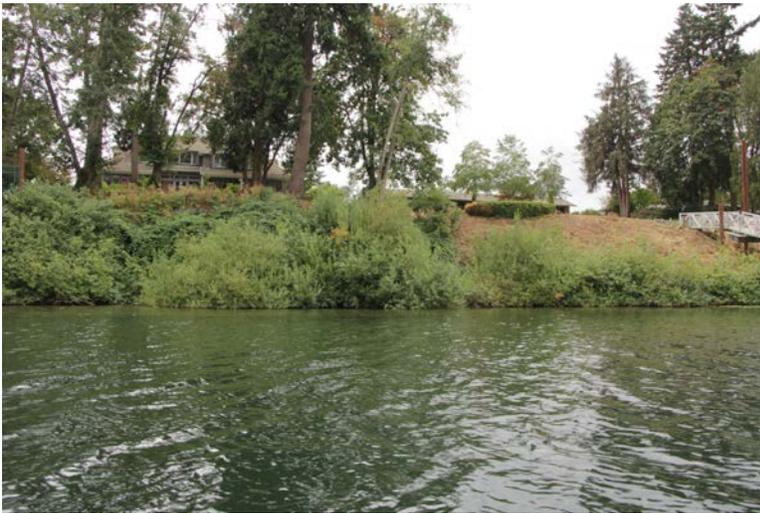
Photo WR-21A

Photos WR-21A and WR-21B were taken at Photo Point 21 within the Towed Water Sport Zone but outside of the Wake Surfing and Water Skiing Zone (see map above). The river bank on this property has some mass failure mostly hidden under the Himalayan blackberry canes toward the upper bank, but the lower bank has some healthy riparian woody vegetation that should be protective of the bank. This property was included here

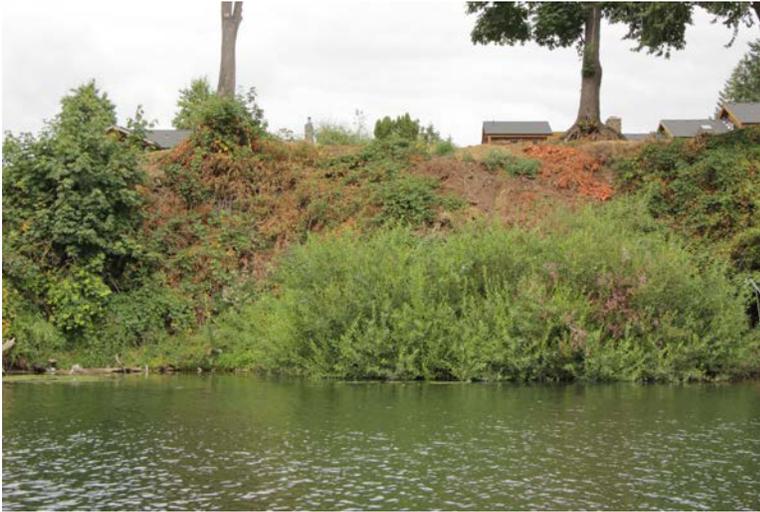
Photo WR-23A

Photos WR-23A and WR-23B were taken at Photo Point 23 within the Towed Water Sport Zone but outside of the Wake Surfing and Water Skiing Zone (see map above). Much of this bank is covered with Himalayan blackberry with some willow on the lower portion of the slope. The blackberry makes the appearance of providing vegetative cover, but underneath the blackberry bushes is bare soil. The blackberry bushes prevent native vegetation from

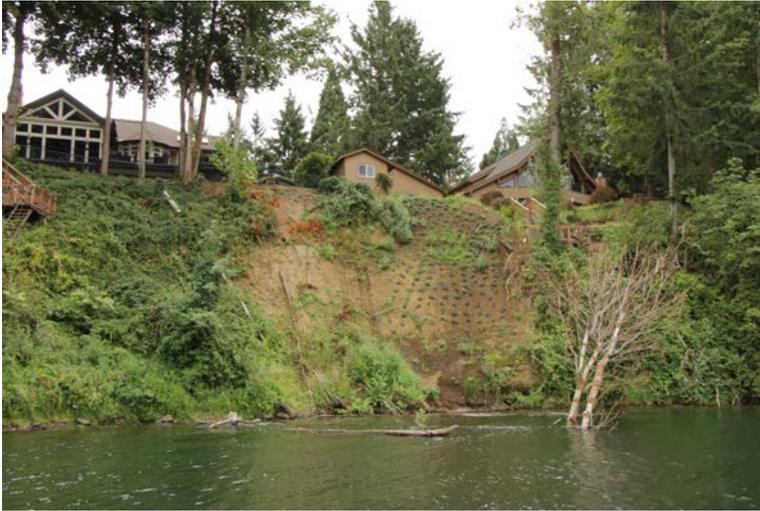
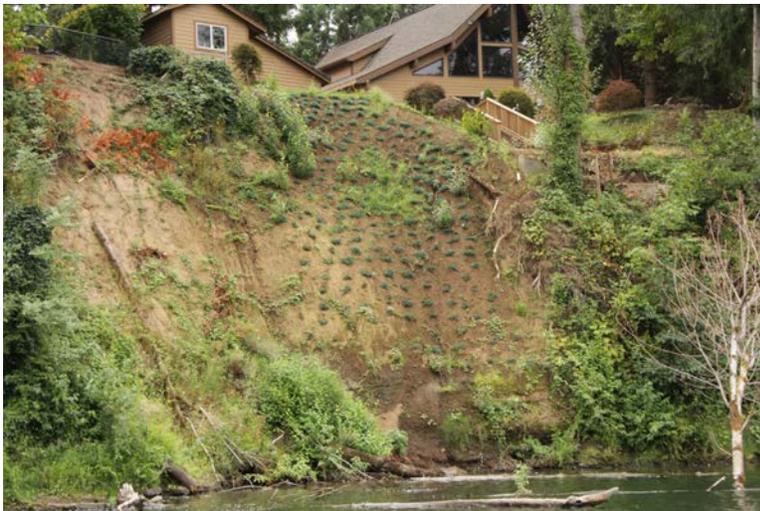
Photo WR-24A

Photos WR-24A through WR-24D were taken at Photo Point 24 within the Towed Water Sport Zone but outside of the Wake Surfing and Water Skiing Zone (see map above). This mass failure appears to be the result of the discharge of water at the top of the slope. A white PVC pipe can be seen in the upper right hand corner of Photo WR-24B and is one source of water. Photos WR-24D and WR-24E show erosion rilling down the face of the slope from a

water source that is still discharging and keeping the bank soil moist. The toe of the slope is completely exposed bare soil and shows some signs of wave erosion. However, the greatest threat to the river bank is the discharge of water at the top of bank and the nearly complete lack of riparian vegetation. The placement of landscaping plants on the slope is not likely to protect the slope from bank scour in the short or long term.

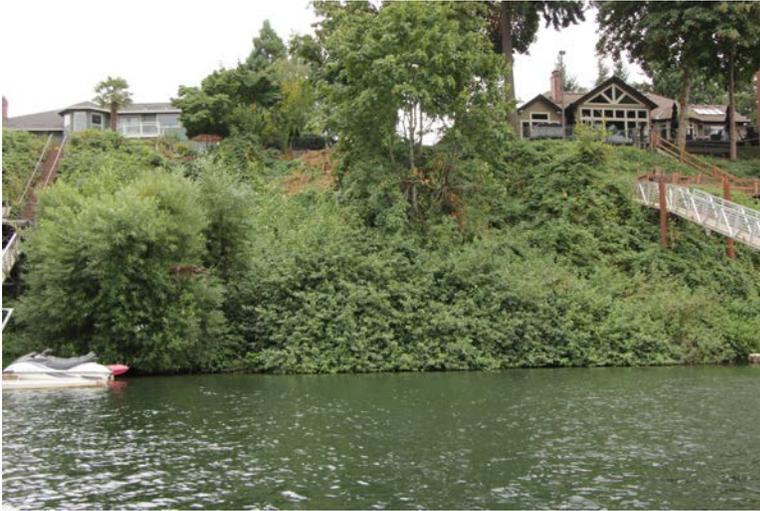
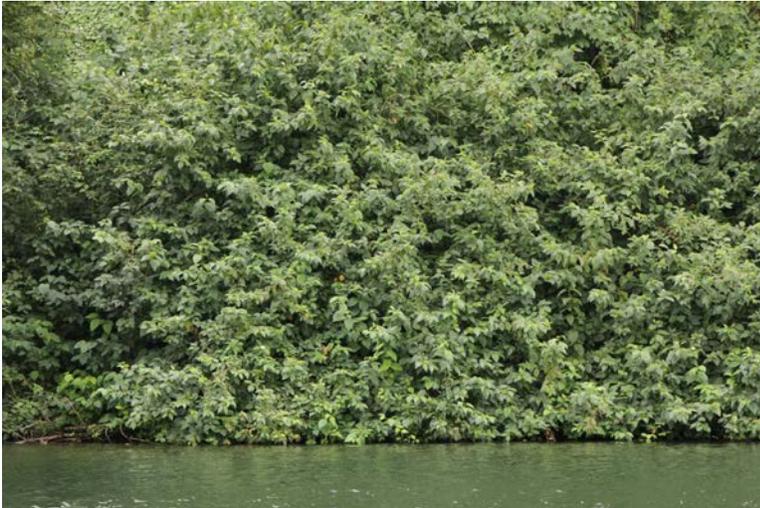
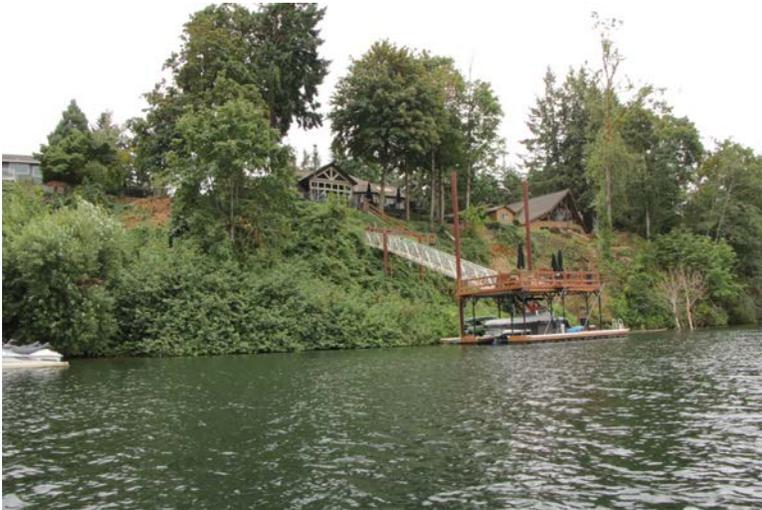
Photo WR-25A

Photos WR-25A through QWR-25D were taken at Photo Point 25 within the Towed Water Sport Zone but outside of the Wake Surfing and Water Skiing Zone (see map above). These photos are of the property just downstream of the property described above. They have been included here as a contrast to the river bank conditions shown in photos WR-24. The river bank on this property has dense riparian vegetation of willow and dogwood on the lower

half of the bank. There is no sign of bank scour, mass failure, or boat wake erosion.

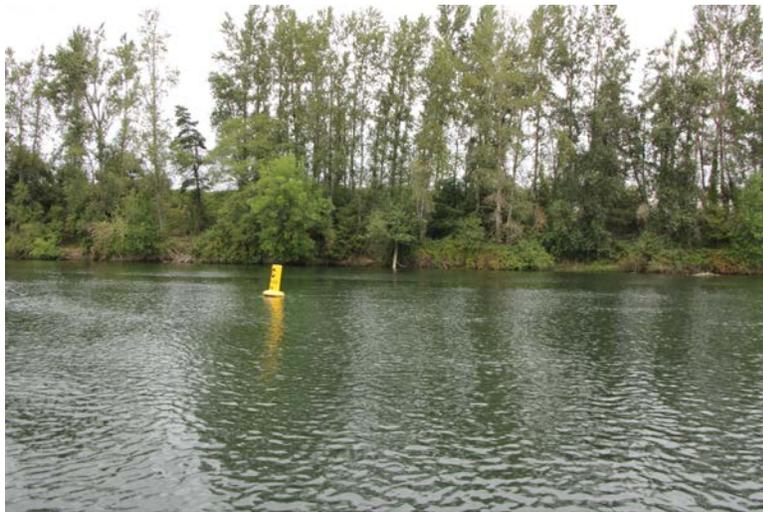
Photo WR-26A

Photos WR-26A through WR26C were taken at Photo Site 26 within the Towed Water Sport Zone and within the Wake Surfing and Water Skiing Zone (see map above). Photo site 26 is located at the upper end of the Surf Zone 2 at RM 33.2. Landuse on the left bank is agricultural and on the right bank is a combination of recreational (a golf course) and agricultural. Neither bank shows noticeable erosion or bank failure.

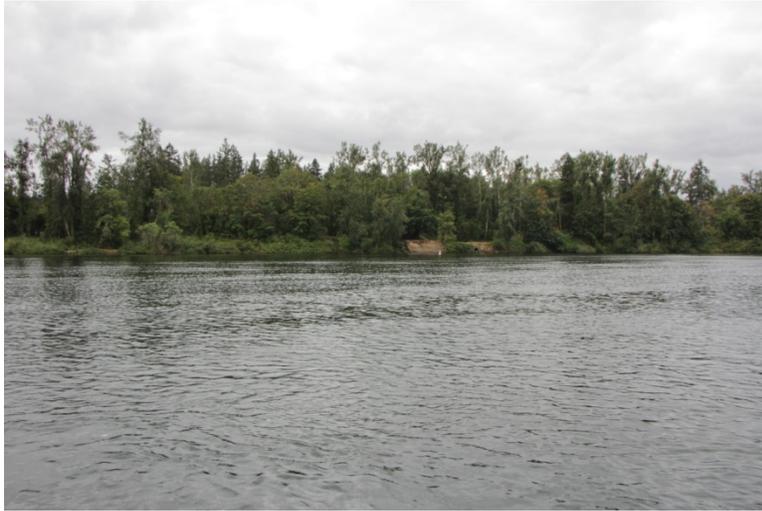
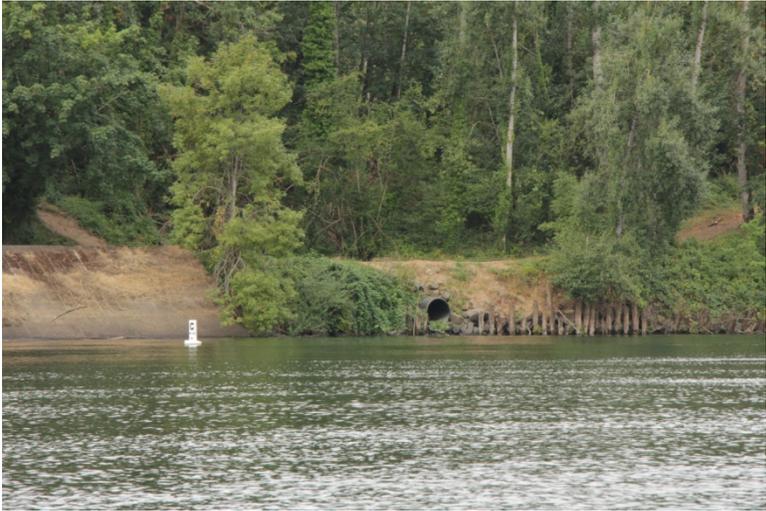
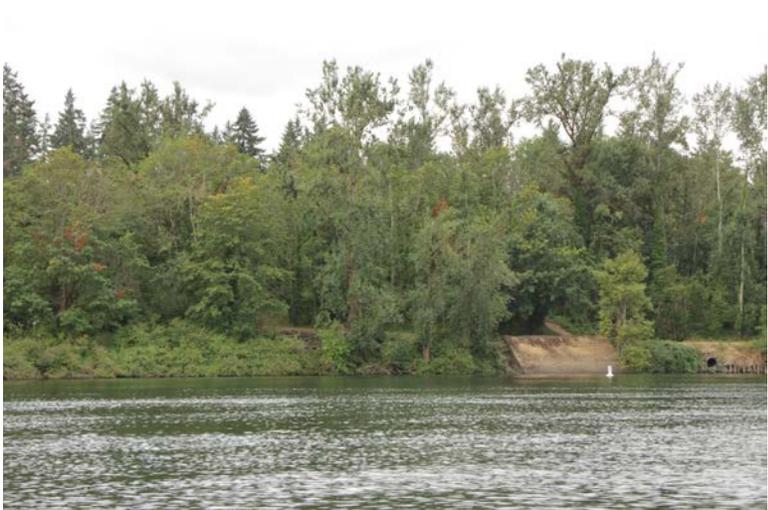
Photo WR-27A

Photos WR-27A through WR27C were taken at Photo Site 27 within the Towed Water Sport Zone and within the Wake Surfing and Water Skiing Zone (see map above). Photo site 27 is located at the upper end of the Surf Zone 2 at RM 33.2. Landuse on the left bank is agricultural and on the right bank is a combination of recreational (a golf course) and agricultural. Neither bank shows noticeable erosion or bank failure. There are some areas of the bank

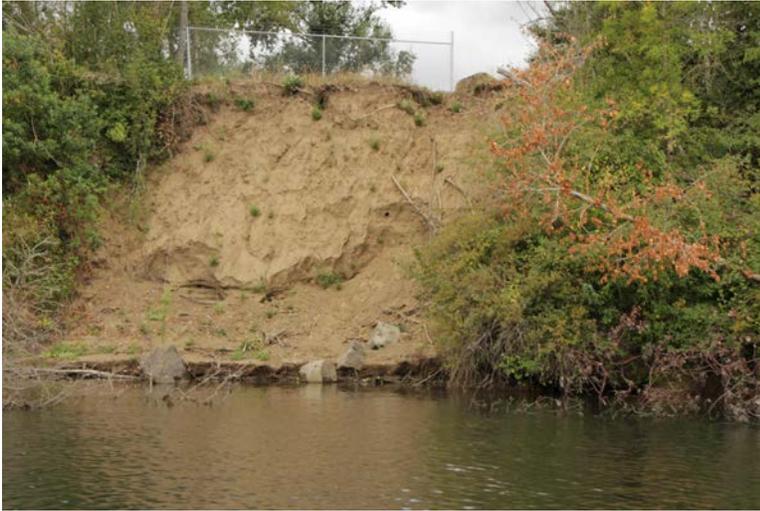
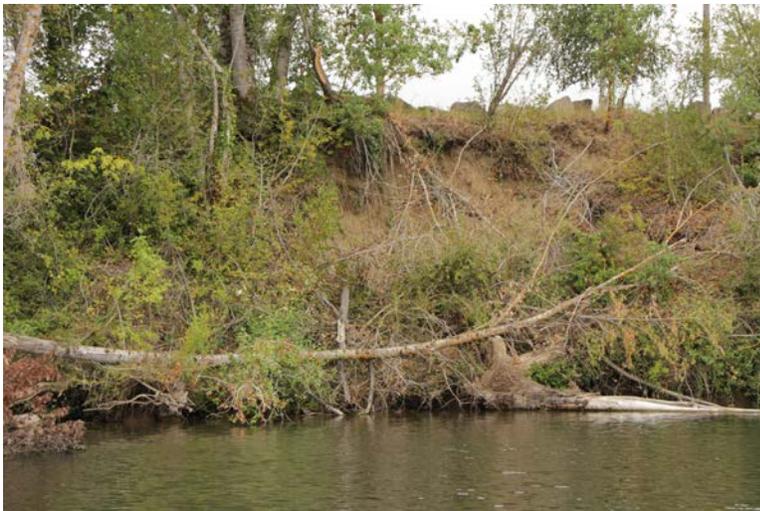
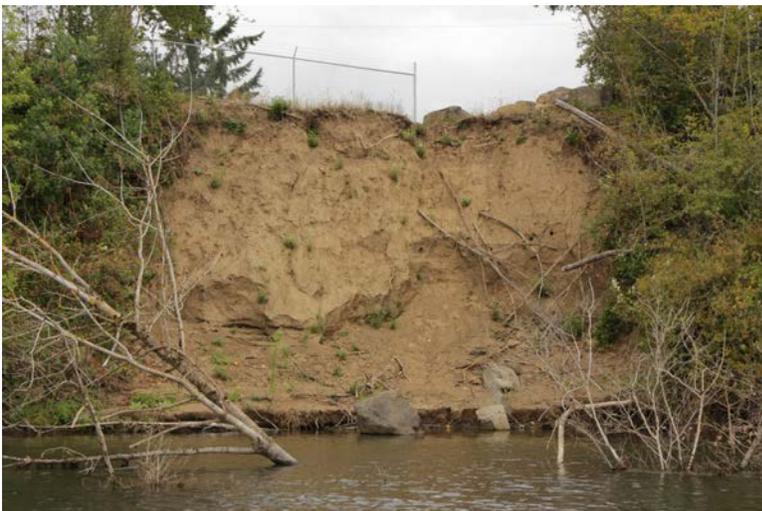
Photo WR-29A

Photos WR-29A through WR-29D were taken at Photo Site 29 within the Towed Water Sport Zone and within the Wake Surfing and Water Skiing Zone (see map above). These photos show a combination of mass failure and bank scour. Potential contributing factors to the mass failure include the existence of a construction road at the top of the river bank and the associated placement of boulders at the top of bank. The added weight of the boulders and

construction vehicles plus the vibration of the traveling construction vehicles are likely contributors to the mass failure. Multiple dump trucks traveled this road to haul in sand to create an artificial beach for the unfinished resident at the end of the road. The bank scour may have been caused by boat wakes or higher river flows. Bank scour shown in Photo WR-29C appears to be caused by high river flows.

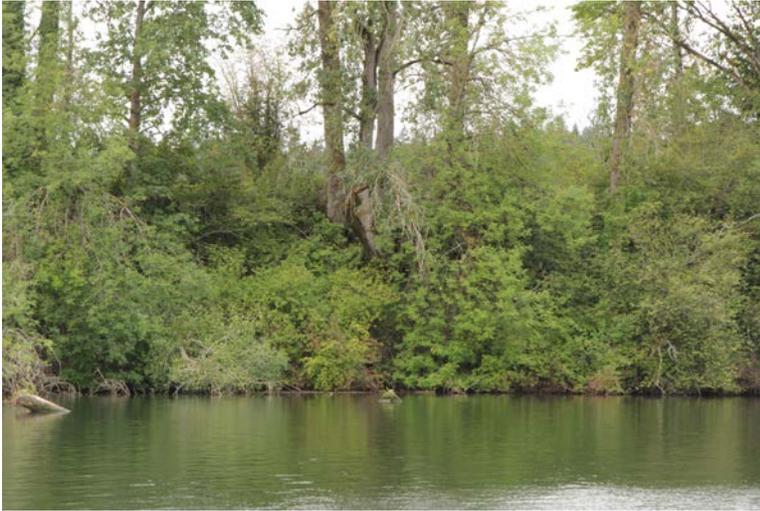
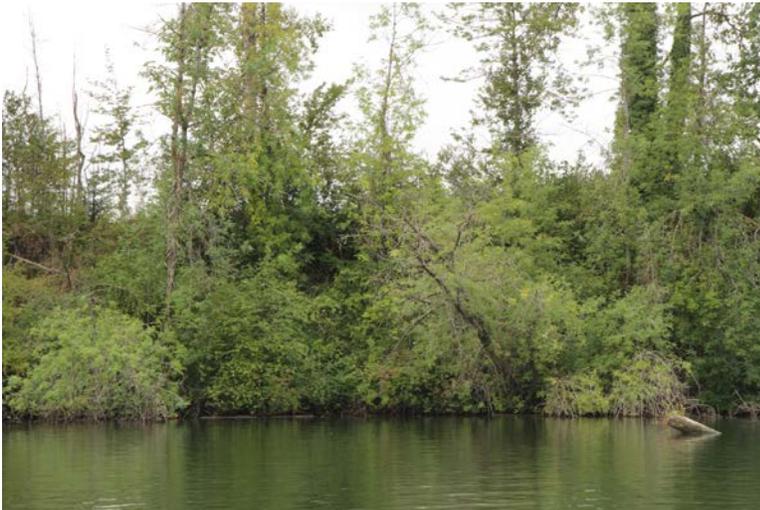
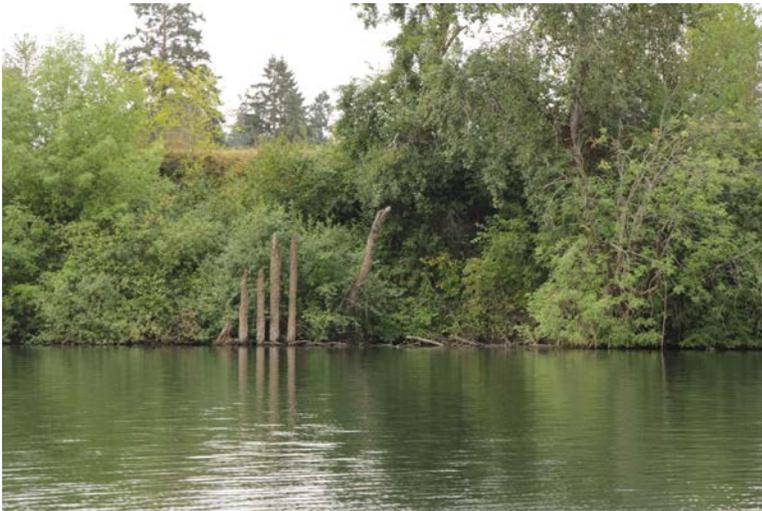
Photo WR-30A

Photos WR-30A through Wr-30F were taken at Photo Point 30 within the Towed Water Sport Zone and within the Wake Surfing and Water Skiing Zone (see map above). This series of photos is of the right bank in the approximate center of Surf Zone 2 where the frequency and magnitude of boat wakes would be expected to be greatest. Land use adjacent to the bank is agriculture with little or no disturbance to the riparian vegetation. There is no evidence of

boat wake erosion, bank scour from high river flows, or mass failure. If boat wakes were the cause of bank erosion within the the Towed Water Sport Zone and within the Wake Surfing and Water Skiing Zone it should be evident at this location, but it is not.
