**Willamette River Newberg Pool
Towed Water Sport Zone and
Wake Surfing and Water Skiing Zone
River Bank Erosion Documentation and Evaluation**

David Gorman, PE
Ecological Engineering, LLC
2016 SE Henkle Road
Corbett, Oregon 97019

September 10, 2021

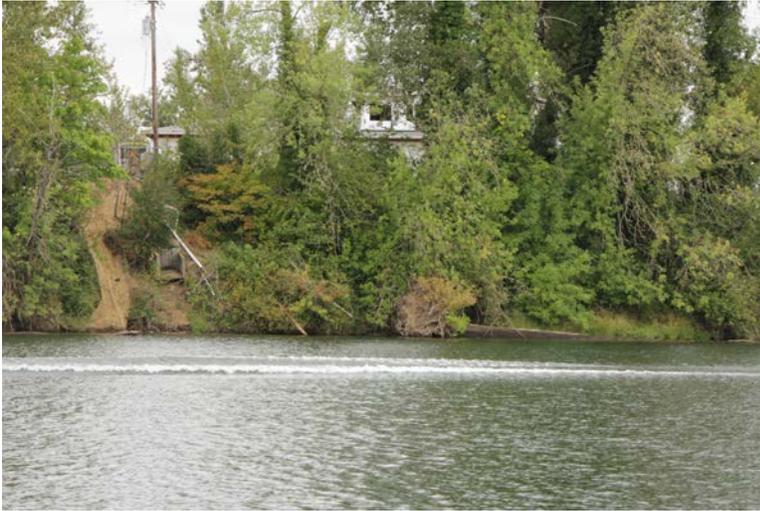
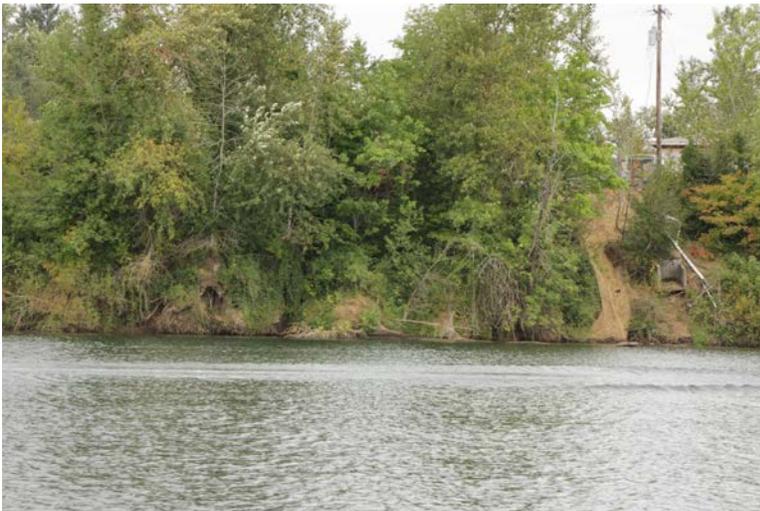
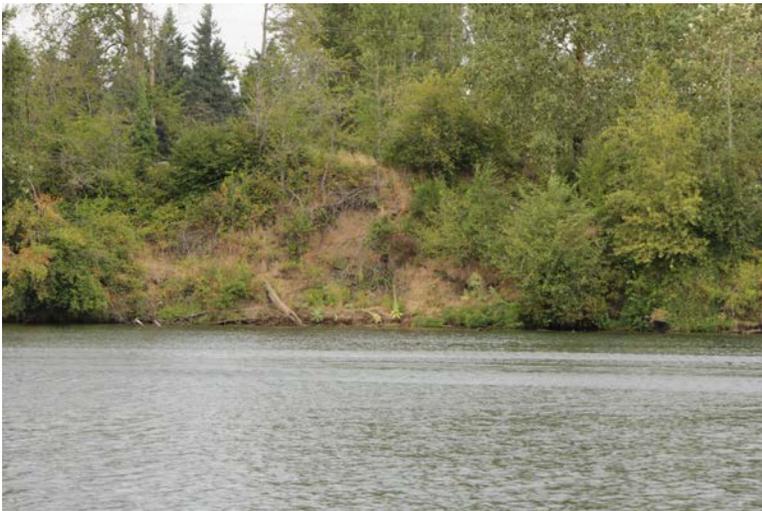
Photo WR-31A

Photos WR-31A through WR-31I were taken at Photo Point 31 within the Towed Water Sport Zone and within the Wake Surfing and Water Skiing Zone (see map above). This series of photos is of the left bank in the vicinity a very large unfinished house. The access road to this house is the same as that discussed above for Photo Point 29. Bank erosion is evident in Photos WR-31A through WR-31 primarily where human activity has been the greatest and healthy

riparian vegetation is lacking. Most of the erosion is above the boat wake zone and is likely caused by high river flows against poorly vegetated banks.

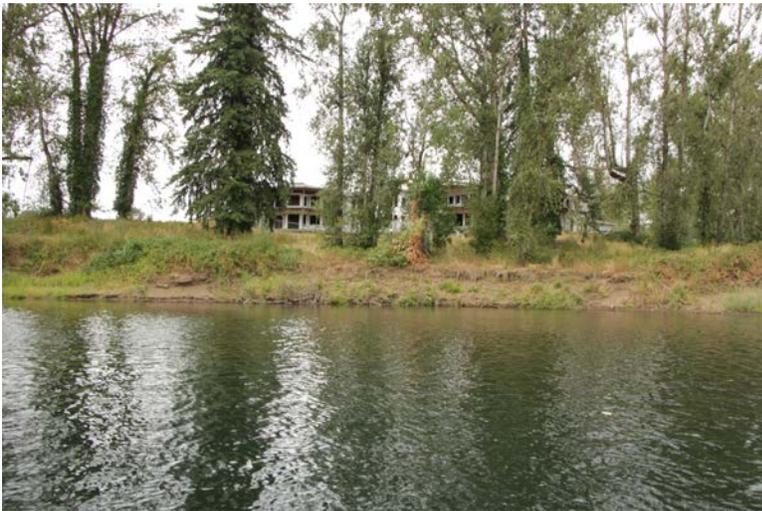
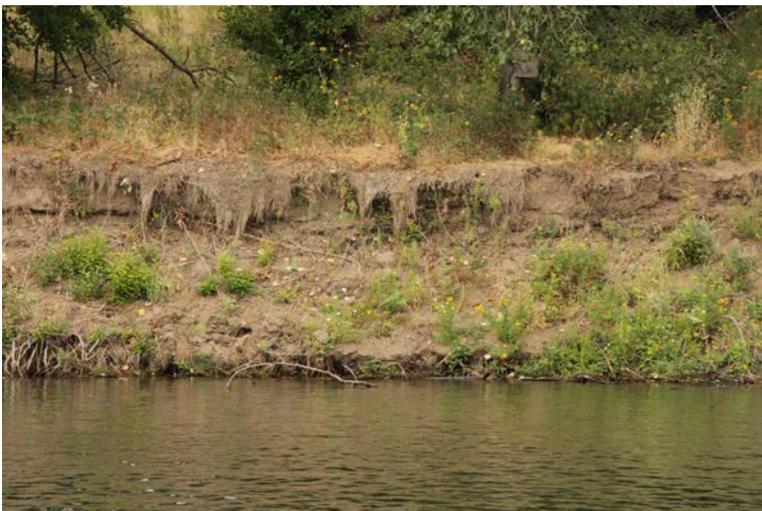
Photo WR-31F

Bank erosion shown in Photos WR-31F through WR-31H may have been caused by boat wakes. However, the bank erosion is only prevalent in those areas of the bank that have had the riparian vegetation removed. See Photos WR-30A through WR-30F taken across the river from Photo Point 31 for comparison with these photos.

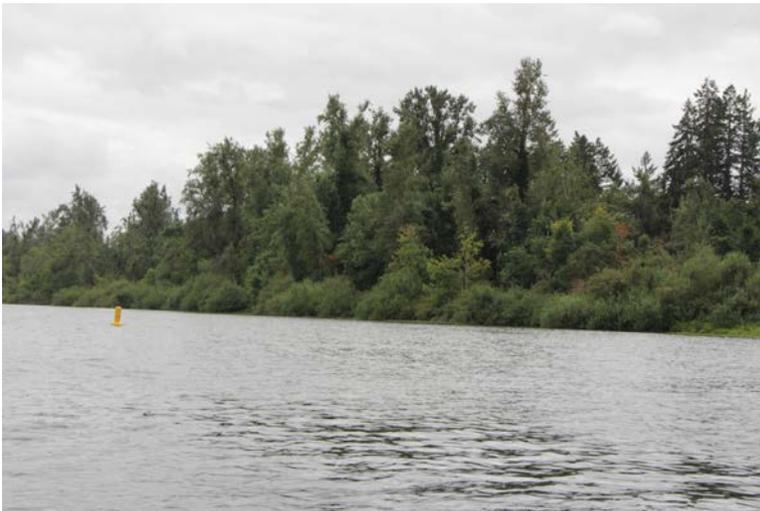
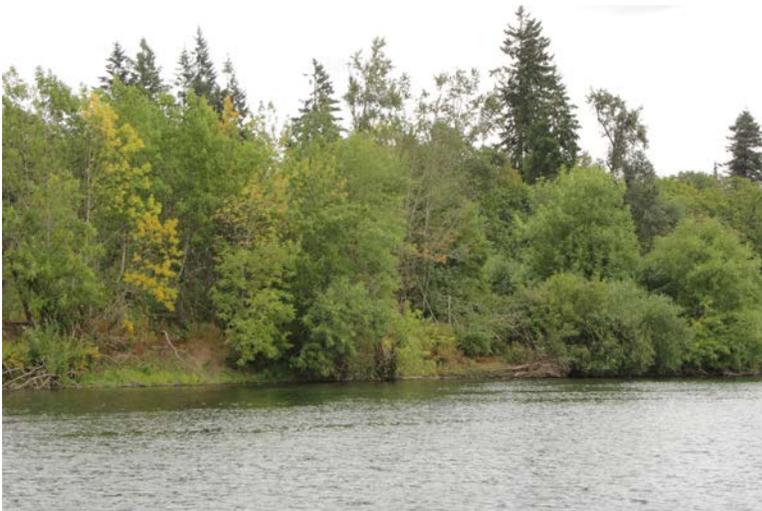
Photo WR-32A

Photos WR-32A through WR-32C were taken at Photo Point 32 within the Towed Water Sport Zone and within the Wake Surfing and Water Skiing Zone (see map above). This series of photos is of the relatively undisturbed right bank at the lower end of Surf Zone 2. Land use along the right bank is a mix of agricultural, residential, and industrial. None of these uses has caused significant disturbance to the riparian zone. The right bank is subjected to the same boat

wakes as the left but there is no evidence of erosion or bank failure from boat wakes, high flow bank scour, or mass wasting. The river bank looks healthy and stable.
