Subject: Testimony in support of SB 726, Landfill Methane Monitoring

Summary of the 2024 EPA Clean Air Act Inspection at Coffin
Butte Landfill

Clean Air Act Partial Compliance Evaluation Inspection Report

Valley Landfills Inc. Coffin Butte Landfill

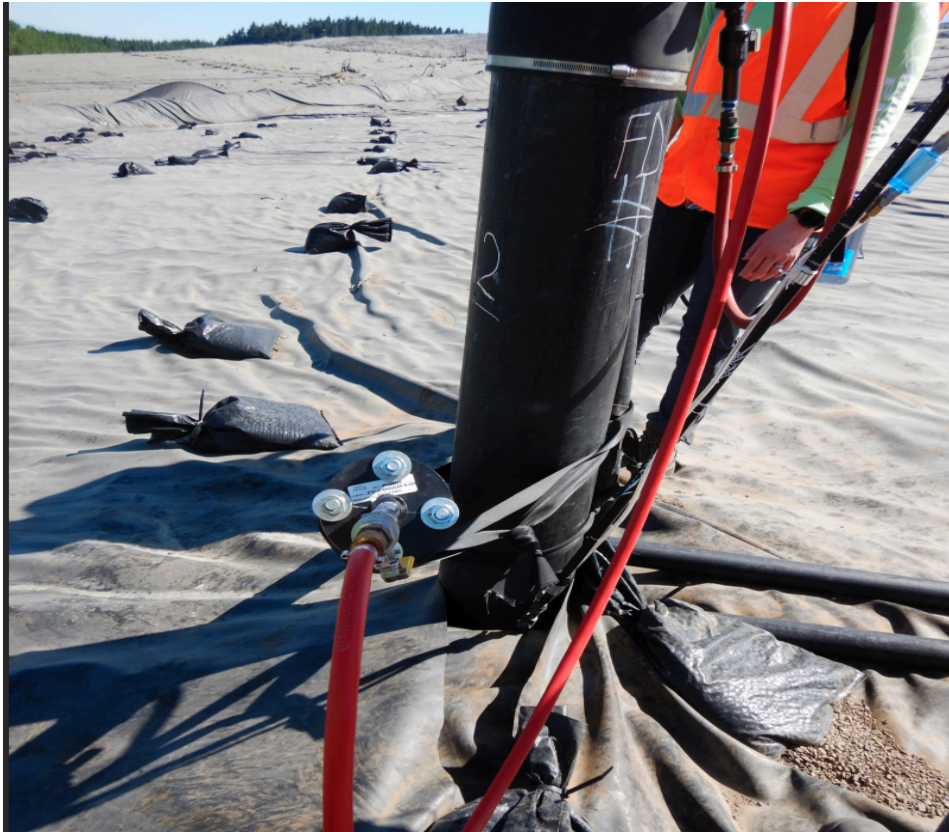
Example 1 - 4,000 ppm Methane Exceedance at gas collection piping/equipment

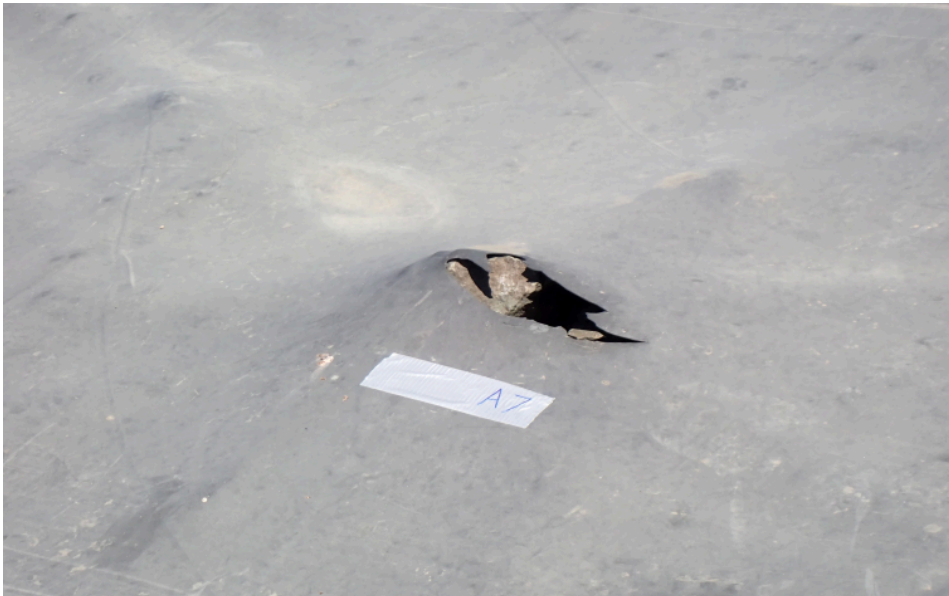
Example 2 - 20,000 ppm Methane Exceedance from small tear in the tarp

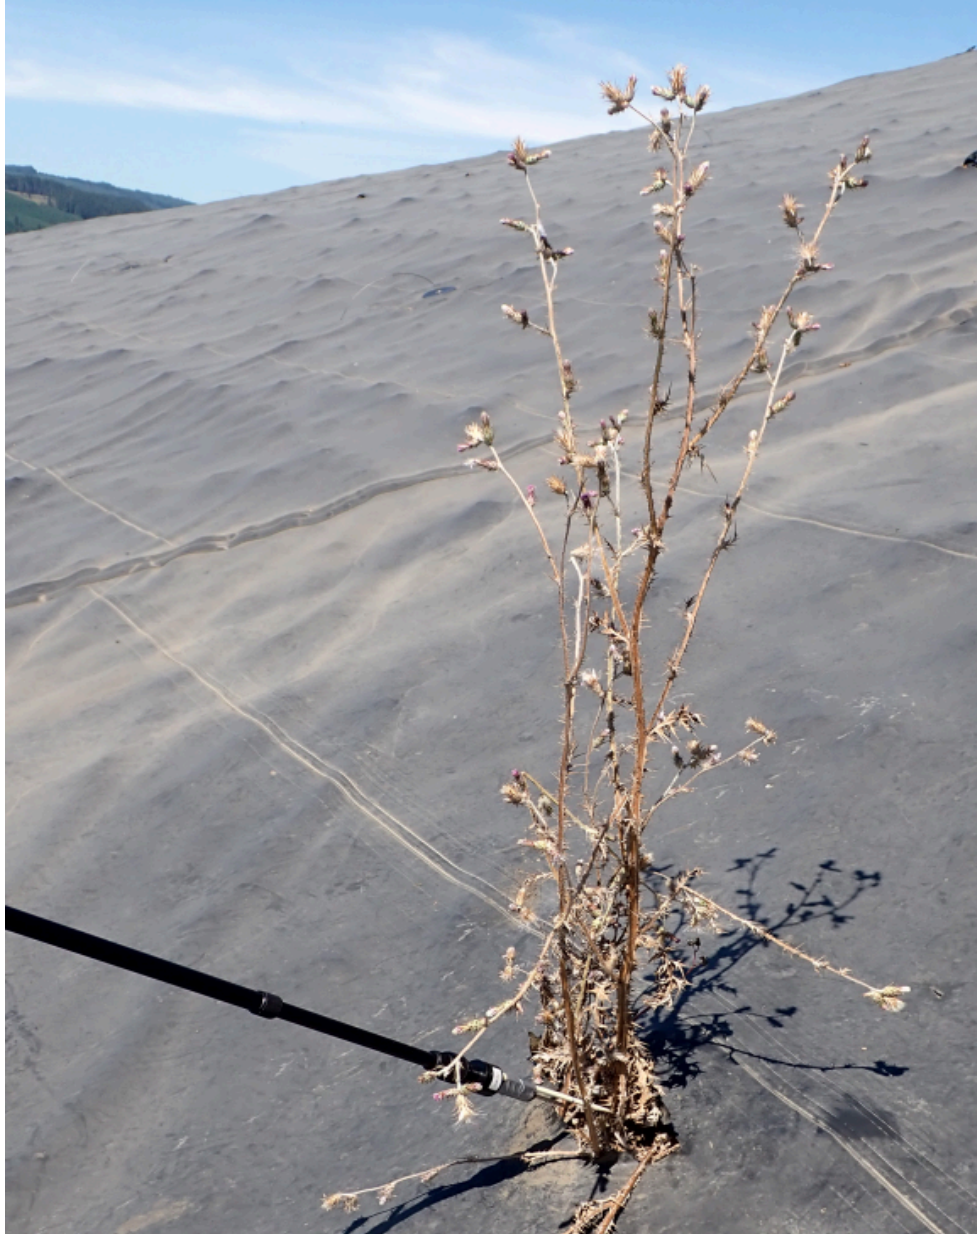
Example 3 - 800 ppm Methane Exceedance measured where a weed punctured the tarp

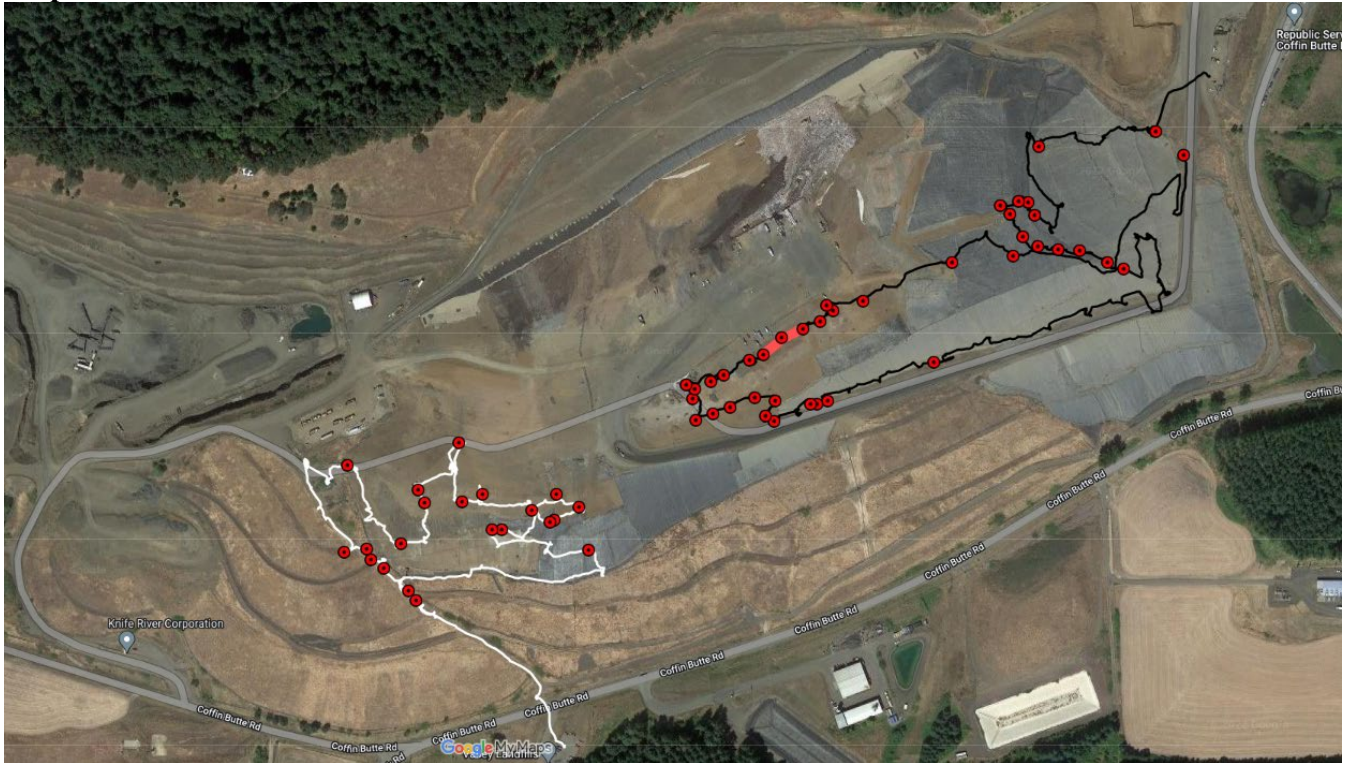
Map of Detected Exceedances

SEM exceedance locations plotted over Google Maps satellite imagery. Approximate monitoring paths included, derived from GPS data. Morning path shown in white, afternoon in black. Line of continuous exceedance at every tarp hole between flags 52 and 54 is highlighted in red.
