Willamette Falls Canal and Locks

*Independent Condition Assessment and Recommendations for
Recommissioning, Escalated for 2026 Construction Costs*

Prepared for:
Willamette Falls Locks Authority

Prepared by:
KPFf Consulting Engineers
1601 Fifth Avenue, Suite 1300
Seattle, WA 98101
(206) 382-0600

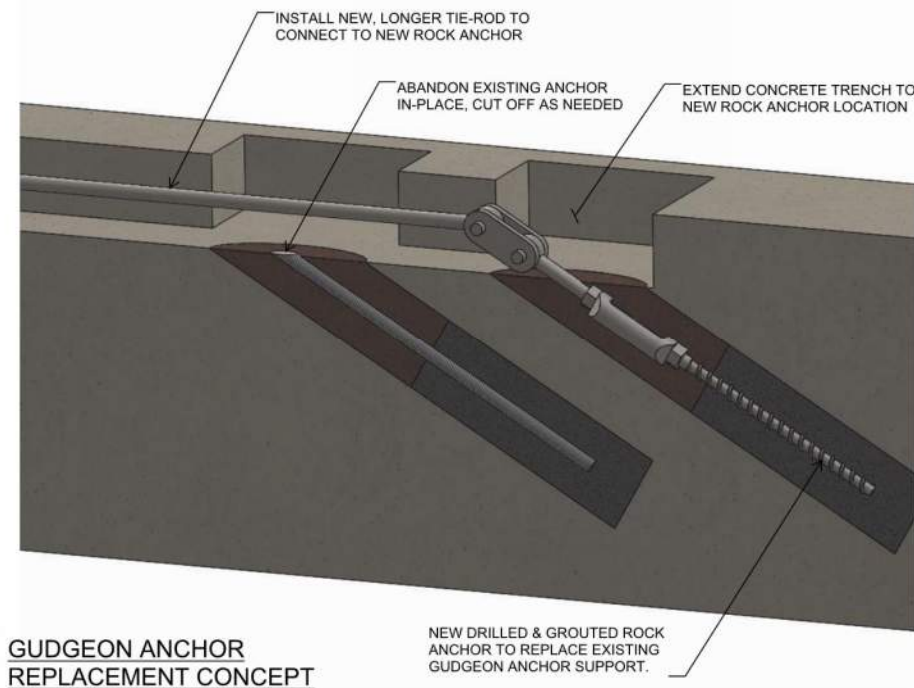
The gudgeon anchorage system for the miter gates was observed to be in poor condition and to be consistent with conditions described by previous inspection reports. The gudgeon anchorage system consisted of anchor rods either buried in the lock wall structure, for the rods parallel with the lock, or buried a significant distance below grade, for the rods perpendicular to the lock. The exposed linkage components connected these anchor rods to the gudgeon pin. The true condition of the buried anchor rods could not be assessed without substantial excavation. Based on the anchorage movements observed at Gate 3 and on corrosion issues noted in previous reports, we concluded that these anchor rods should be replaced to support reliable and safe operation of the miter gates in the future. Portions of the exposed linkage components appeared to be in relatively good condition and could have been refurbished to provide safe and reliable operation.

9. Replace Corroded Gudgeon Anchorages (\$780K): This wasn't one of the highest cost items, however it was heavily discussed in previous reports. This estimate assumed all gudgeon anchorages needed to be replaced for Gates 2, 3, 4, 5, 6, and 7 to mitigate any concerns regarding the safety of these anchorages. For the anchor rods parallel to the lock, these rods were assumed to be replaced in kind. For the anchor

rods perpendicular to the lock, the approach was to abandon the existing anchor rod in place and install new drilled in and grouted rock anchors a few feet further back from the gate and then install longer tie rods to connect to the gate. This was true for all perpendicular gudgeon anchors except at Gates 4 & 5 Mill side, where they were replaced in kind. This recommendation for repair and scope of work was different from the 2011 USACE evaluation, which recommended abatement of existing corrosion and replacing only a handful of pieces of hardware, which did not address the potential for corroded and buried anchorages which were not accessible for inspection. See the figure below for a conceptual sketch of the replacement gudgeon anchor.
