**SUBJECT:** CLEAN AIR ACT INSPECTION REPORT  
Waste Connections Finley Buttes Landfill, Boardman, OR

**Facility Name:** Waste Connections Finley Buttes Landfill

**Date of Inspection:** On Site Inspection: June 29, 2022  
Virtual Conference: July 6, 2022

**Purpose of Inspection:** Surface emissions monitoring (SEM) and evaluating compliance with landfill air rules.

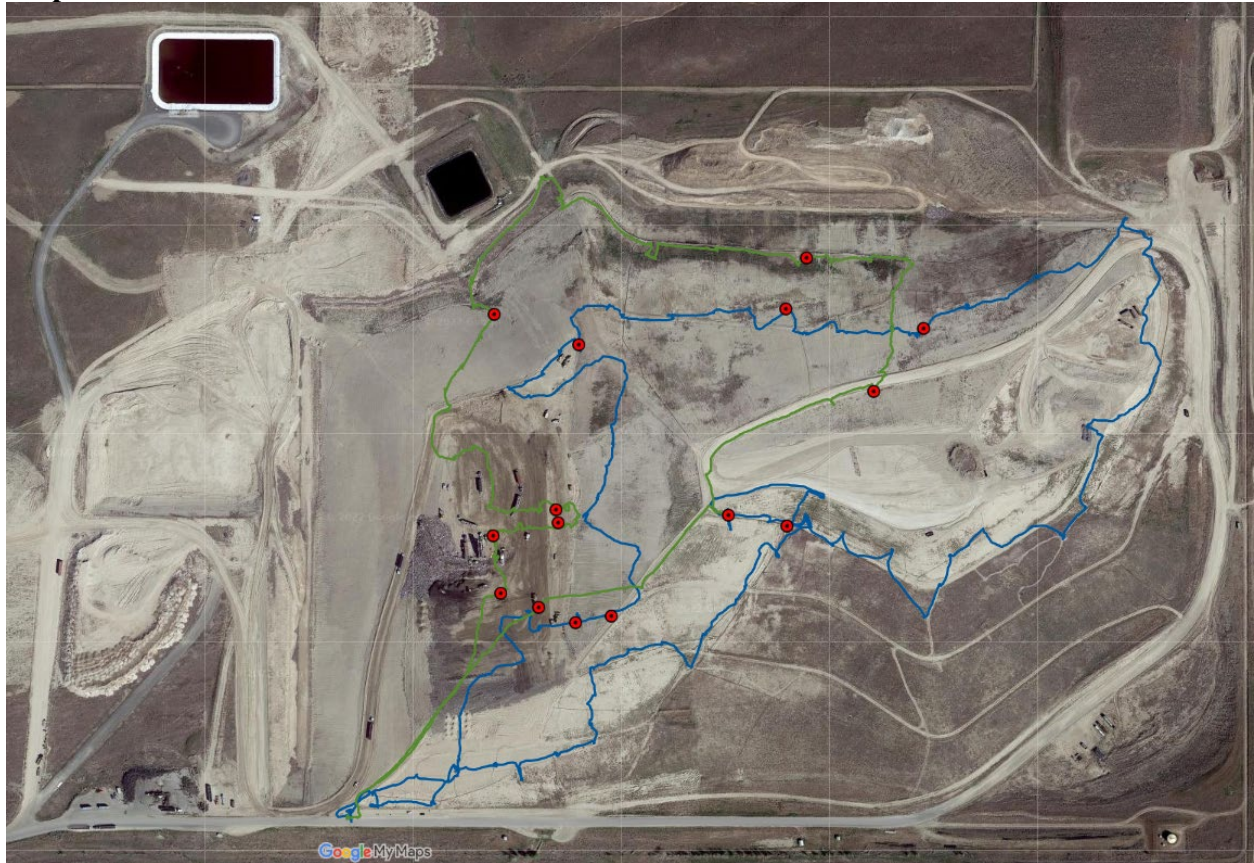
#### Map of Detected Exceedances

EPA detected 15 points in exceedance of the surface methane standard. Five exceedances were at points of cover penetration by the GCCS and five exceedances were at locations with clearly identifiable exposed waste.

SEM exceedance locations plotted over Google Maps satellite imagery dated to April 2021. Approximate monitoring paths included, derived from GPS data. Morning path shown in blue, afternoon in green.
