# **WILLAMETTE HERITAGE CENTER**

## **EXTERIOR SITE AND BUILDING OBSERVATIONS**

NOVEMBER 2024

**CBTWO**  
ARCHITECTS<sub>LLC</sub>

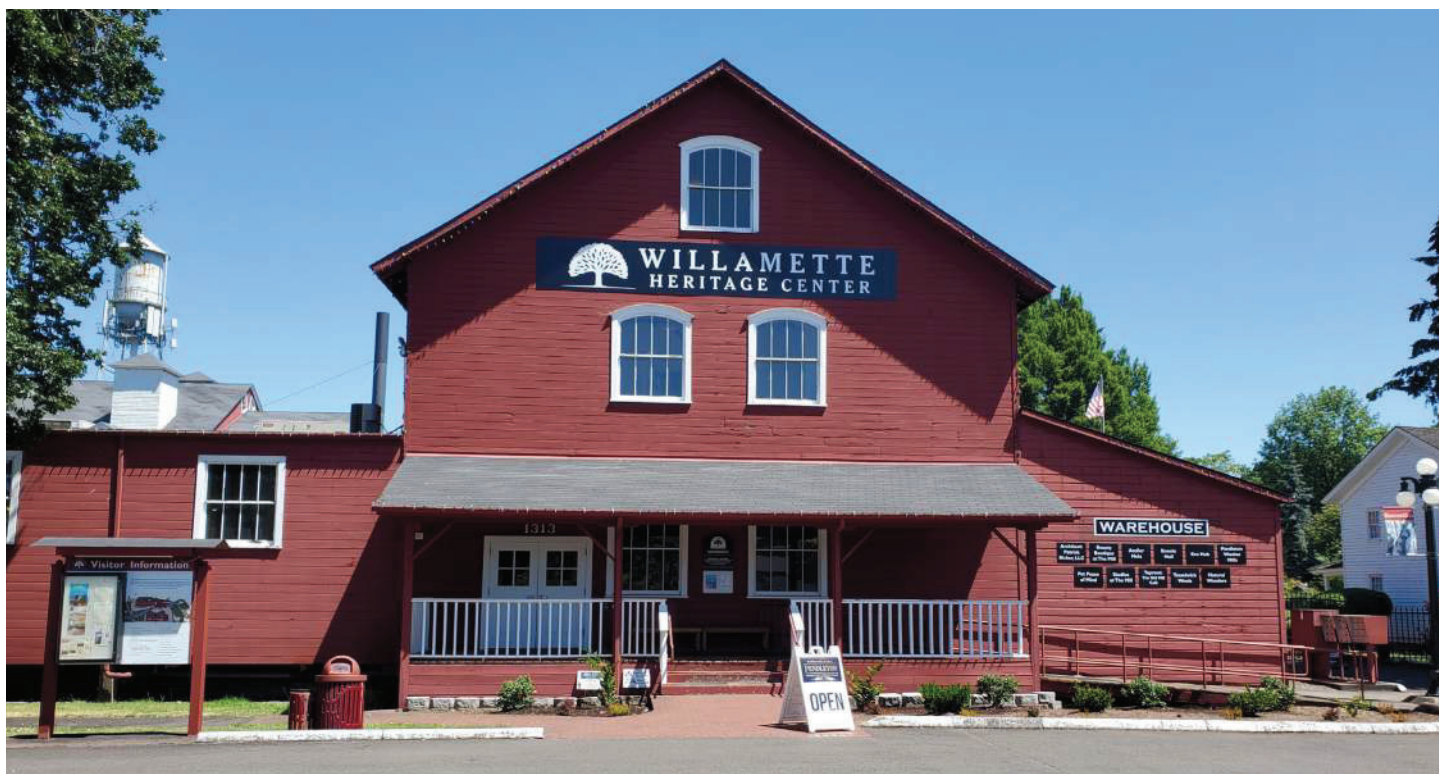
The Warehouse serves as the front door for the entire WHC campus, providing the first impression for visitors and staff. In addition to the cosmetic repair needed on the building, some accessibility improvements will likely be required.

On the wooden decks, several boards are warped or pulling away from the substructure, causing an uneven surface with tripping hazards (Figure 5.1). The sliding gate serving as the main entry to campus currently remains opened during operating hours, but the swinging side gate serves as the main exit point when the sliding gate is closed. This gate is accessed through a gravel walkway, which is not an accessible route (Figure 5.5).

There were many instances of damage to siding and window trim, leading to water intrusion and eventual wood rot. In some areas, siding has chipped or broken away, leaving exposed nailheads and an unknown plastic substrate (Figure 5.2). At window and door trim heads, there appears to be no caulk, waterproofing, or flashing used to deflect water away, which is allowing for water intrusion behind the trim and moss growth (Figure 6.3). A electrical panel was observed splitting away from wooden mounting plate on the east wall of the building (Figure 5.4).

Finally, masonry foundations appear to be in generally good condition, but appear to include some temporary solutions. Wood shims and other material have been placed on top of masonry piers, which are exposed to weather (Figure 7.1). Flashing is observed at piers which are slightly proud of exterior siding, but the flashing in some cases do not extend the full length of the pier, allowing for water intrusion (Figure 7.2).

Observation	Figure	Priority
Uneven boardwalk surfaces, and a mix of historic and non-historic boards used from previous repairs	5.1	Low
Chipped/rotting siding, allowing for water intrusion	5.2, 6.1, 6.4,	High
Siding reveal type changes occur on front elevation	5.3	Low
Panel breaking away from siding	5.4	Low
After-hours exit not accessible due to gravel path	5.5	Mid
Doorway/window trims are rotting, exhibiting moss growth and likely contributing to water intrusion	6.2, 6.3	High
Masonry foundations are flashed inappropriately and built up with improper materials, many of which do not appear historically accurate	7.1, 7.2	Mid
West door missing flashing and trim	7.3	Low
Siding nails are rusting/deteriorating	7.4	Mid

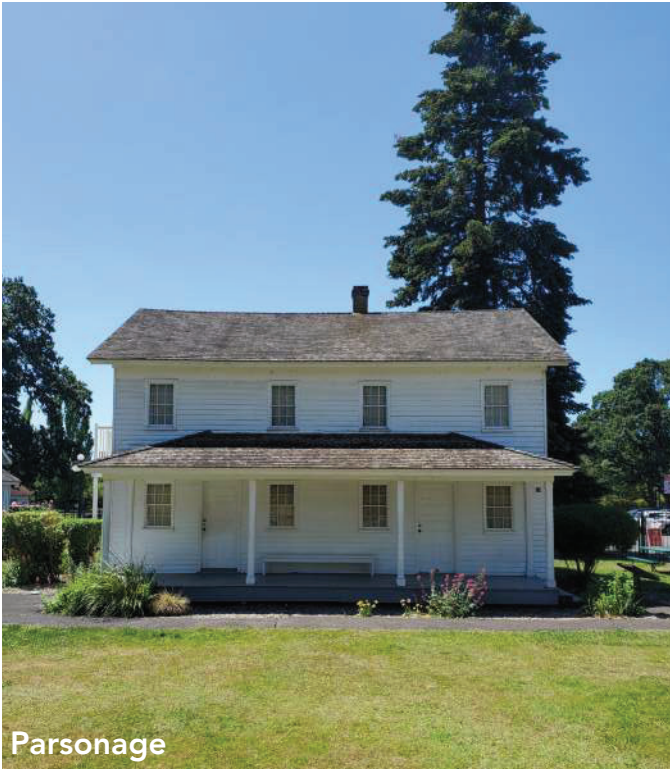
The Parsonage exterior displays some of the heaviest weathering and damage observed among the buildings on campus, especially in regard to the category of buildings that were relocated to the WHC campus.

Primary weathering damage occurs at transitions at first floor building corners (Figure 9.1), walls against roof shingles due to lack of step flashing (Figure 9.3), and exposed doors and window trim (Figure 9.5). A column supporting the east edge of the front porch roof is showing signs of significant structural damage, with the wood base splitting apart and wind-driven water intrusion evident. The wood boards on the second floor stairway landing are showing significant weathering, with the railing supports and joints beginning to split away.

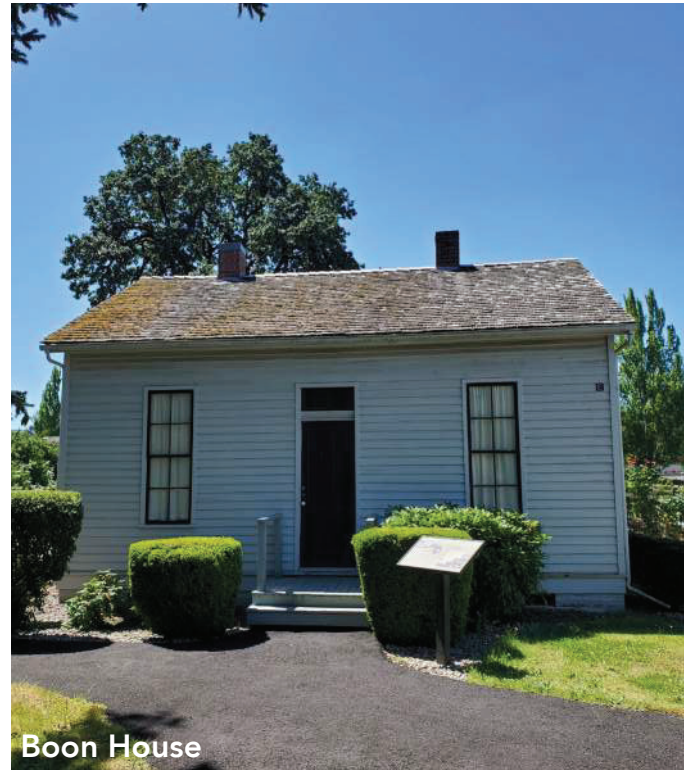
The Boon House has very similar issues as the Parsonage, though to a lesser degree of damage. The trim at the southeast corner wall base has significant damage (Figure 10.4), and the siding against the roofing is rotting at the end grain of the wood (Figure 10.5). The roof shingles appear to be nearing their end of life, with significant moss growth across the entire surface (Figure 10.1). Siding on the east elevation in particular is warping and bowing, creating an uneven surface where water can intrude behind the siding.

Observation	Figure	Priority
Corner trims at base of siding heavily deteriorating at Parsonage and Boon House	9.1, 10.4	Mid
Structural damage at Parsonage porch column	9.2	High
Siding against roofing rotting, heavy water intrusion at Parsonage and Boon House	9.3, 10.5	High
Upper stair landing deteriorating at Parsonage	9.4	Low
Chips in siding and trim causing water intrusion at Parsonage and Boon House	9.5, 10.2, 10.3	Mid
Boon House roof sagging	10.1	Mid

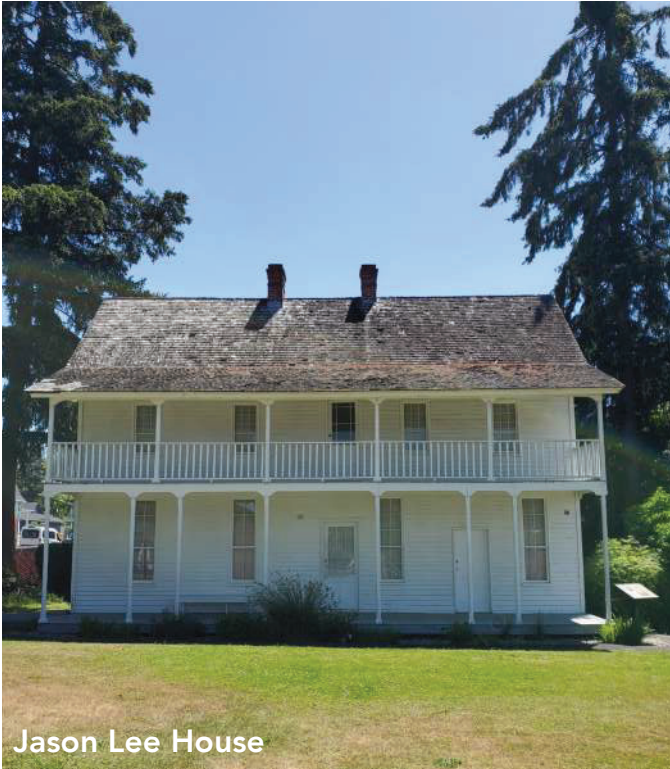
The Jason Lee House is displaying many of the same issues as the Parsonage and Boon House, with several deferred maintenance items that require remediation. In several instances, we observed Bondo or a similar wood filler substance used on window trim and window sashes (Figures 12.3 and 13.1), but further treatment (sanding and painting) was not performed to match the adjacent finish. Most of the other observations on the following pages highlight issues with aging exterior envelope items. Mold growth was visible on siding on the rear elevation (Figure 13.2). Balcony decking on the front elevation is weathering and/or rotting, resulting in chipping and cracking in the wood boards (Figure 12.1 and 12.2). Elsewhere, paint is chipping from siding and door/window trim (12.4, 13.3, 13.4), as well as window mullions (13.5).

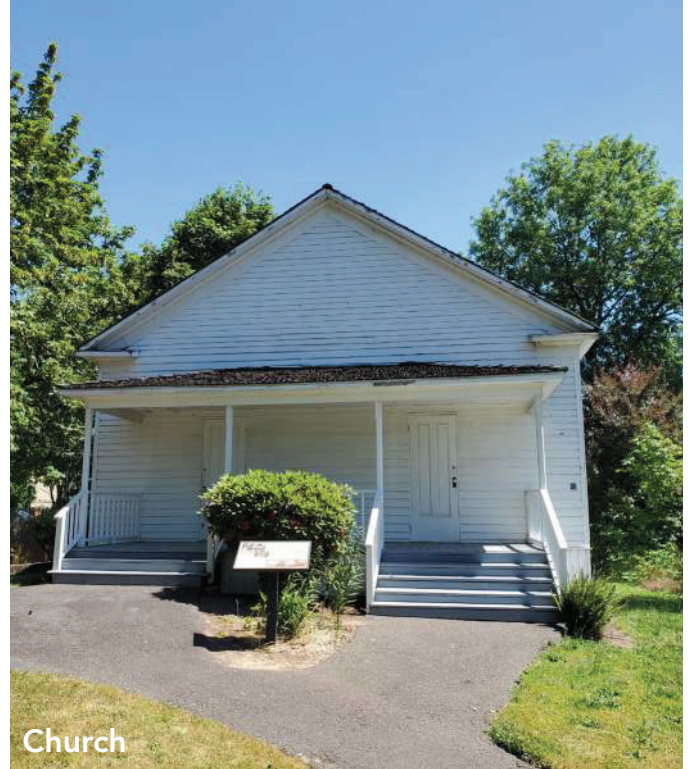
The Church includes many of the same issues as the Jason Lee House, including mold growth on exterior walls (Figures 14.4 and 14.5) and paint chipping and cracking (Figure 14.3). Some unique issues observed on the Church exterior were gaps in the porch roof soffit and structure (Figure 14.1), and a couple instances of bubbling water pockets in the siding, which is being caused by water intrusion from the window sills (14.2).

Observation	Figure	Priority
Balcony decking deteriorating at Jason Lee House	12.1, 12.2	Low
Wood filler not properly finished at Jason Lee House	12.3, 13.1	Low
Wood trim and thresholds at end of life on Jason Lee House	12.4, 13.4	Mid
Corner base trim at Lee House heavily deteriorating or missing entirely	12.5, 13.3	Mid
Mold growth on siding at Jason Lee House and Church	13.2, 14.4, 14.5	Mid
Paint chipping from window mullions at Jason Lee House	13.5	Low
Church siding bubbling due to water intrusion	14.2	Mid
Paint chipping on Church siding	14.3	Low

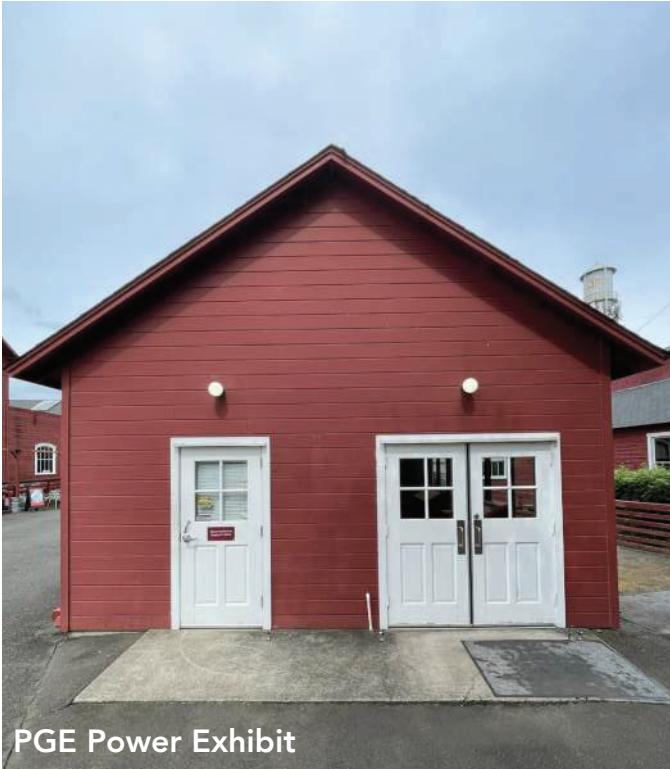
The PGE Power Exhibit building, as the newest building on campus, appears to be in suitable condition, with no critical repairs appearing necessary. To the north side of the PGE building, the top of the wooden guardrail is beginning to split and warp (Figure 16.2).

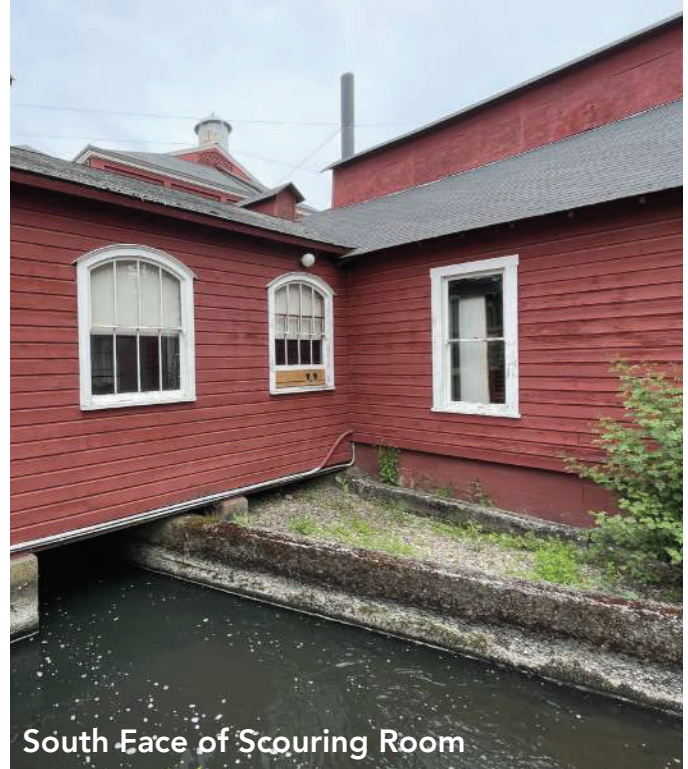
South Face of Scouring Room

The south portion of the Scouring Room, included on the following page, shows signs of foundation erosion on the south elevation (Figure 16.3), along with siding damage that requires further remediation from what has been done previously (Figure 16.4).

Observation	Figure	Priority
Railing against creek splitting	16.2	Low
Foundation eroding beneath Scouring Room	16.3	High
Paint finish on wall is inconsistent	16.4	Low
Plywood siding on upper wall of Scouring Room deteriorating, and does not match typical siding on lower walls	16.5	Mid

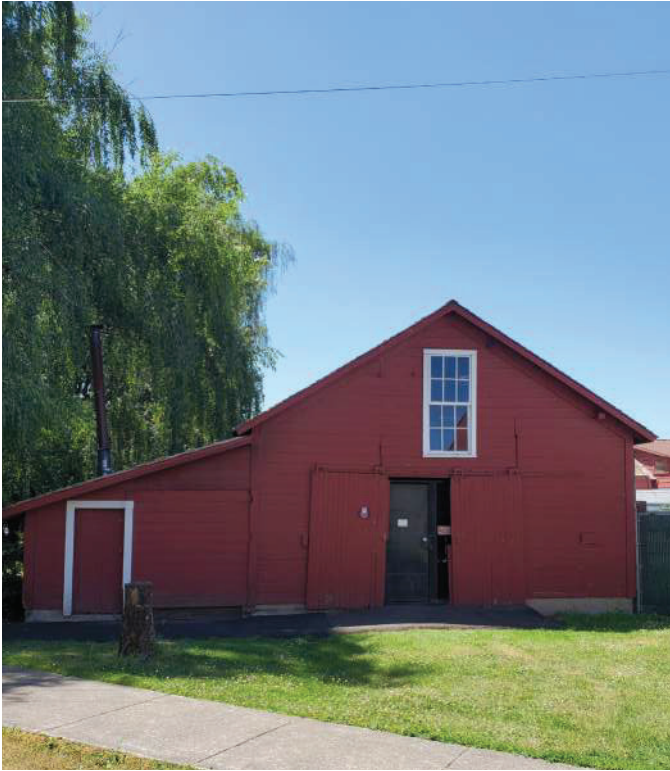
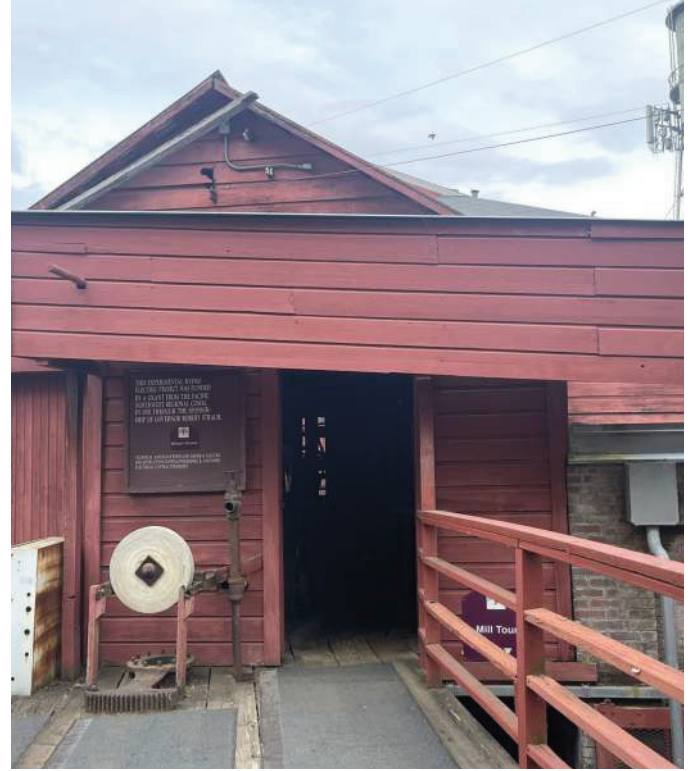
The Mentzner Machine Shop was observed to be in better exterior condition than most of the other buildings on campus. The major concern is the east roof, which is directly underneath a willow tree. The roof shows heavy debris from the tree, which provides potential to trap water and erode the roof surface (Figure 18.1).

At the Picker House deck, there is a vast layering of historical interventions and changes that make it difficult to discern what is historically significant, and thus determine priority in making repairs. A large panel of plywood is covering a large hole that appears to be temporary (Figure 19.3). In addition, there are several holes or missing pieces of cladding that are providing ample space for water intrusion, including a missing panel of lap siding above the tunnel (Figure 18.3) and missing brick veneer where a pipe penetrates into the Picker House (18.5). A circular hole in the concrete wall contains a mesh screen, but it does not fully cover the hole (19.4). Most importantly, dripping water was visible underneath the concrete creek run, suggesting structural damage or cracking that should be rectified immediately to prevent further damage or leaking (19.5).

Observation	Figure	Priority
Moss and debris on Machine Shop roof, from overhanging tree	18.1	Low
Moss on Scouring Room roof	18.2	Low
Several instances of holes in exterior causing water/insect intrusion	18.3, 18.5, 19.3, 19.4	High
Rusting flashing on Picker House deck	18.4	Low
Water intrusion at base of window at masonry	19.1	Mid
Vertical slats on Picker House deck guard pulled apart, resulting in gap	19.2	Low
Dripping water beneath concrete creek run suggests failing structure	19.5	High

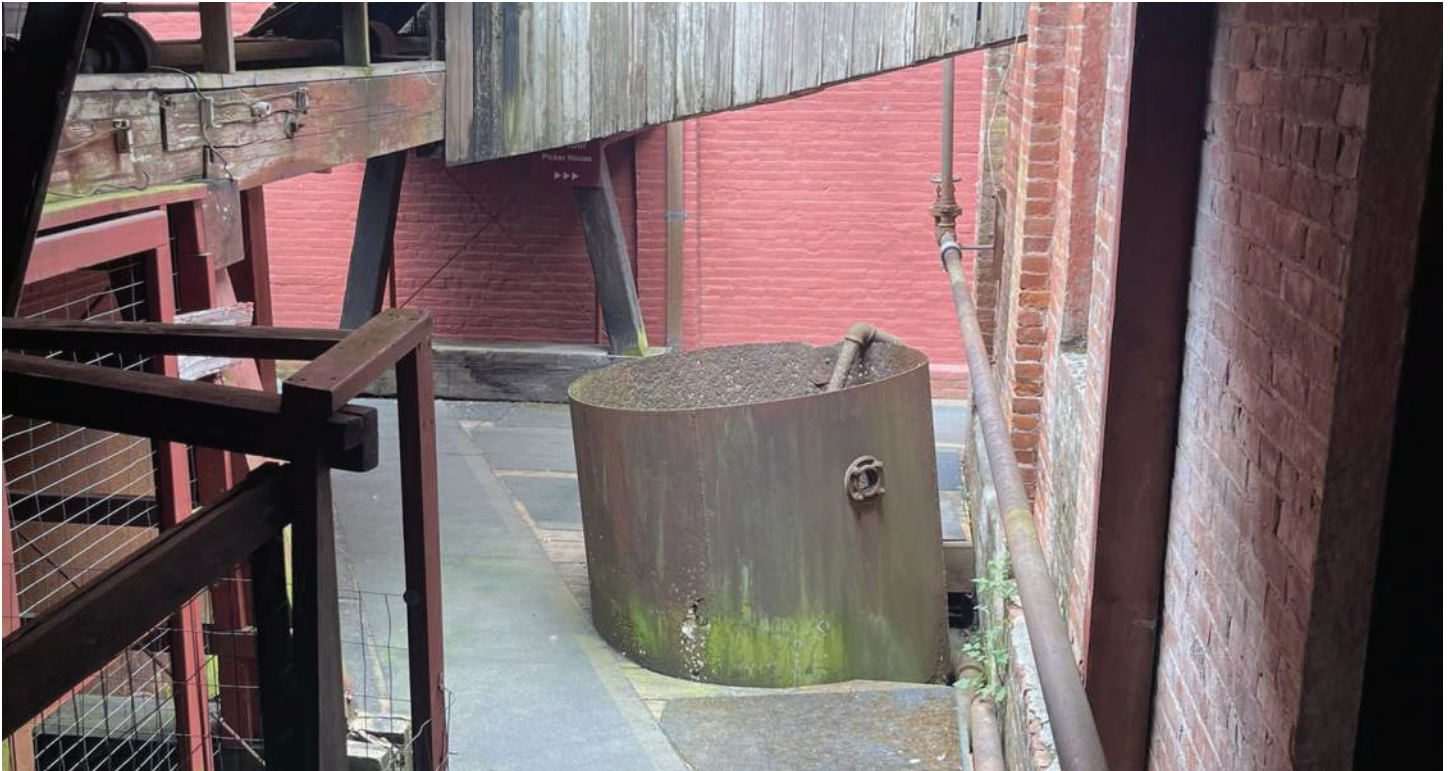
The exterior area between the mill building, picker house, and scouring room shows a variety of structures, most of which are clearly showing age but not pointing to any major issues. The one critical item observed at this location is a wood beam sitting on the ground that serves as part of the support for a bridge structure above. The base beam is showing severe water/insect damage, hollowing out from the center, which could compromise the column support (Figure 21.2). Siding on one of the equipment bridges is rotting at the bottom, allowing for water to penetrate inside (Figure 21.3). We also observed a unique area of masonry efflorescence on the west edge of the Picker House, which points to years of water intrusion behind the brick (Figure 21.1). The efflorescence itself is not a major issue, but remediation of the brick may be required to prevent future intrusion of water. Water damage to the brick is also evident above the arched doorway on the west elevation of the Picker House (Figure 21.4).

Lastly, significant mold growth was observed on the west elevation of the Scouring Room/Dye House, caused by a large crack in the siding (Figure 21.5).

Observation	Figure	Priority
Masonry efflorescence on west side of Picker House	21.1	Low
Floor beams supporting mill turbine structure are rotting/hollowing out	21.2	High
Siding deterioration and incorrect installation of roof flashing	21.3	Mid
Heavy masonry weathering at west side of Picker House	21.4	Low
Moss growth on siding	21.5	Mid

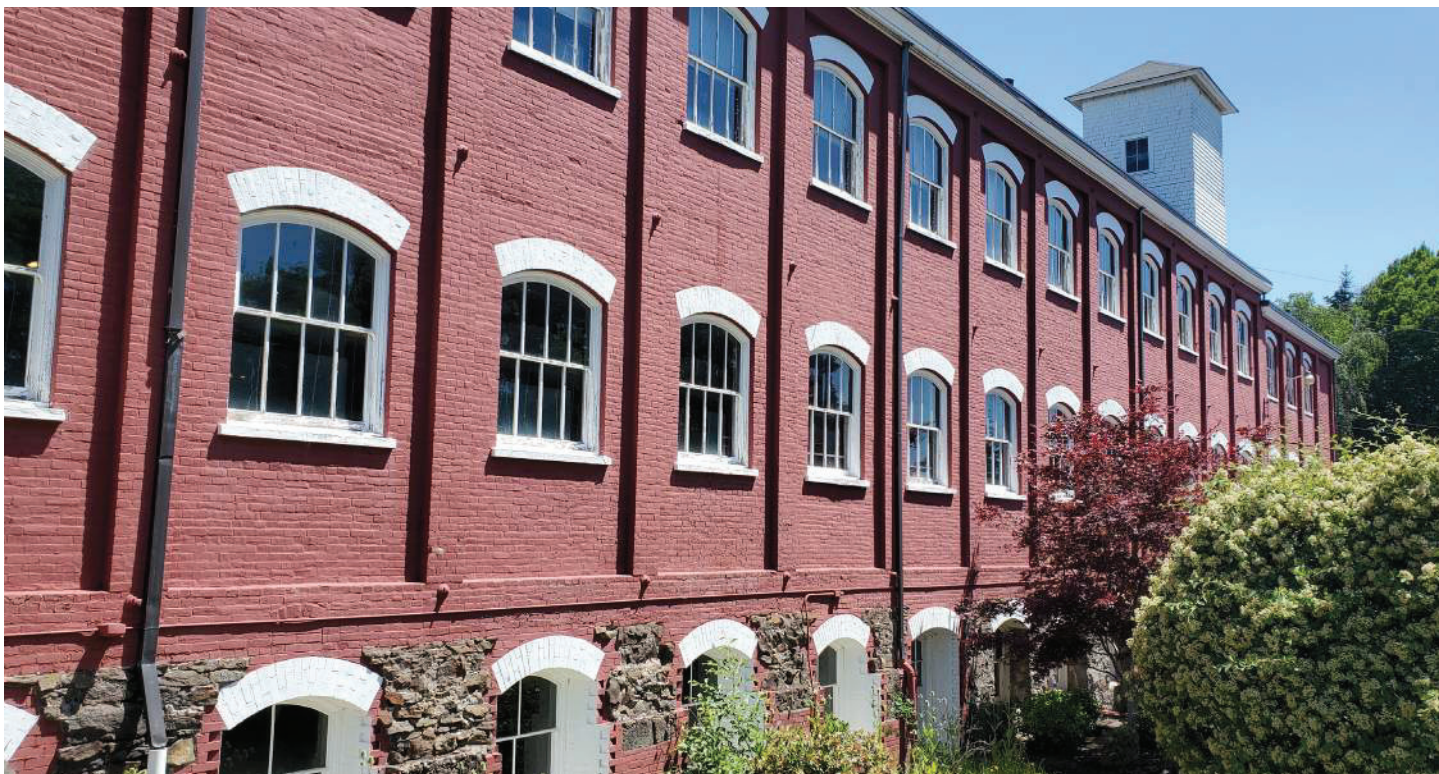
The Thomas Kay Woolen Mill Building is the crown jewel of the Willamette Heritage Center campus. On the main building volume, we observed a large amount of surfaces requiring cosmetic repair due to weathering. Paint was beginning to chip away on the arched stone window headers (Figure 23.1), as well as most of the window sills, sashes, and window trim (Figure 23.2). There were localized pockets of damage on the roof cornice, which appears to be resulting from wind and water damage (Figure 23.3). Recessed doorways and other outside corners of masonry are eroding, causing small lips that allow for standing water and further water damage (Figure 23.4). Weeds and moss are growing on the repurposed stone used from the original mill building, but based on our review of the exterior, it is unclear if any remediation is needed beyond weed control (Figure 23.5).

The rear (north) side of the Mill Building would require extensive work in building repair and safety upgrades. Ventilation grates at the ground level were filled with insulation in recent history, but batts are now breaking away and hanging down in front of the grate (Figure 24.2). The roof of the submerged maintenance shop is approaching end of life, with moss growth and other debris scattered across the surface (Figure 24.3). The stairs down to the lower portion of the Boiler Room have been removed, leaving an open hole that is overgrown with weeds and grasses (Figure 24.4). On this portion of the campus, the grounds were overgrown, with debris scattered across pathways and unsafe stair conditions.

Observation	Figure	Priority
Paint chipping and deterioration on window trim and door/window headers	23.1, 23.2, 23.4	Low
Roof cornice damage, dutch gutter joints failing	23.3, 25.2	High
Original stone provides areas for water intrusion and weed growth	23.5	Low
Electrical outlet on west exterior wall is not protected nor appears to be historically significant	24.1	Low
Insulation damage in foundation vents	24.2	Low
Maintenance roof nearing end of life	24.3	Mid
Unsafe stairwell to lower Boiler Room	24.4	Mid
Water damage near maintenance shop door	24.5	Mid
Masonry wall buckling under weight of turbine structure	25.1	High
Retaining wall against creek settling due to damage against bank	25.3	High
