SB 747: Independent oversight is the key to making transit safety the first priority.

The SW Baseline Road crossing in Beaverton, scene of four preventable deaths on Portland's MAX system.

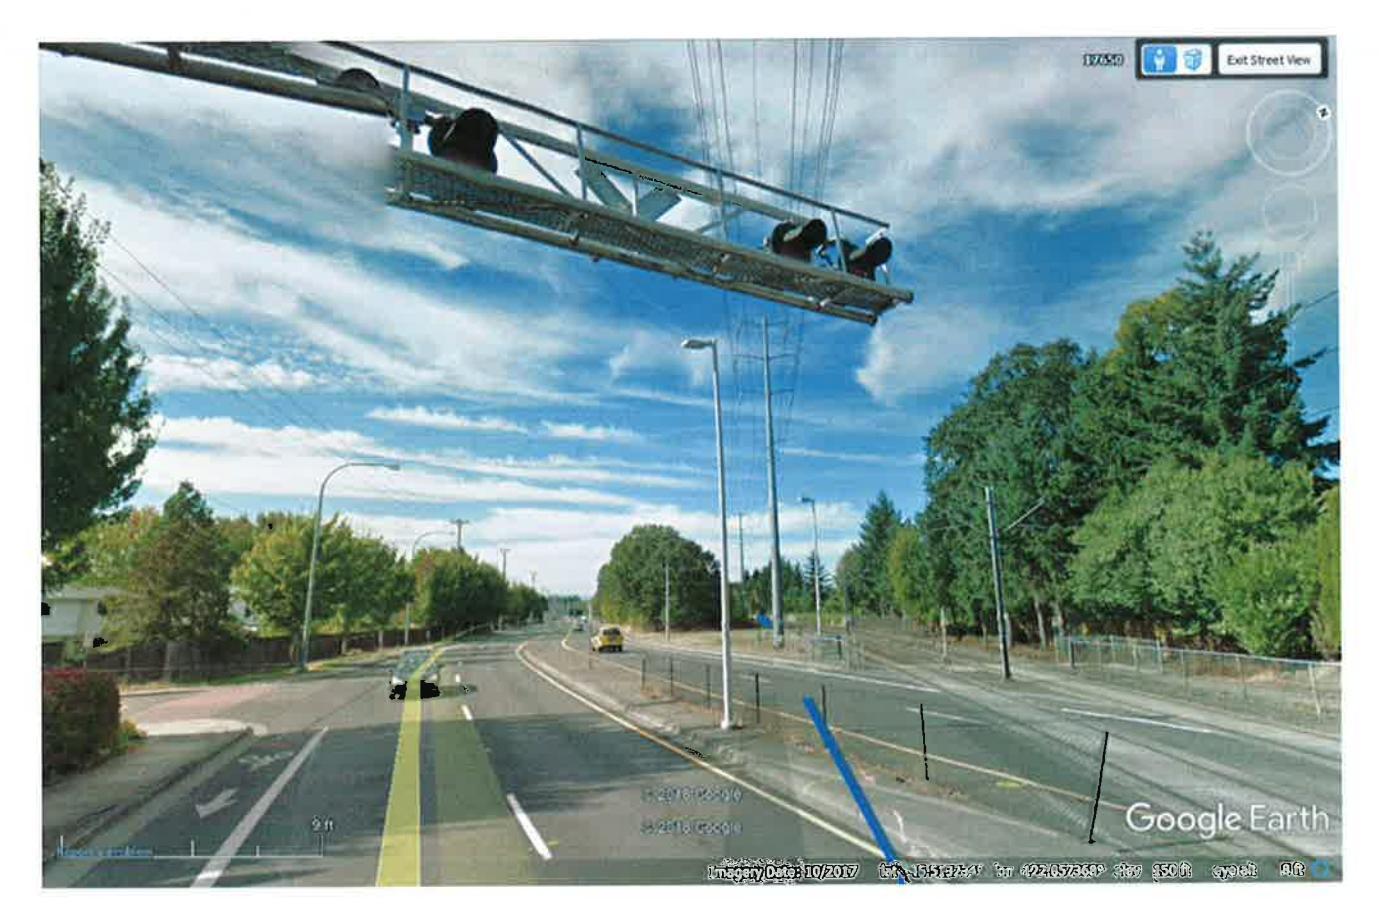
Figure 3. SW Baseline Road crossing looking west

Looking closer at these two trouble spots, at the Baseline crossing (Figure 3, below) there are no traffic signals on a street where cars travel at high speed and no marked crosswalks on the street, though there are designated track crossings for pedestrians. This can cause pedestrians to focus more on auto traffic than trains. Trees limit visibility looking to the west. An angled track crossing makes it difficult to watch for trains and cars at the same time. Both the track and street heading to the west are curved, limiting visibility of oncoming car and train traffic. While pedestrians are supposed to cross the tracks at a right angle using separate sidewalks, the sidewalks are located inconveniently well away from the roadway, tempting people to take a shortcut by crossing the tracks using the bike lanes along Baseline. The angled crossing of the bike lanes lengthens the amount of time that pedestrians are in the track area, possibly making a person's judgment of the amount of time needed to cross the tracks deceptively short. Since pedestrians usually walk facing traffic, they are not blocked by crossing gates in this situation.

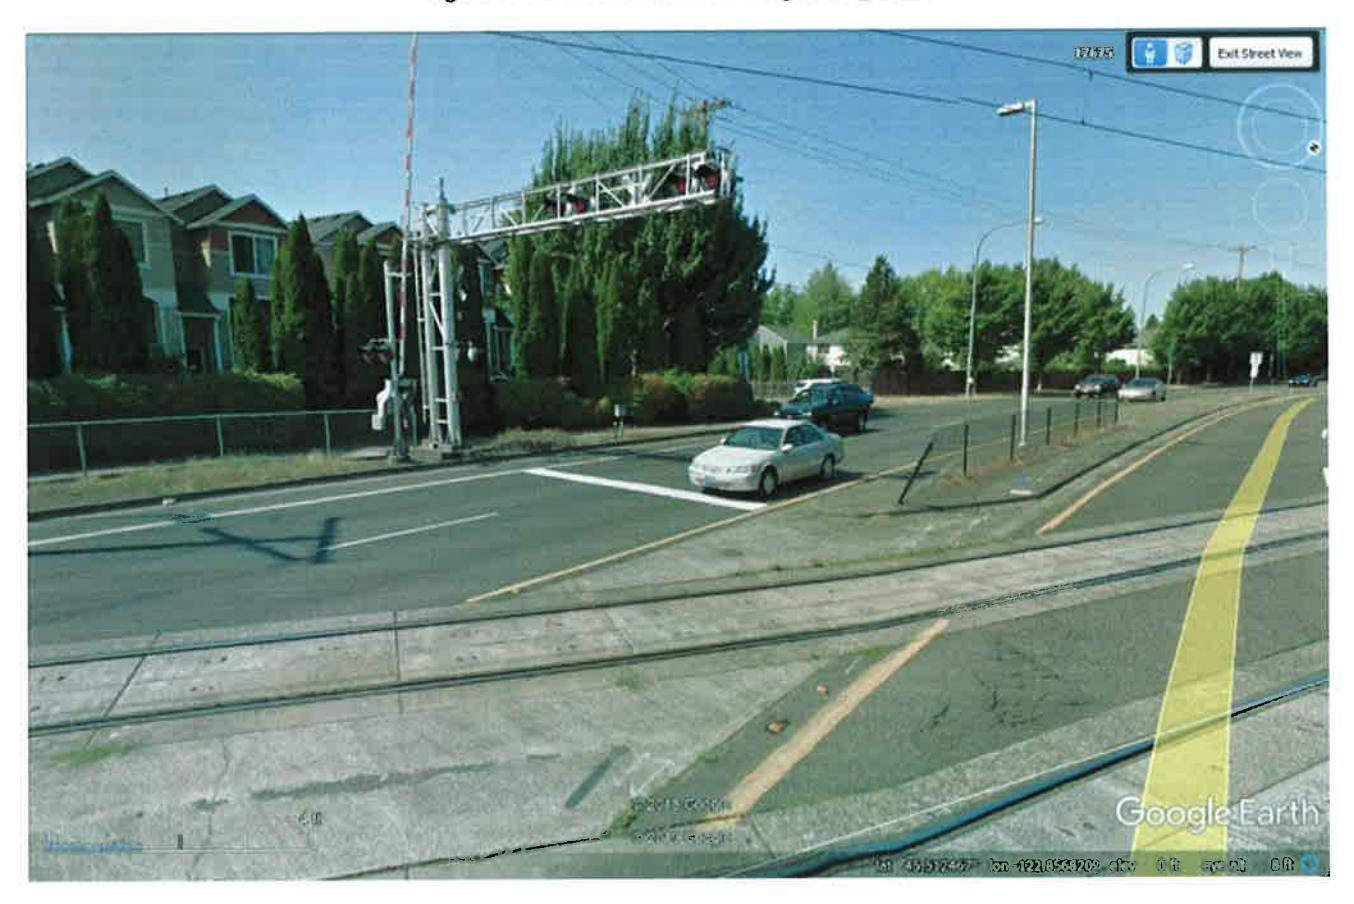
Figure 4. Deceptively safe crossing directs pedestrians into trackway when cars are stopped at crossing gates

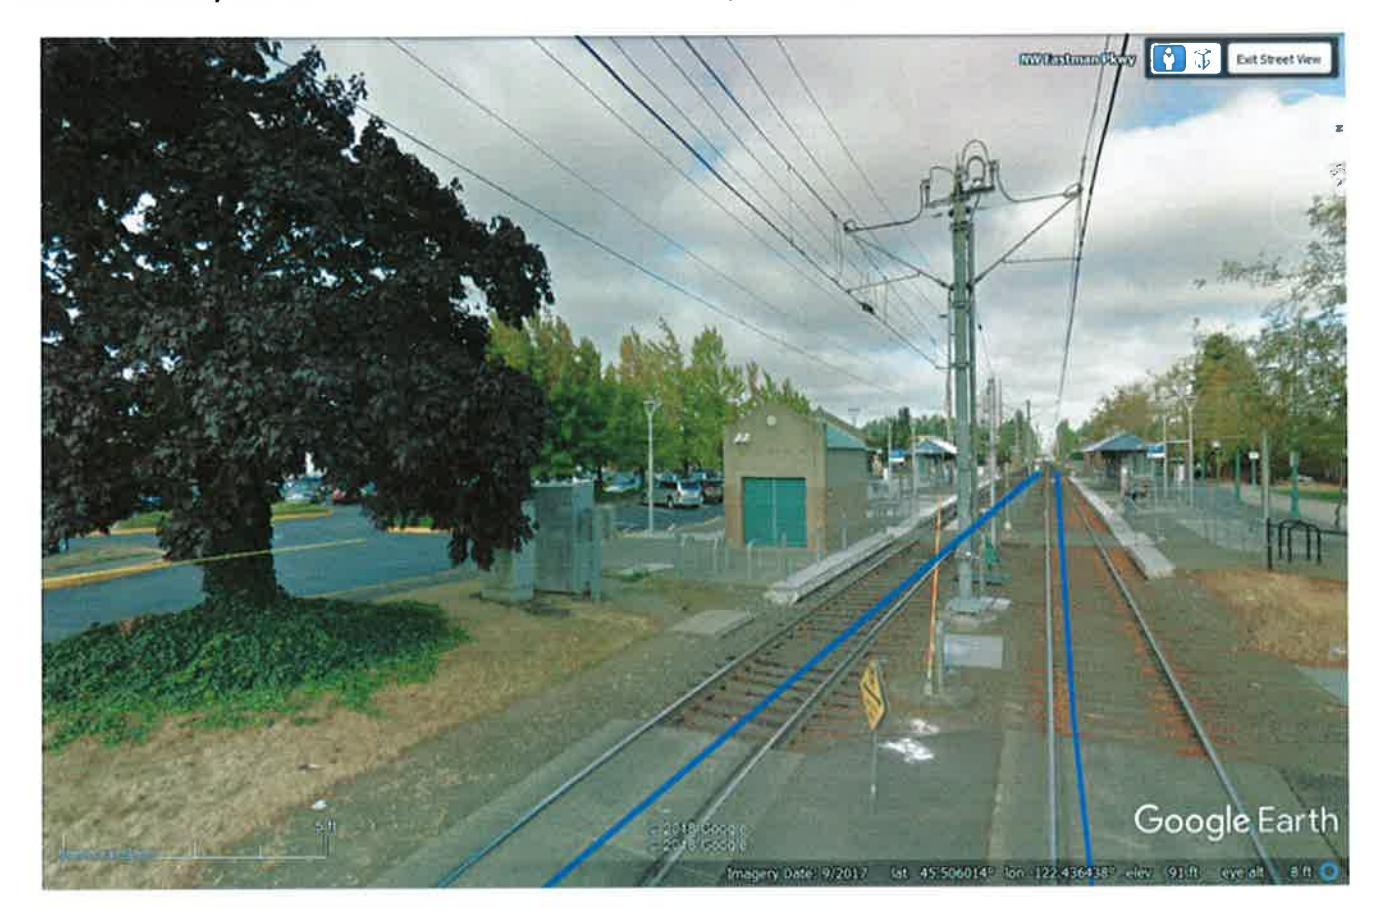
At the Gresham City Hall station, there are buildings and trees on both ends of the platform that restrict visibility close to where pedestrians cross tracks. Once again, there are no traffic signals where the tracks cross NW Eastman Parkway and the tracks cross NW Eastman Parkway at an angle. There is a marked crosswalk.

Figure 5. Gresham City Hall station looking west from NW Eastman Parkway

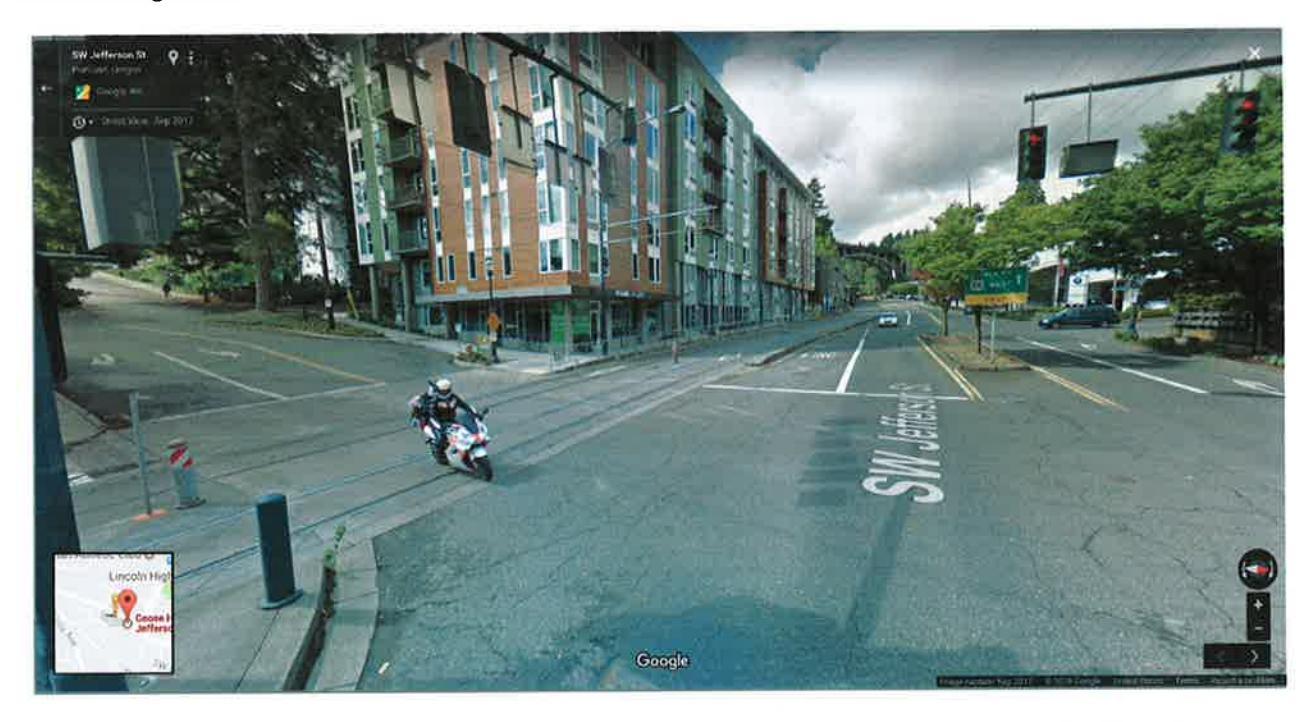
The Goose Hollow/SW Jefferson St. MAX Station is an example of a fatality location where tall buildings restrict visibility and there are no crossing gates. The low barrier along the left side of Jefferson along the sidewalk in the distance is easily jumped by pedestrians. It's an example of a difficult design decision where a taller barrier would reduce trespassing onto the tracks, but it would prevent a person in danger from jumping out of the path of an oncoming train.

Figure 13. Goose Hollow/SW Jefferson St. MAX Station showing visibility issues and pedestrian/traffic conflicts

Below are some locations of fatalities that illustrate difficult design decisions on urban streets. In these situations, the best known practice to improve safety is to move tracks underground.

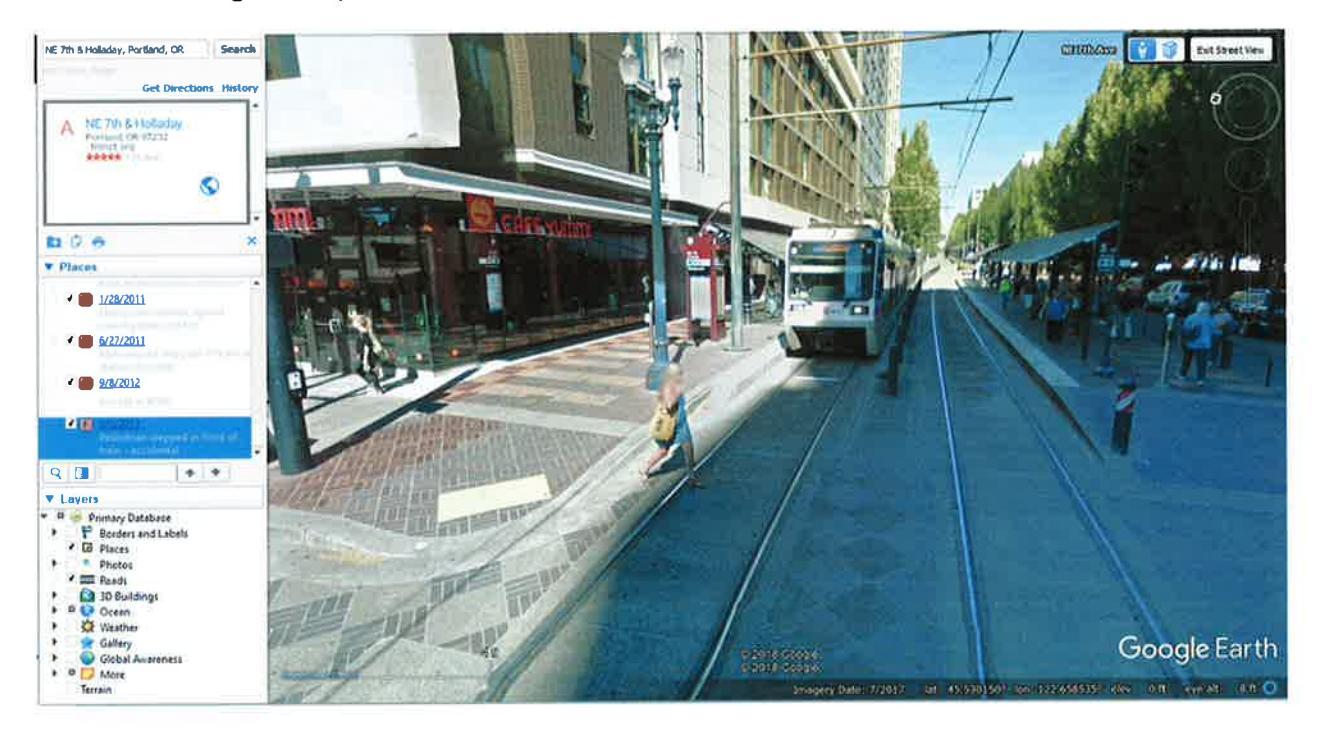
Figure 14. NE 7th & Holladay station

NE 7th & Holladay is another example of a fatality with close proximity of trains and pedestrians with buildings on street corners limiting visibility. Downtown, there are many such locations that are dangerous.

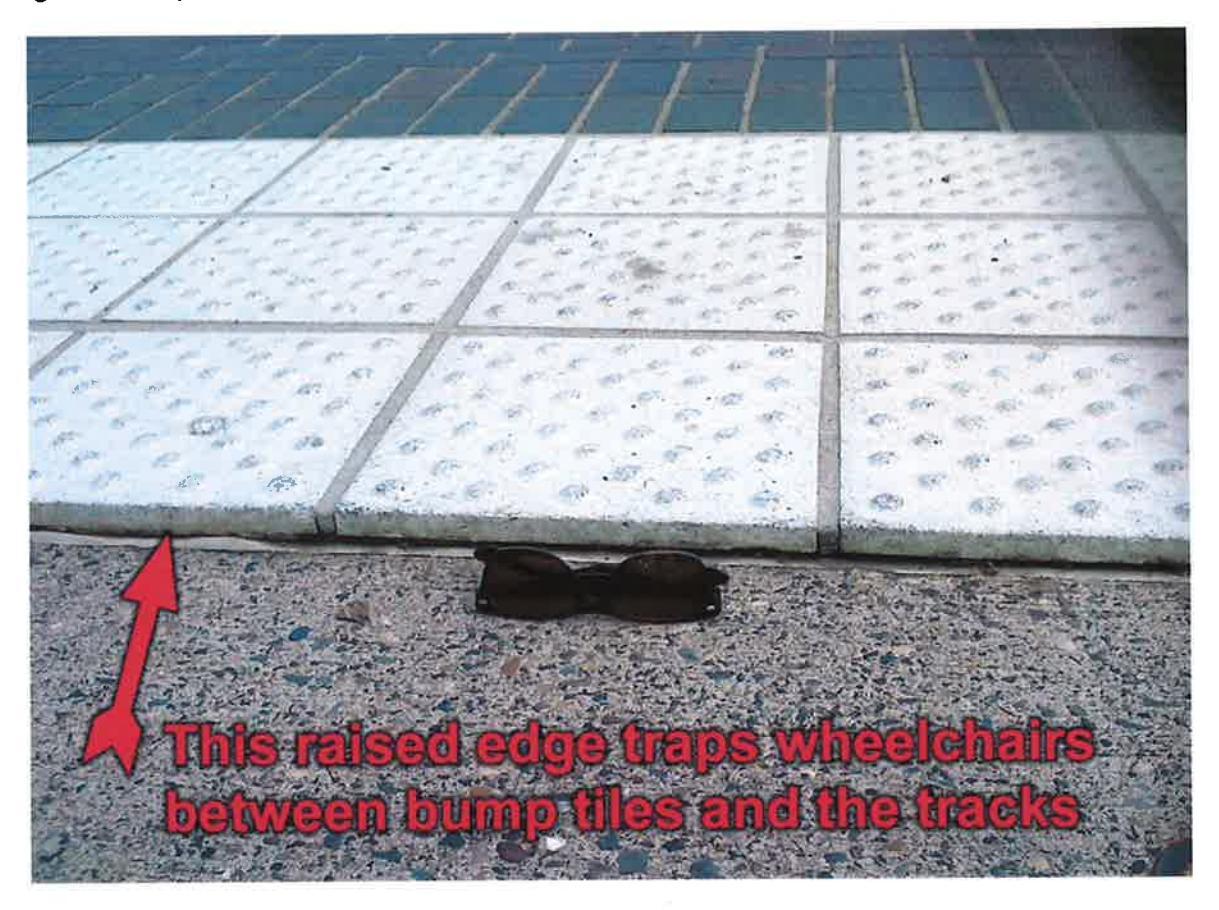
Seemingly small issues with station infrastructure can contribute to unsafe situations and might go unnoticed as contributing to some accidents. At the Beaverton Transit Center there is a section of bump tiles that's been installed improperly, leaving a raised edge that's difficult for wheelchair users to move over safely. The position of the edge makes it possible a wheelchair user could be trapped in the track area in front of a moving train.

Figure 15. Bump tiles at Beaverton Transit Center showing a trap risk for wheekhair users

This issue was first observed in August 2015. It was reported to TriMet, but still hasn't been resolved as of the date of publication of this report. While no fatality from this situation has happened, it is a sign that the safety culture at TriMet can improve because an obvious area of risk with a simple solution hasn't been addressed for a long time since being discovered.

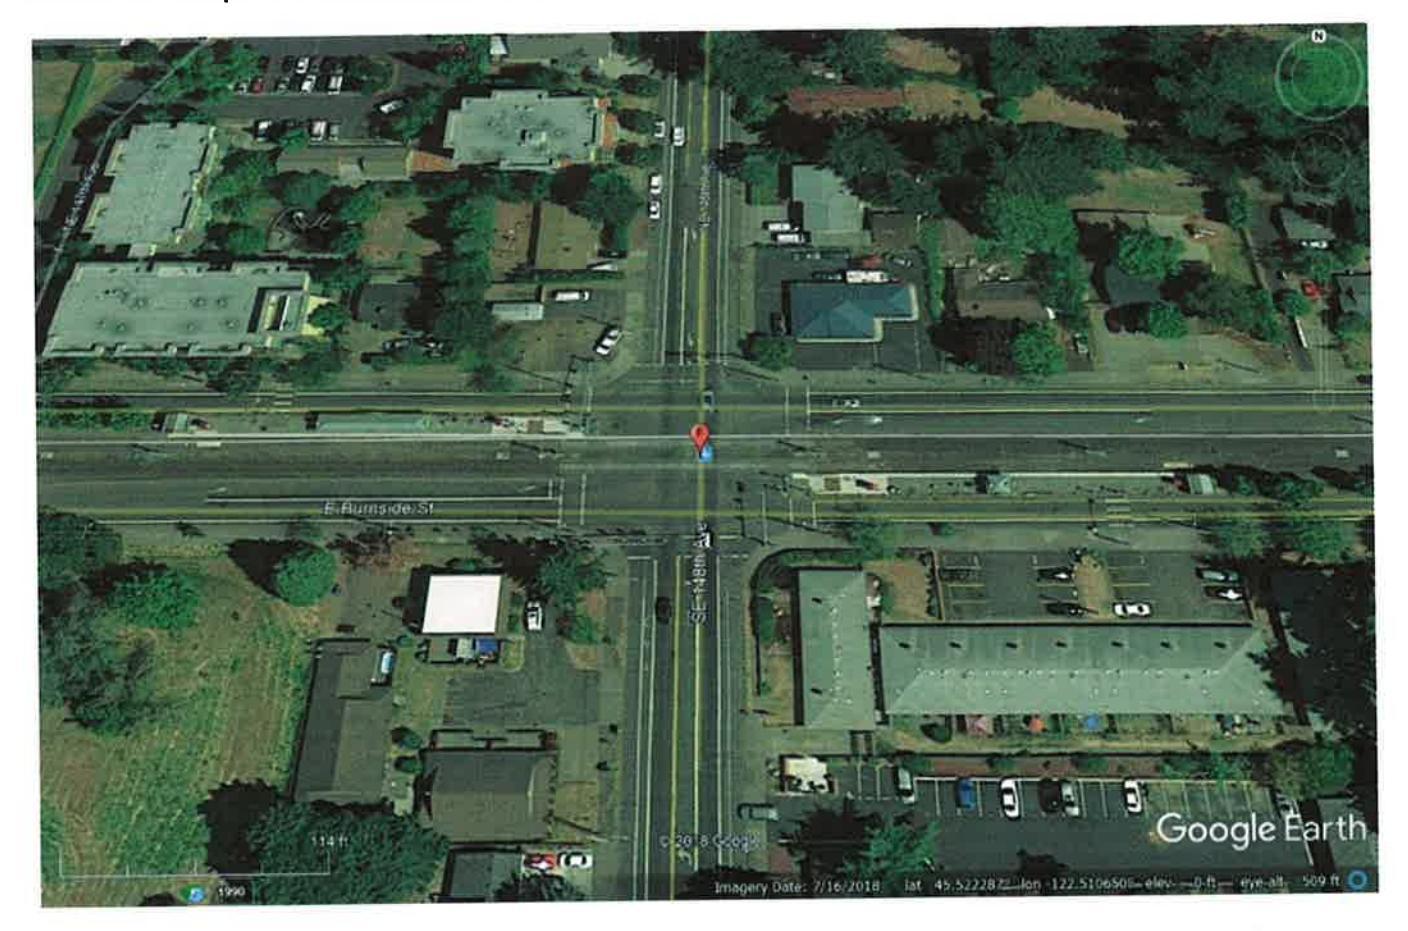
Along East Burnside and in downtown Hillsboro, tracks run down the center of the street. Most stations are designed so that the eastbound platform is located at the southeast side of the intersection and the westbound platform is at the northwest side (Figure 22, below). This configuration requires a train operator to be braking from cruise speed while crossing an intersection. Pedestrians who see an approaching train might be tempted to dart in front of it to catch it. The risk of a collision is greater in this situation than if the platform positions were switched to have the eastbound platform at the southwest side and the westbound platform at the northeast side. Braking would then happen mostly on restricted right of way. Acceleration through the intersection on departure would be slower, allowing more reaction time for an operator to avoid a collision, and the operator could verify the intersection and crosswalks were clear before accelerating from a stop. There would be no temptation for pedestrians to rush in front of a train to catch it. This layout change would eliminate the need to stop at some pedestrian crossings along the route, saving travel time and allowing the use of that measure elsewhere on the system where it's needed due to design constraints.

While there was only 30% significance found for intersection braking, the actual risk is difficult to quantify because it is highly dependent on train speed and different stations have different exposure to the issue depending on the platform distance from the intersection, the location of each platform relative to the intersection, and varying degrees of grade separation. In downtown Portland most stations will have braking through intersections on both sides of the platforms in both track directions, but train speeds are much lower. A

Figure 22. Station configuration along East Burnside showing high-risk layout requiring braking through intersections

- 14. Add pedestrian crossing request signals at dangerous intersections or track crossings such as those along East Burnside that require train and/or car traffic to stop, and warn pedestrians if a train cannot stop safely in time. These are in use at the Tuality Hospital/SE 8th Ave. MAX Station in Hillsboro.
