March 24, 2023

**OREGON STATE POLICE
STRATEGIC MASTER FACILITIES PLAN
FIRST PHASE**

EXECUTIVE SUMMARY

**OREGON STATE POLICE
STRATEGIC MASTER FACILITIES PLAN
SECOND PHASE**

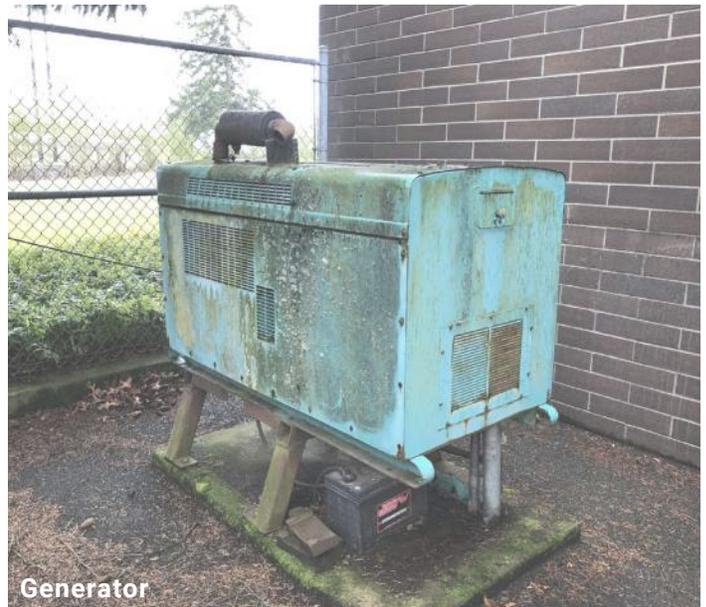
Generator

The Springfield facility is not equipped with a backup generator at this time. There is a generator on site, but it is non-operational. This means that there is no backup power or emergency lighting provided on site. If the building were to experience a power outage due to a storm, system failure, or other event, OSP operations would be completely shut down at this location and critical evidence could be lost. Evidence storage freezers and refrigerators, Forensic Services Lab freezers and refrigerators, patrol operations, and the server room are all spaces that would benefit from being equipped with emergency backup power.

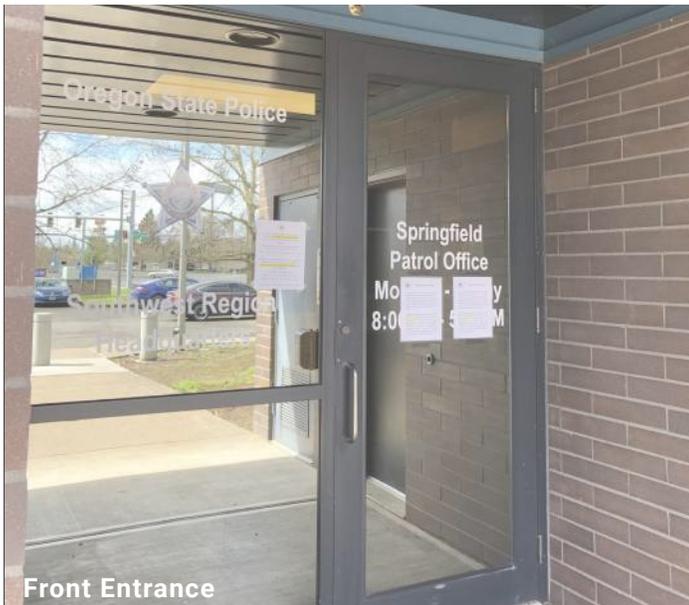
Security was a repeated concern throughout the Springfield site. There are currently no security cameras on site and no visual security or exterior surveillance measures in place to protect building occupants. The service building also creates a blind spot, and there have been encampments set up on the back side of it in the past. At one point, someone living at that encampment started a fire against the shop building.

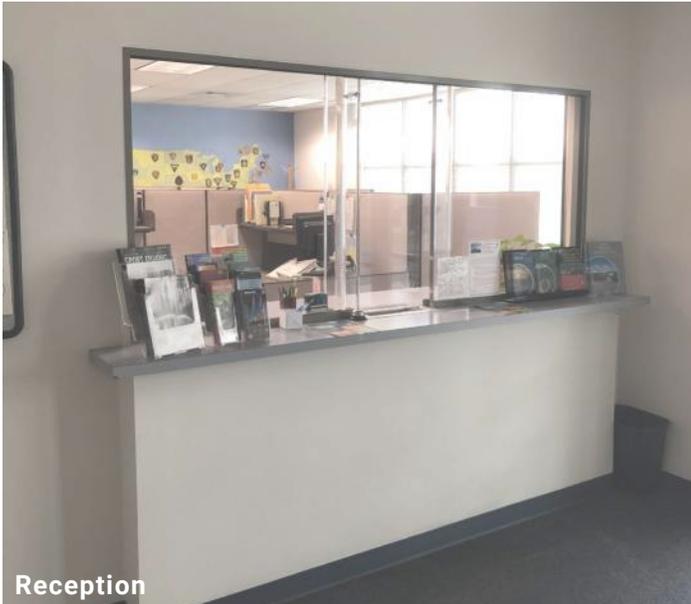
Little has been upgraded or added to the facility in terms of security. Bollards were installed at the front of the parking lot to protect against ramming vehicles, though little else. Currently there are only two security cameras on site, both of which are original to the building. One at the front door and one at the back entry. There are no cameras surveying the perimeter, parking area, or security gate. In the event the facility is attacked or there is an active shooter on site, OSP has no ability to survey the exterior and determine the threat.

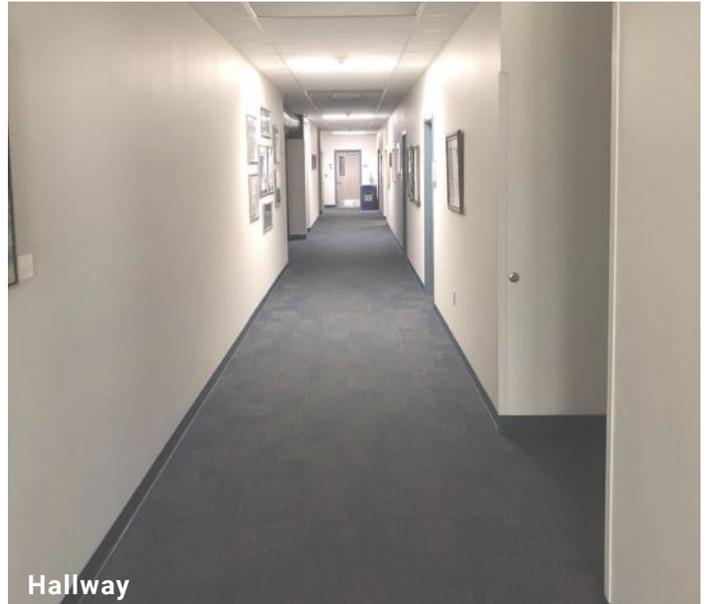
Hallway

The overall building environment is outdated and has not been updated since initial construction. The majority of HVAC rooftop units have exceeded their estimated useful life and are in poor condition. Furthermore, they operate on a refrigerant with is no longer available. Therefore, full replacement of the HVAC units is recommended.

The furniture is the same furniture from when OSP moved in 23 years ago and does not meet current OSP standards. There is carpet in high traffic areas, which is hard to keep clean, and the original acoustical tile ceiling and fluorescent lights remain. Several storage rooms have been reclaimed for office and meeting spaces, meaning storage and janitorial supplies are in the hallways. There is also a lack of access to natural daylight in the report writing room, sergeants office, and fish & wildlife office. An evidence-based design approach to daylighting and workplace environments would increase employee health and wellness, in alignment with state agency wellness plan goals.

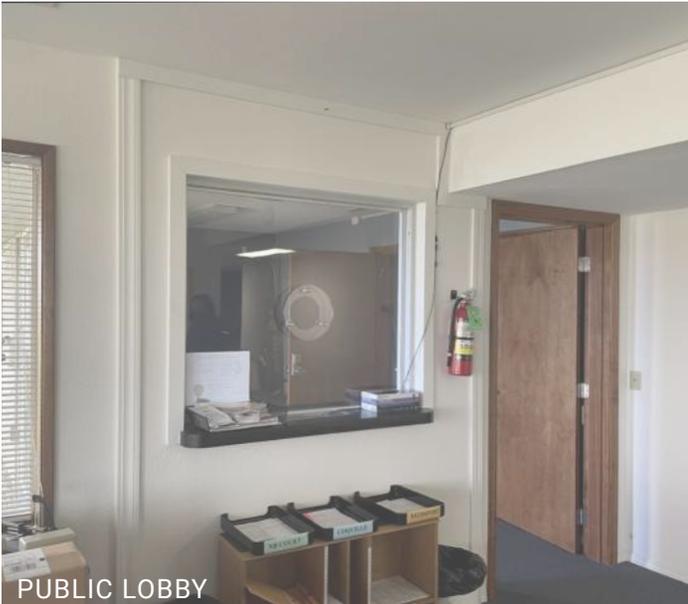
Facility Data from 2020

The building does not have vehicle deterrents or ballistic protection. The only ballistic glazing observed was at the transaction window at the public lobby. The exterior windows are mirror tinted, but such a mirror tint only functions in daylight. When it is dark outside, one can see into the building, which can create security concerns.
