Life Safety Considerations – Port of Coos Bay Charleston Marina

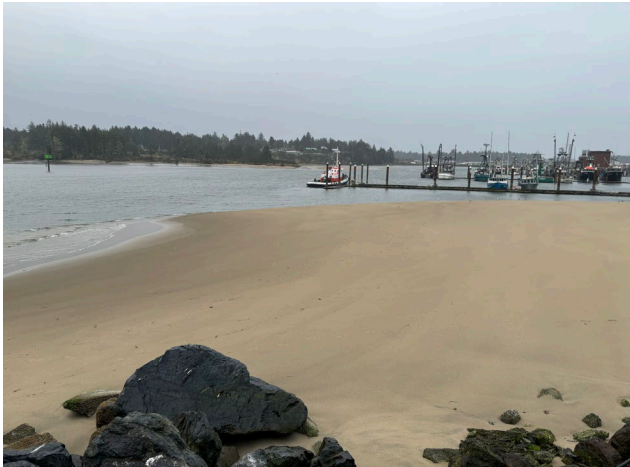
- Current conditions cause frequent hull strikes and groundings as the shoal is at least partially submerged during high tide.
- The dynamic nature of the shoal prevents installation of static aids to navigation.
- A 2019 grounding resulted in a ship capsizing and the USCG emergency rescue of four people. The risk of future capsize events resulting in injury or loss of life remains.

2024 view of the button shoal facing south at low tide

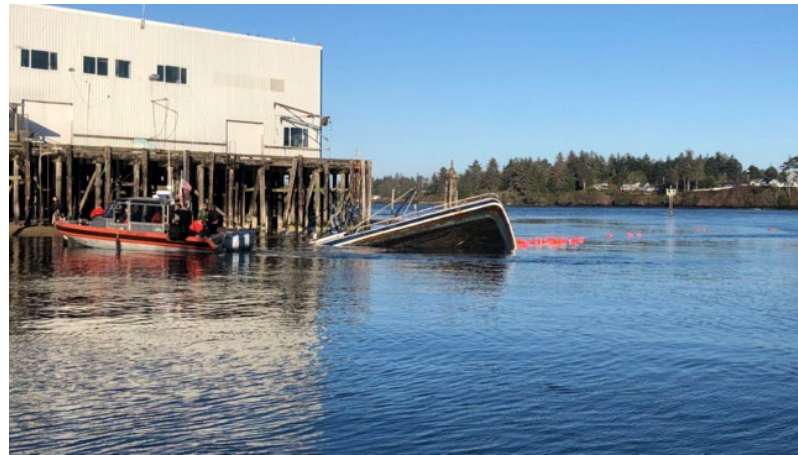
Capsized Dorean Rose (2019) requiring the rescue of four and USCG salvage of the boat

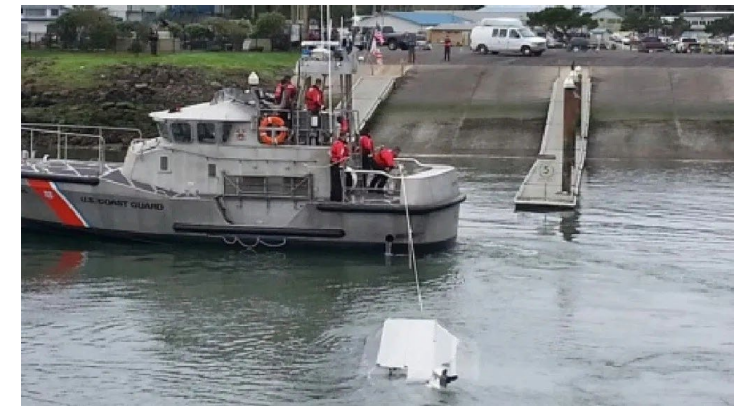
Capsize of a recreational vessel in 2016 requiring the rescue of three by USCG
