Timescales of response on streams treated with Artificial Beaver Dams, Silvies River, OR

River Restoration Northwest 2015

Caroline Nash, Oregon State University

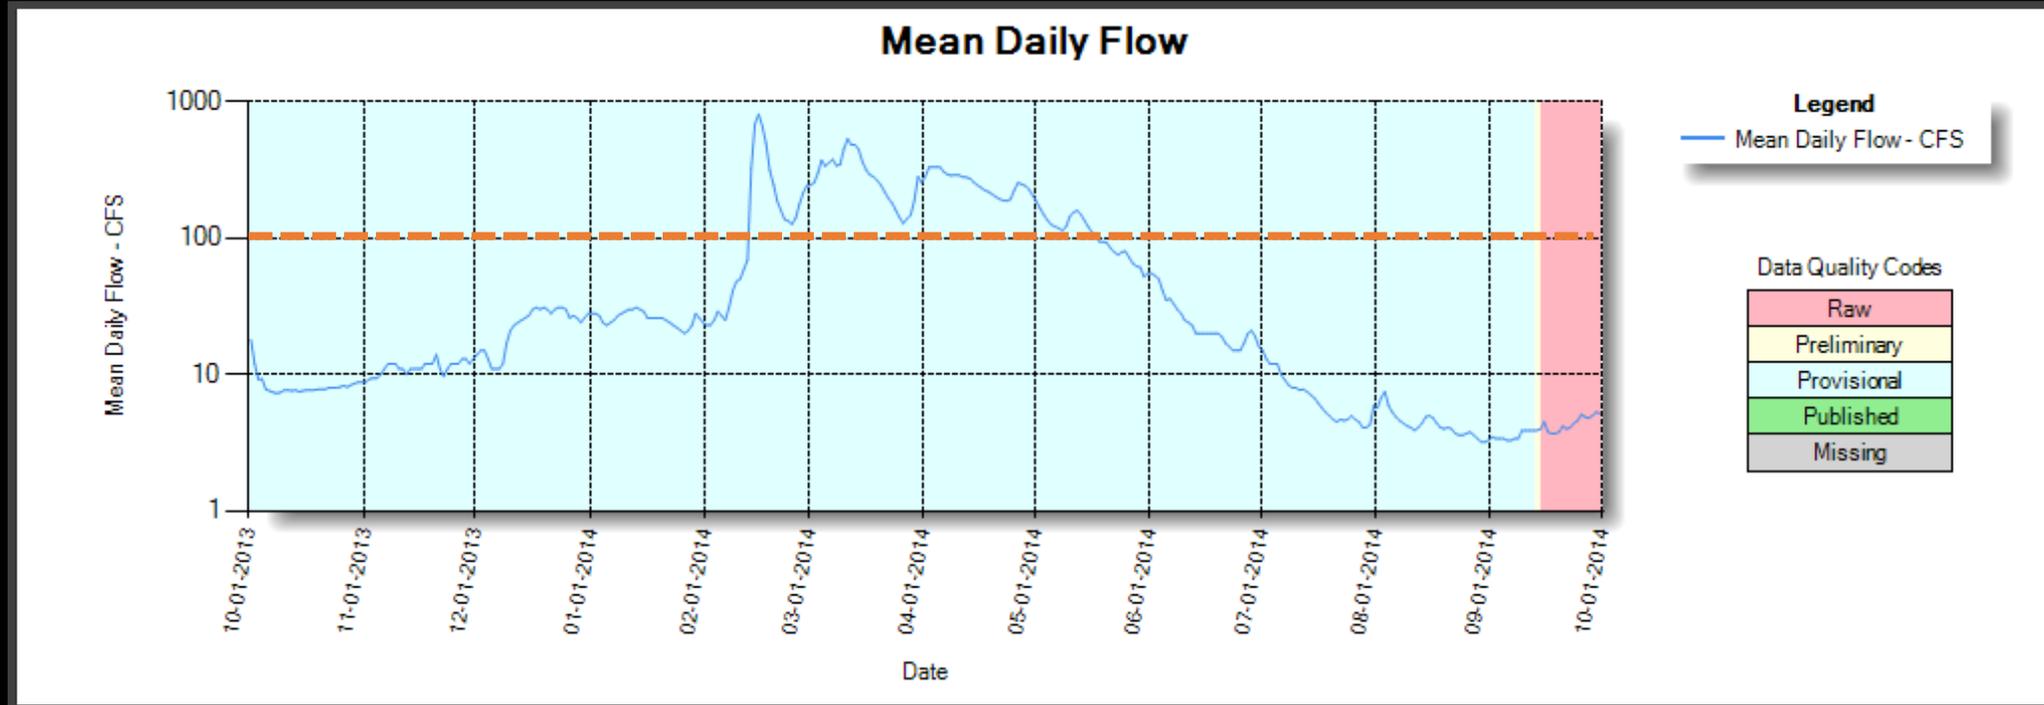
2014 Water Year

From OWRD station 10393500, Near Burns, OR

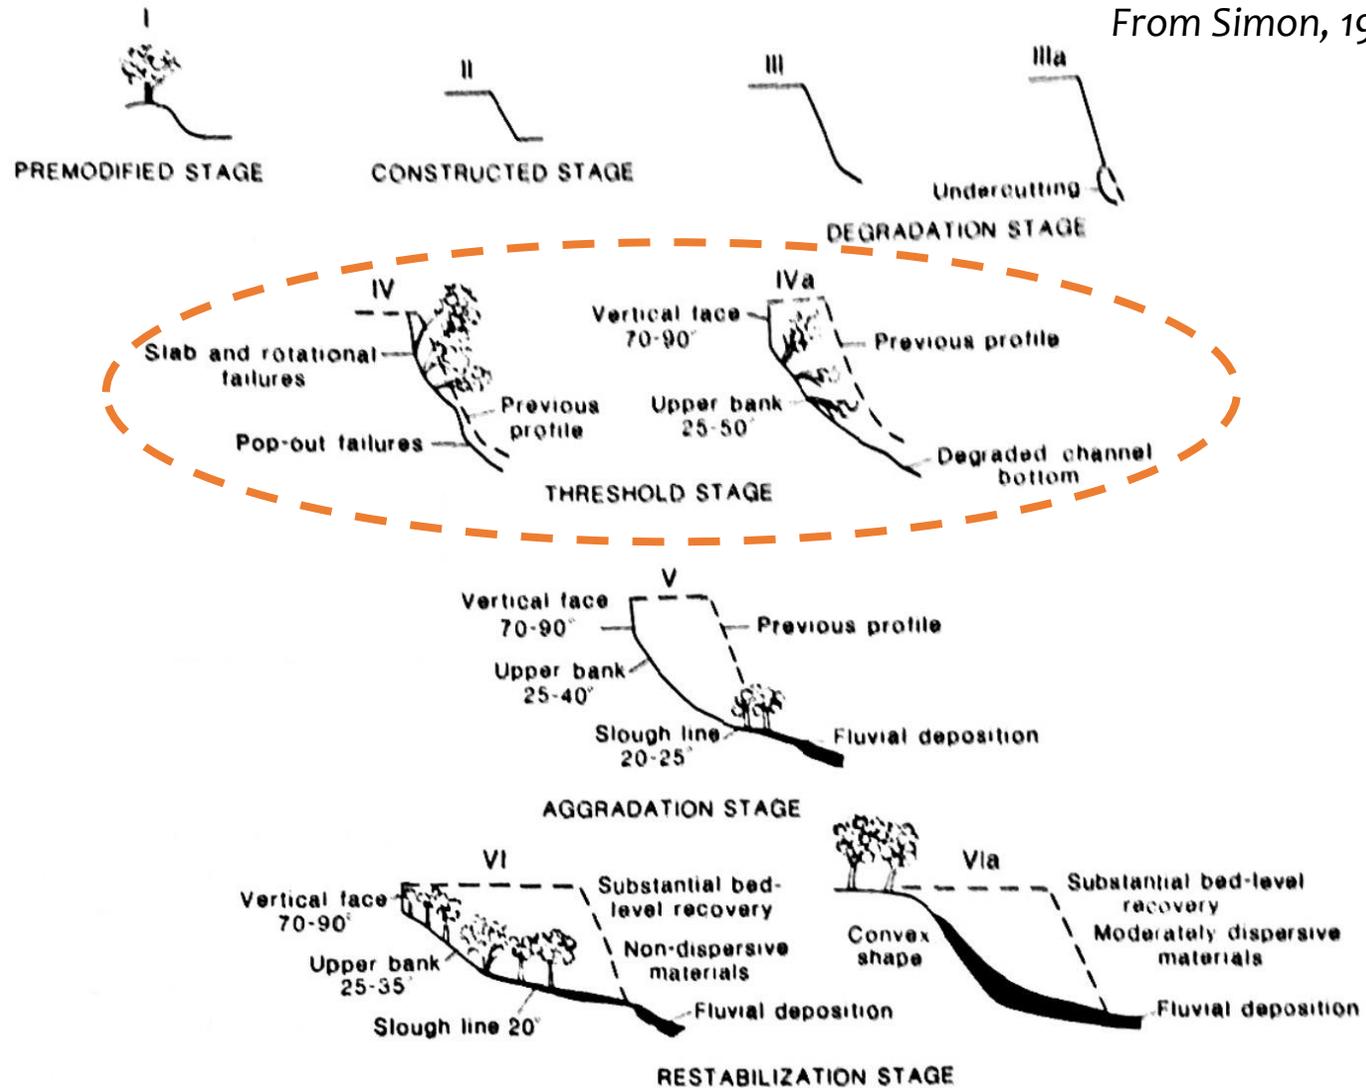
Figure 5. The six stages of bank-slope development

Note: Scale is relative.

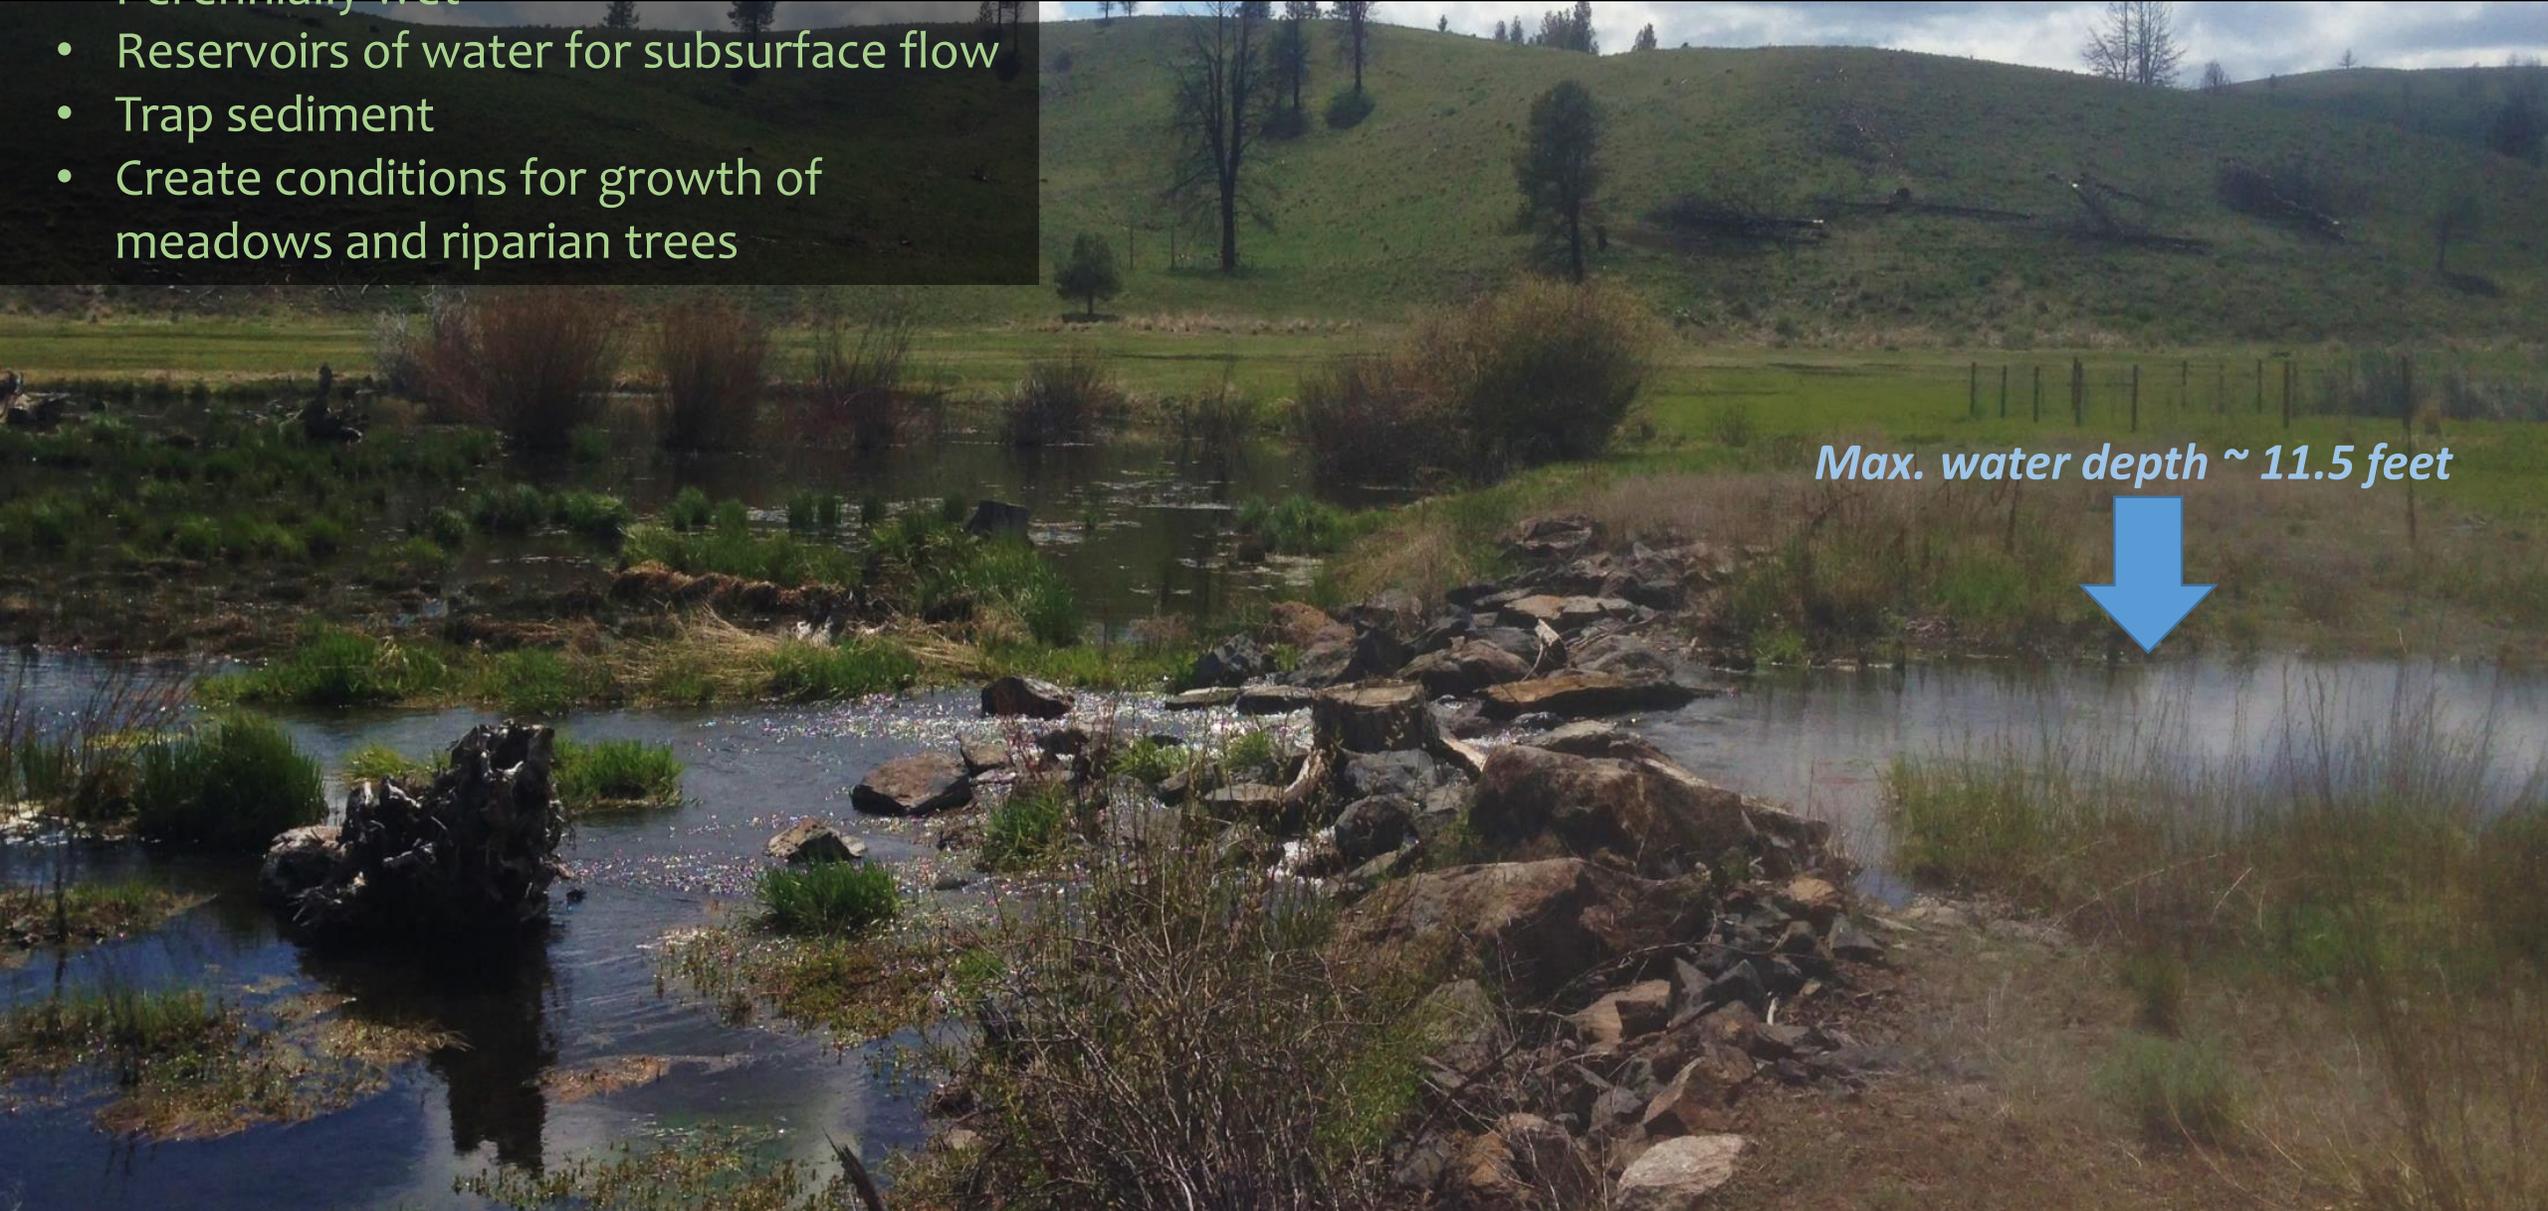
***Camp Creek
Silvies River Basin, OR***

- Perennially wet
- Reservoirs of water for subsurface flow
- Trap sediment
- Create conditions for growth of meadows and riparian trees

Max. water depth ~ 11.5 feet

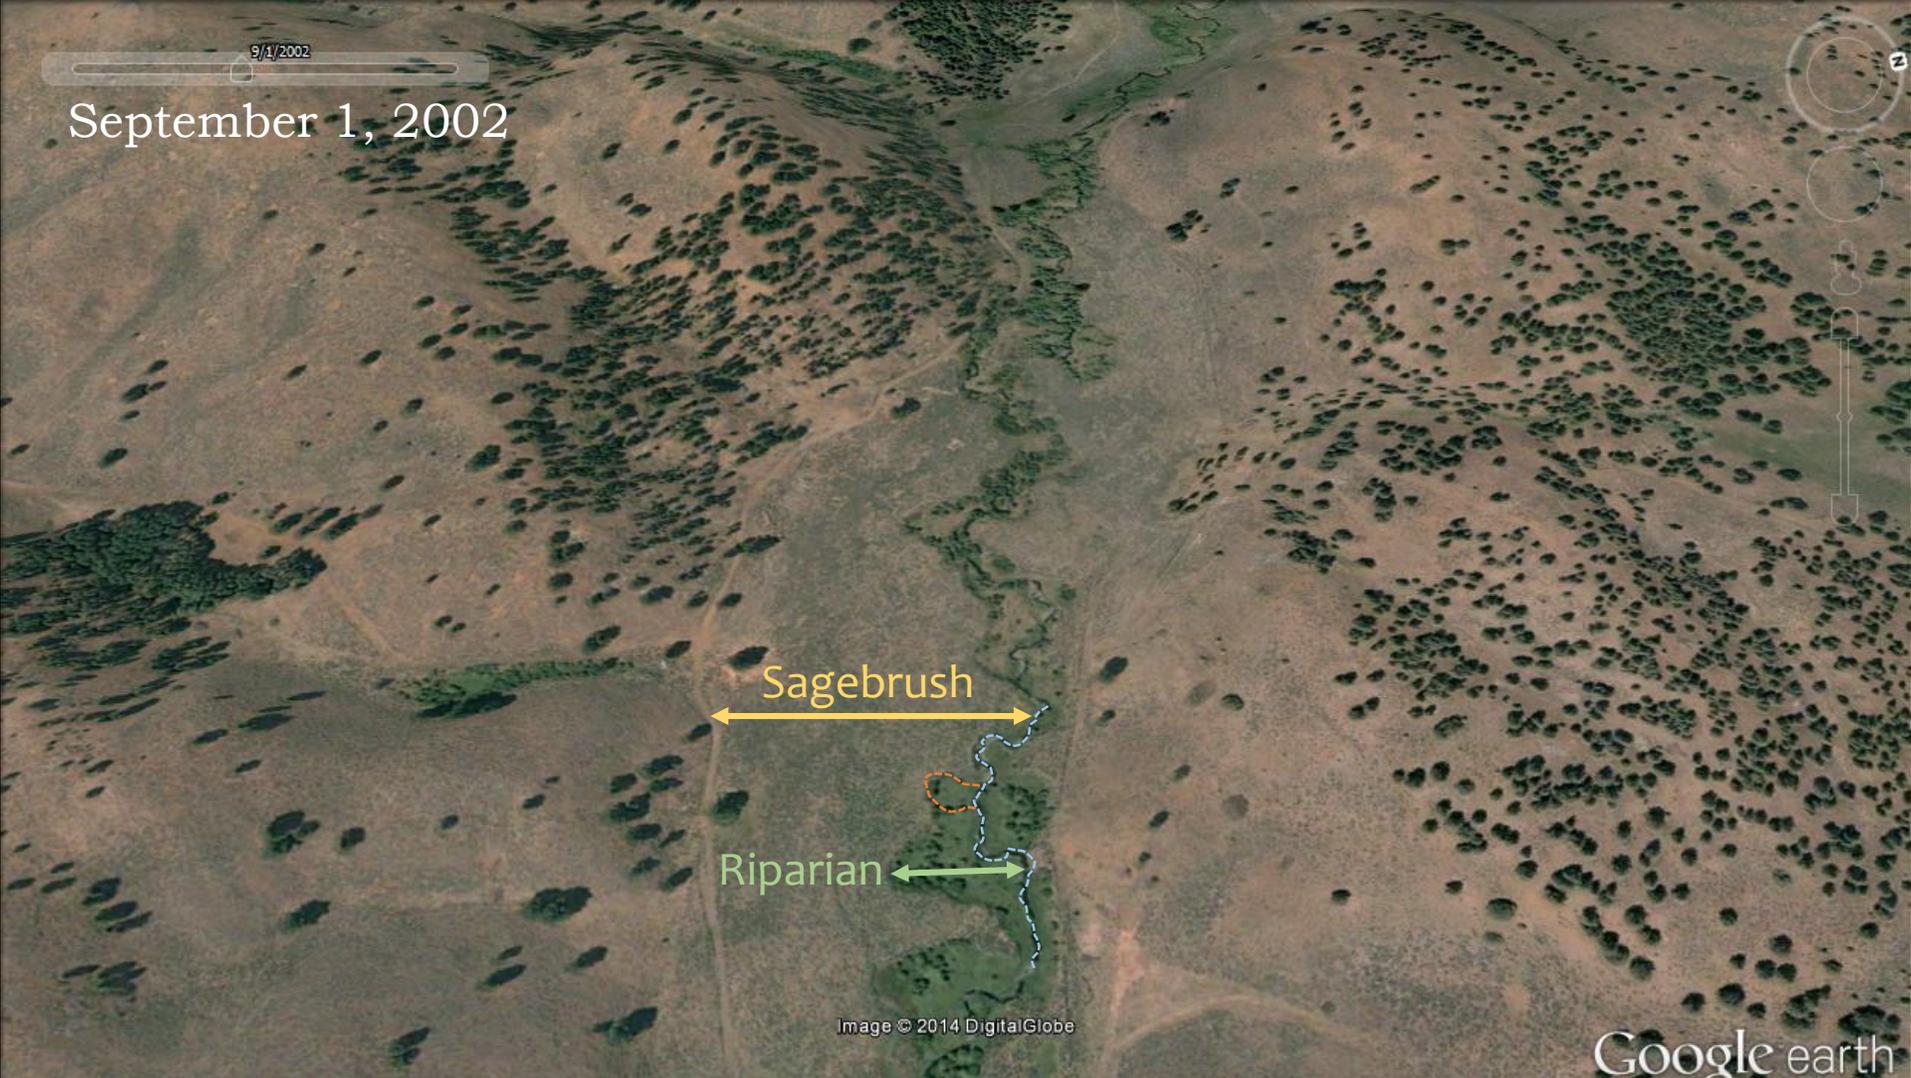
September 1, 2002

Imagery Date: 9/1/2002 44°03'00.25" N 118°59'50.20" W elev 4668 ft eye alt 6803 ft

4 years prior to restoration

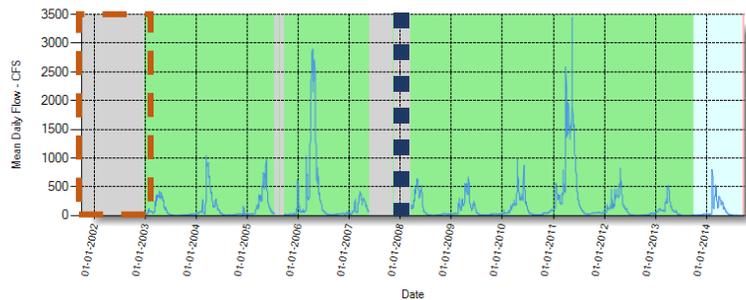
SILVIES R NR BURNS, OR Mean Daily Flow

Legend Mean Daily Flow - CFS

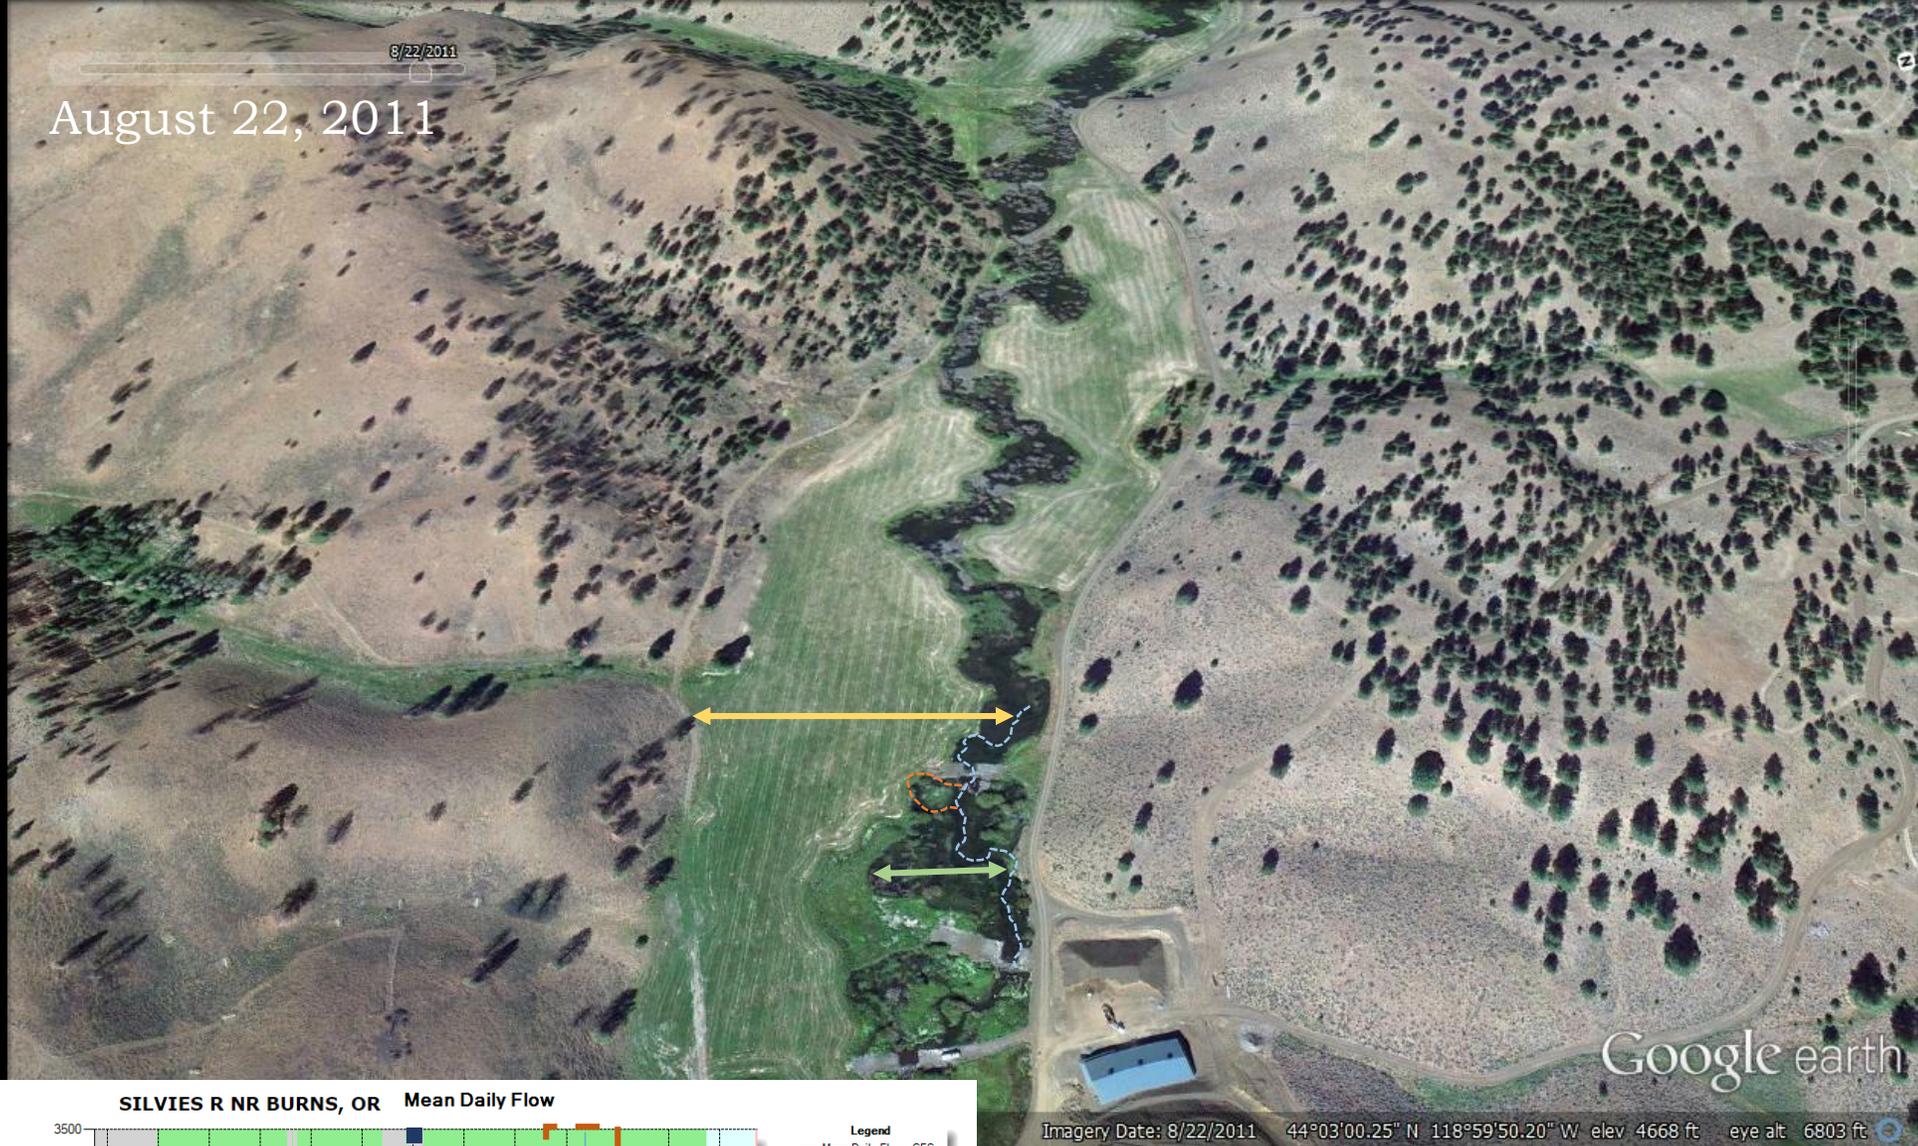
August 22, 2011

Imagery Date: 8/22/2011 44°03'00.25" N 118°59'50.20" W elev 4668 ft eye alt 6803 ft

3.5 years after restoration

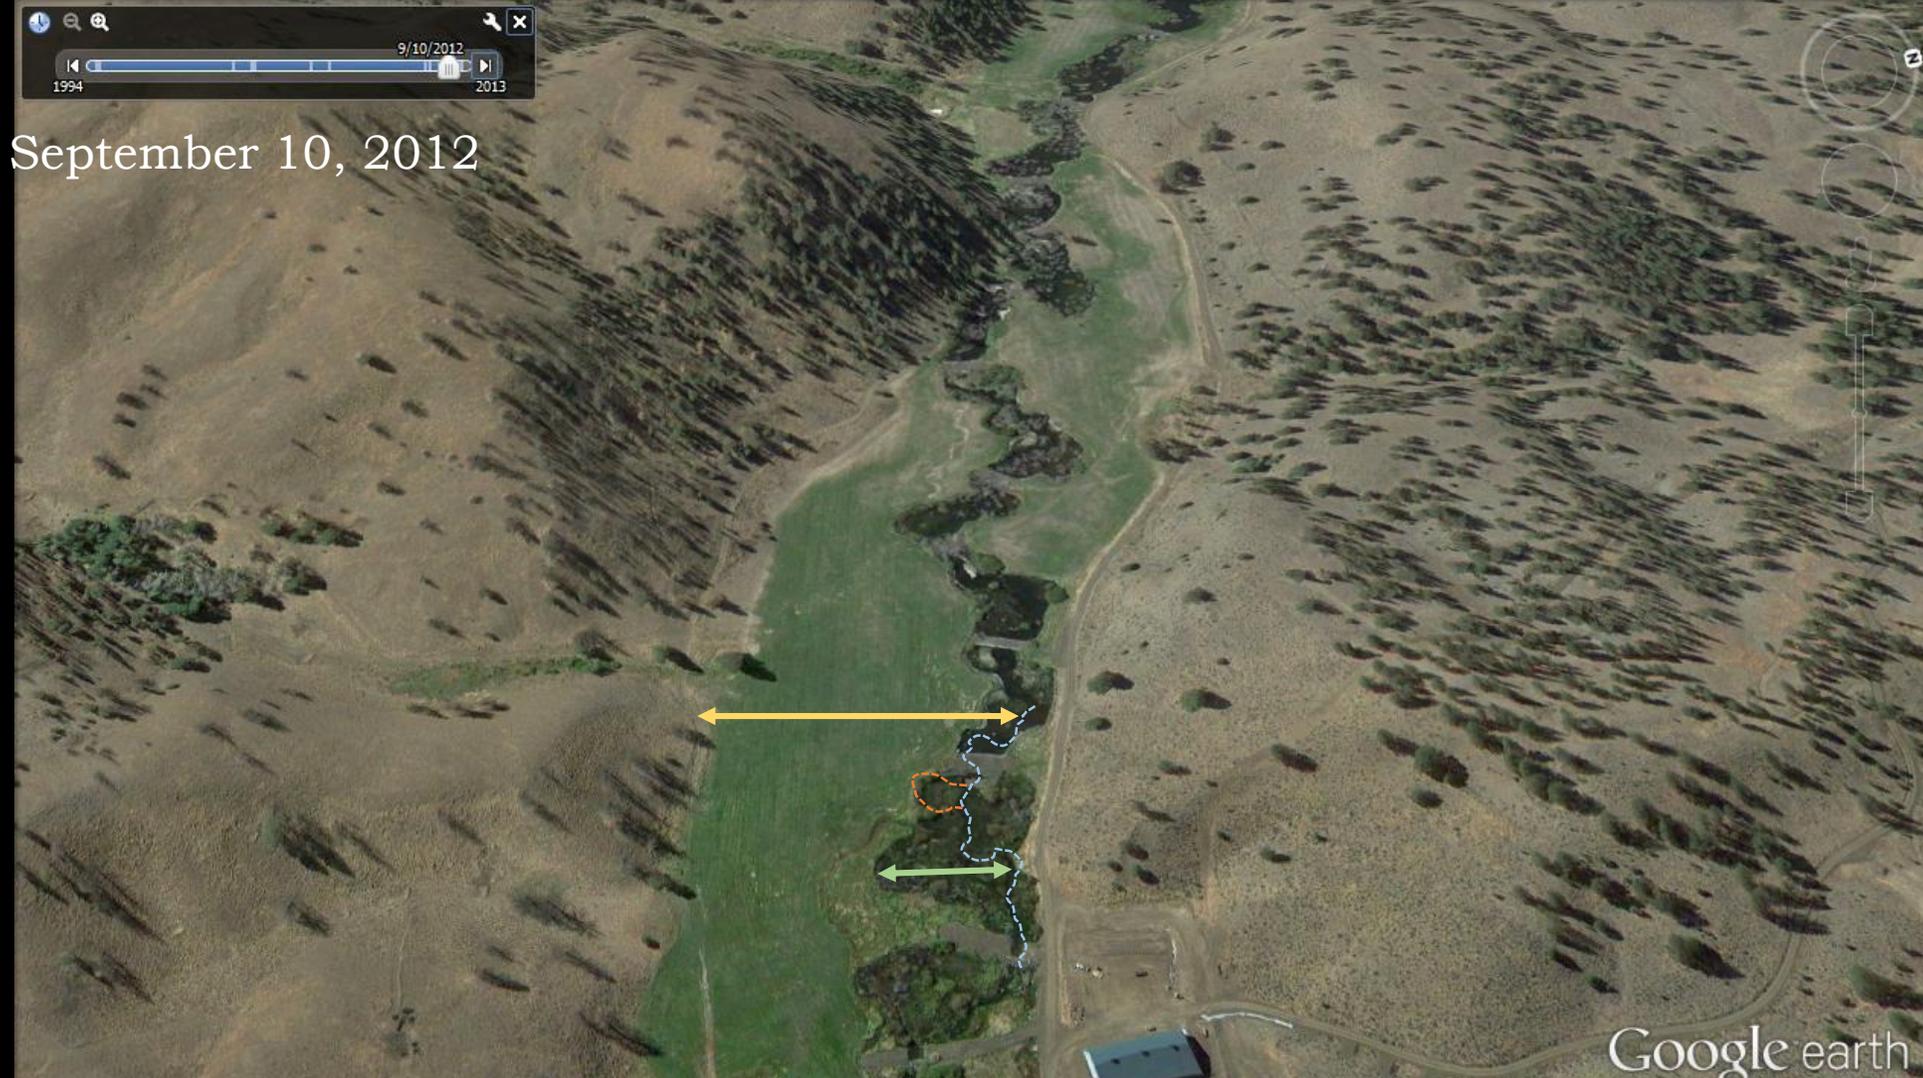
September 10, 2012

Imagery Date: 9/10/2012 44°03'00.25" N 118°59'50.20" W elev 4668 ft eye alt 6803 ft

4.5 years after restoration

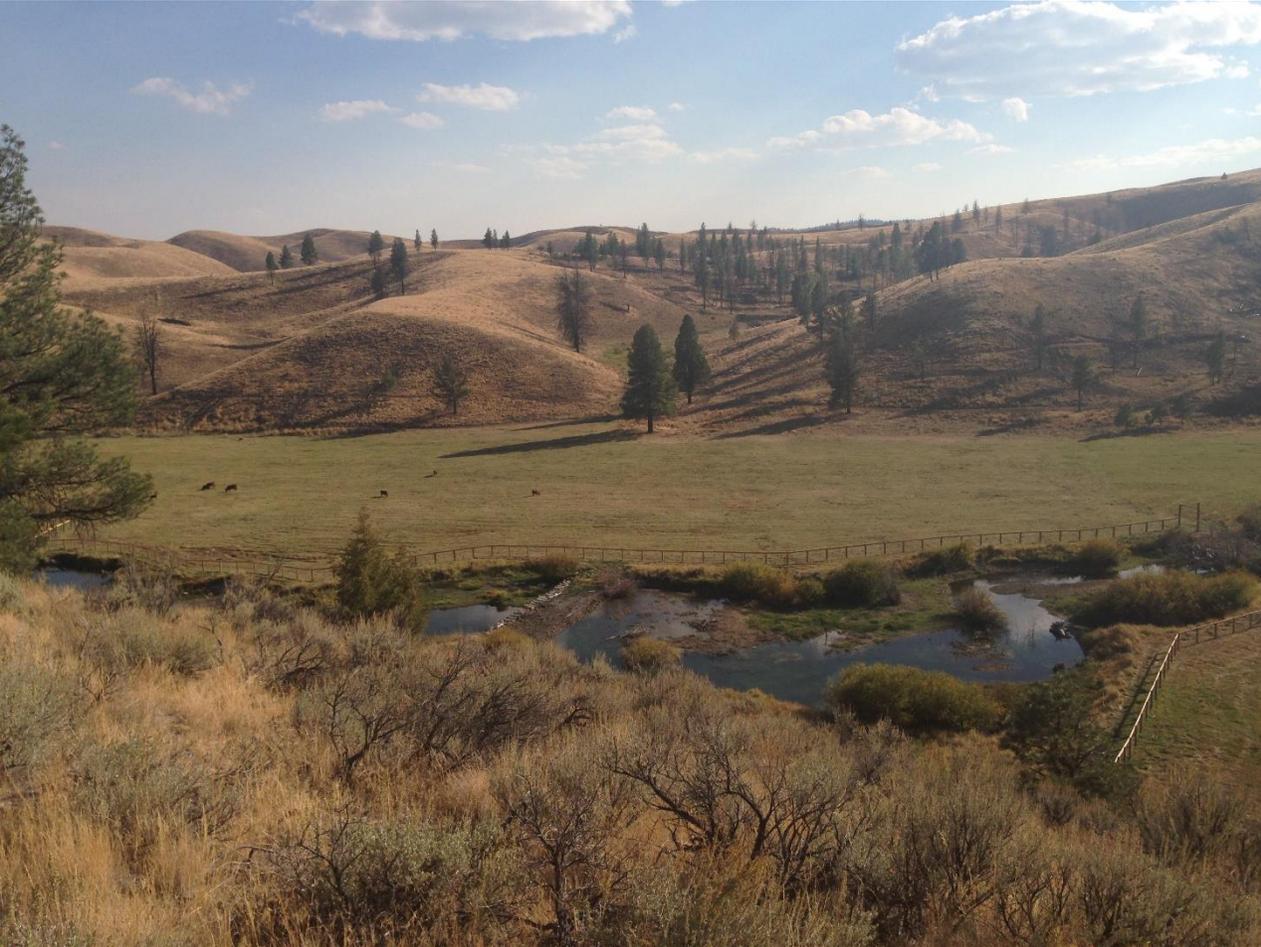
Project Impacts

- Surface Water: **+600%**
- Av. riparian width: **+ ~ 100%**
- Cumulative deposition: **1-14 cm ***
- Late summer stream flow: **?**
- Groundwater flux: **?**
- Ecological Succession: **?**
- Knickpoint propagation: **?**
- Economic productivity: **+10%****

**No ground-truthed before data from which to measure*

***Improvement to entire ranch profitability from single creek's restoration*
