# 2015-2016 Bus Collision Analysis

*October 23, 2017*

TriMet  
4012 SE 17th Ave.  
Portland, Oregon 97202

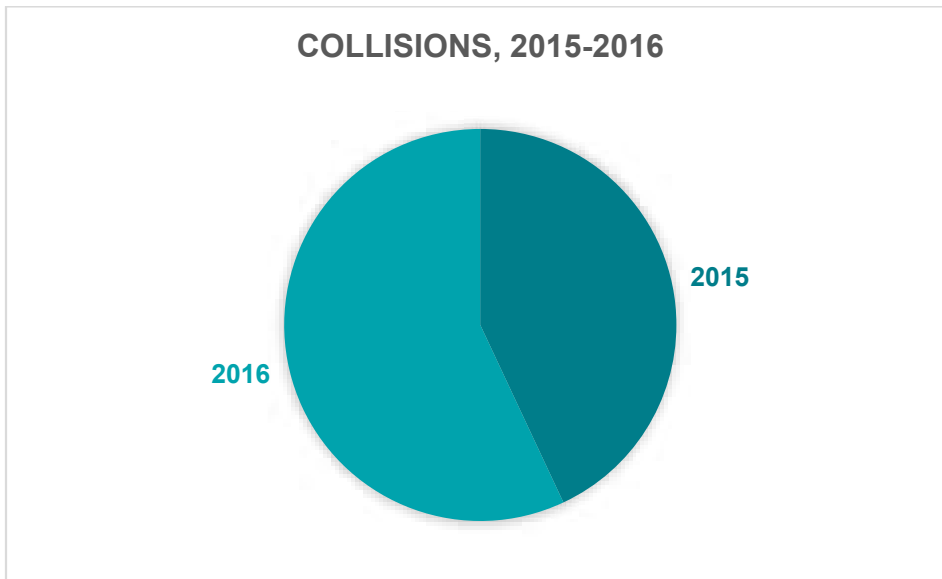
In total, TriMet experienced 2,242 bus collisions over the past two years (2015-2016). There has been a slight uptick in number of collisions between these years.

Seventy-seven collisions led to injury, and two involved fatalities, which were both caused by collisions with a moving vehicle.

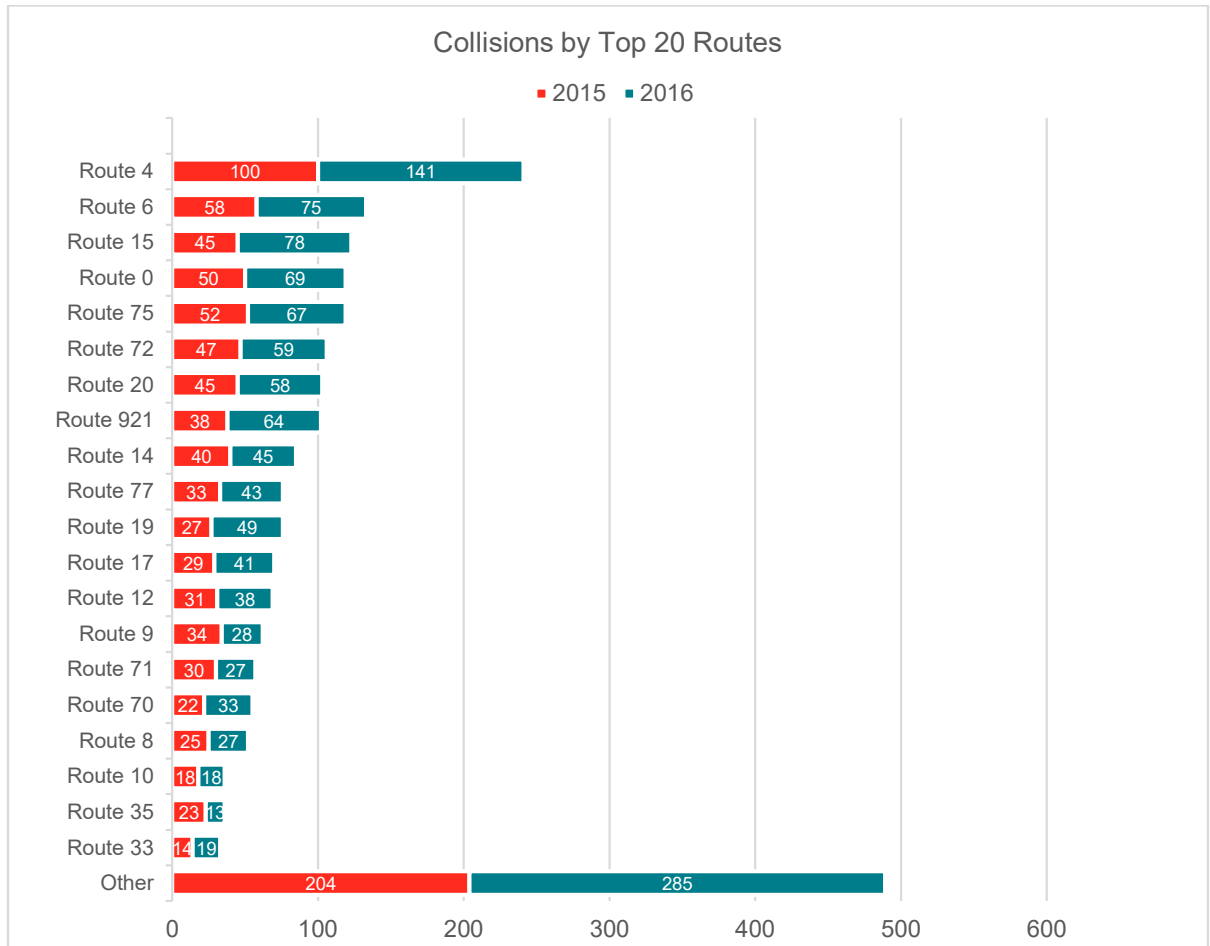
The routes on which collisions were most likely to occur in 2015-2016 are listed below. The route with the most frequent collisions was Route 4, with 10% of the collisions. Route 4 collisions increased by 29% between 2015 and 2016, and Route 6 collisions increased by 23%. Route 15 collisions increased by 42%.

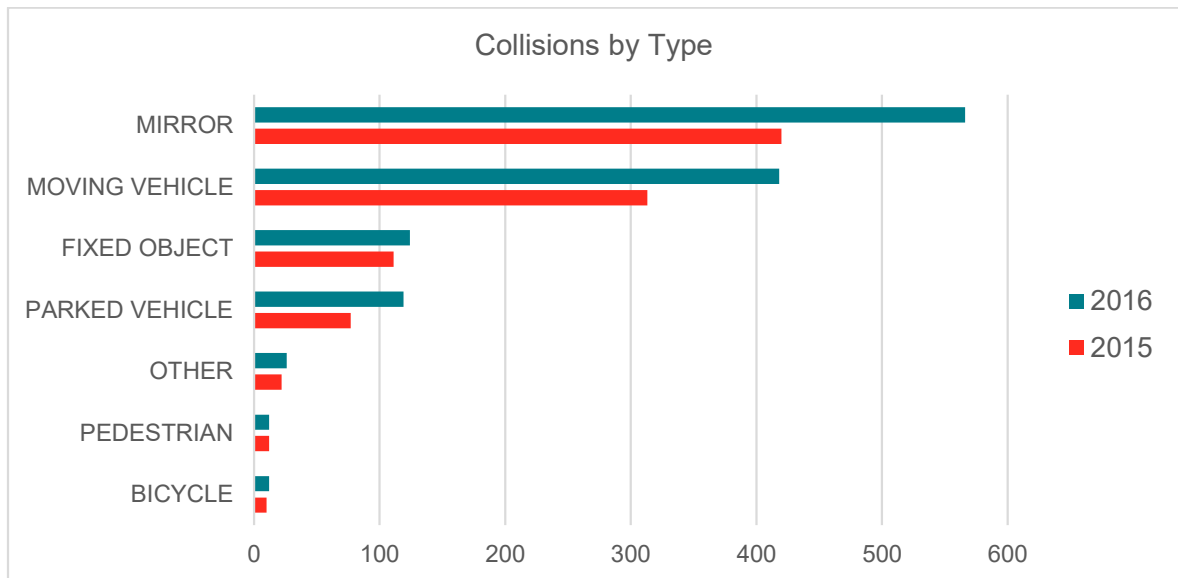
Between the last two years, both *mirror strikes* and *moving vehicle* collisions increased by 25%. Parked vehicle collisions increased by 35%.

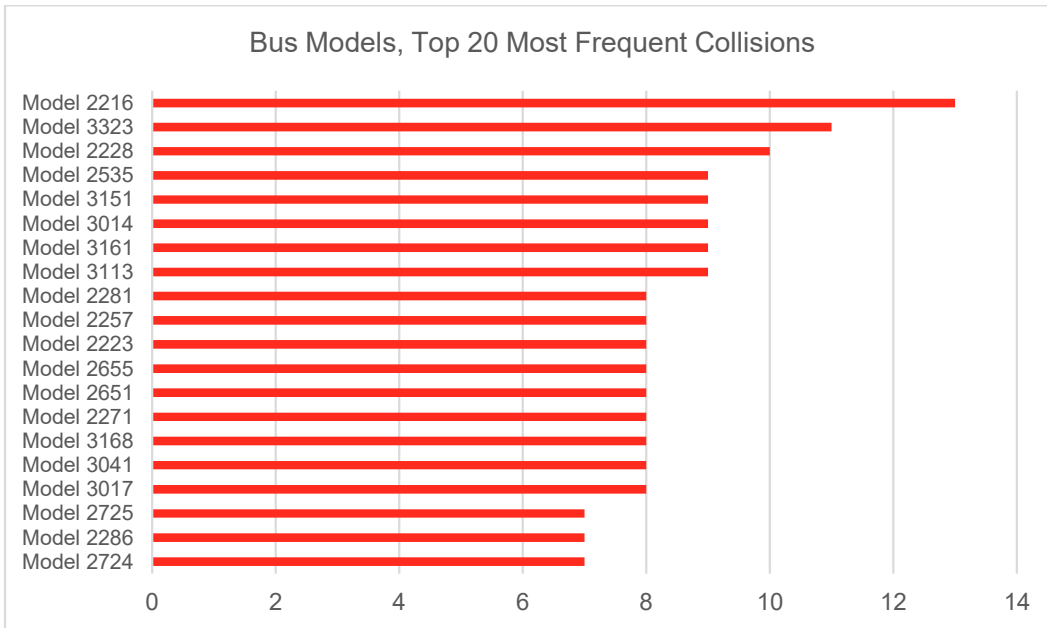
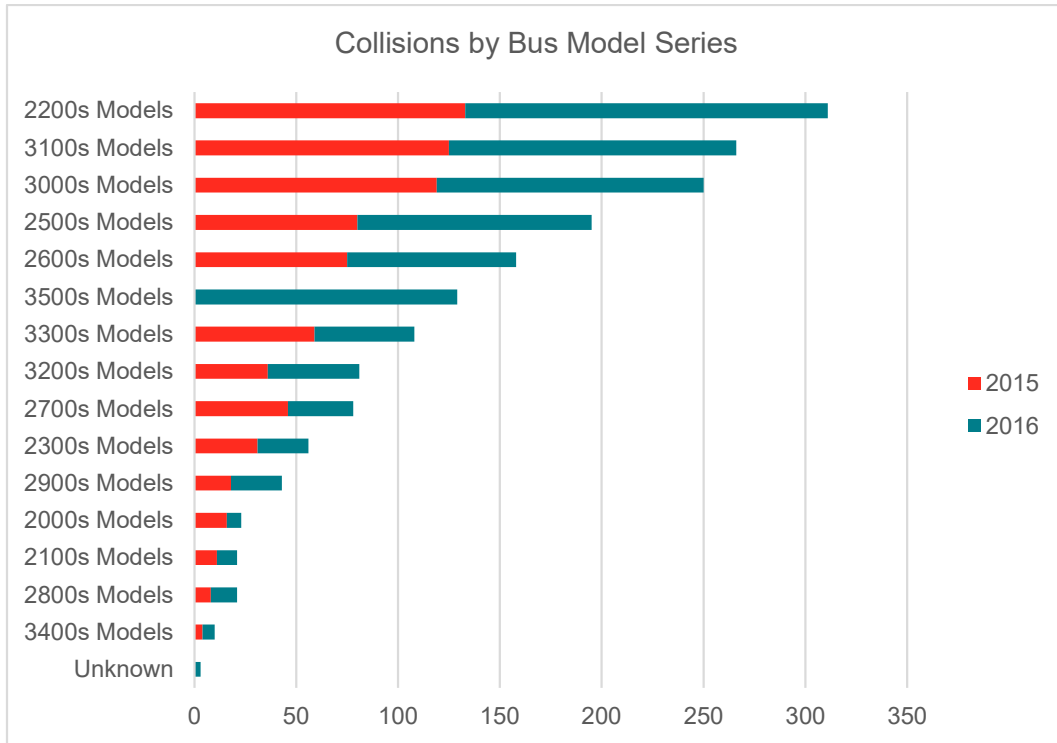
Bus models most involved in collisions are listed below. The *2216 model*, with the most frequent number of collisions, accounts only for 0.5% of all collisions between 2015-2016. In general, it does not appear that there is a trend in collisions with a particular bus model.

- ❖ **Recommendation 6: *Investigate bus model 2216.*** BSI recommends performing various investigatory tasks on bus model 2216 to look for inefficiencies or positioning, functionality, rear lighting, and distracting advertising that could increase risk of collision. The investigation should include a visual inspection, maintenance inspection and records review, ride-alongs, interviews with drivers, and a deeper dive into historical incident data.

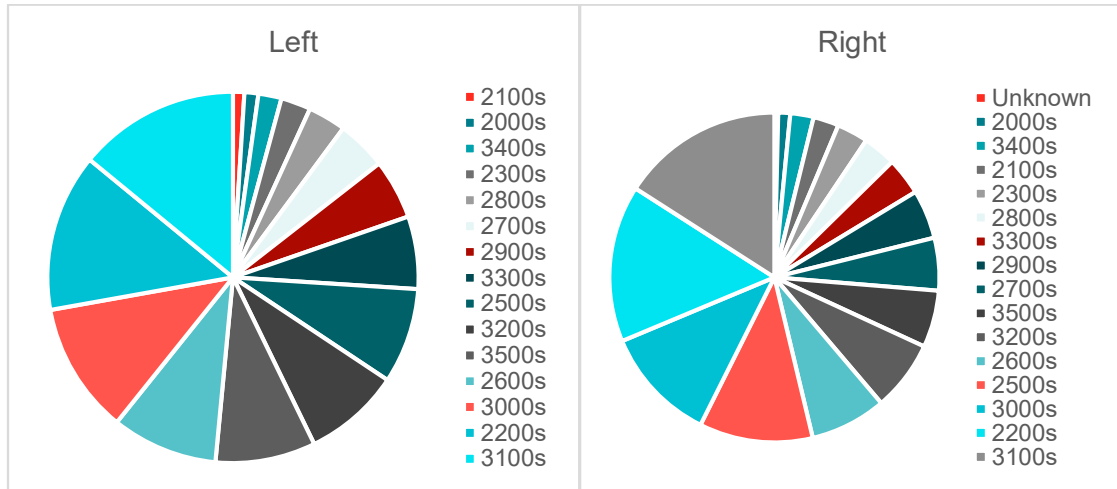
BSI compared side clearance to bus series to define any observable trends that may indicate certain blind spots on either side with particular a particular series of bus. Significant differences were not observed. The 3300s and 2200s were common bus models for both left and right collisions. Though BSI does not have this information, it is suspect that these are the most

common bus models in TriMet's fleet, indicating no correlation between bus series and side clearance.

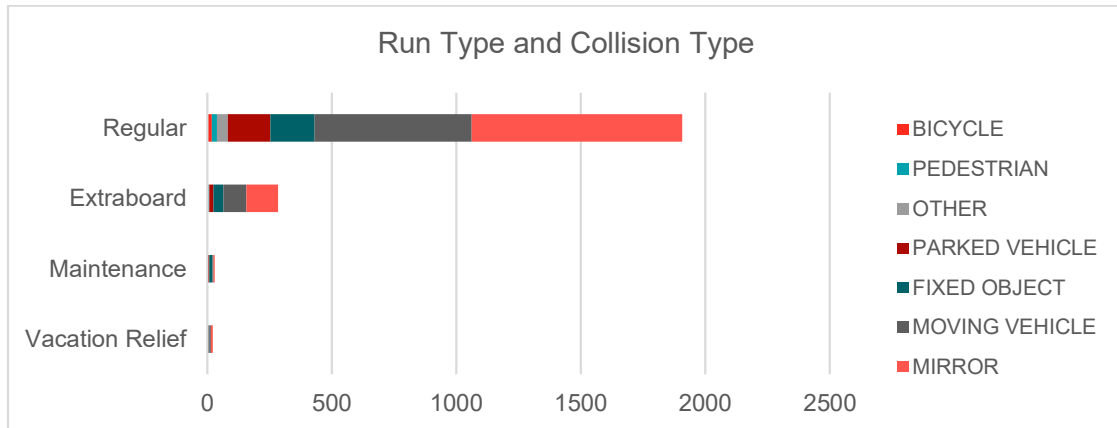
Overall, collisions are 50% more likely to occur on Regular runs than Extraboard. Maintenance workers and operators on Vacation Relief account for only 2% of all collisions between 2015 and 2016. These trends did not change from year to year.

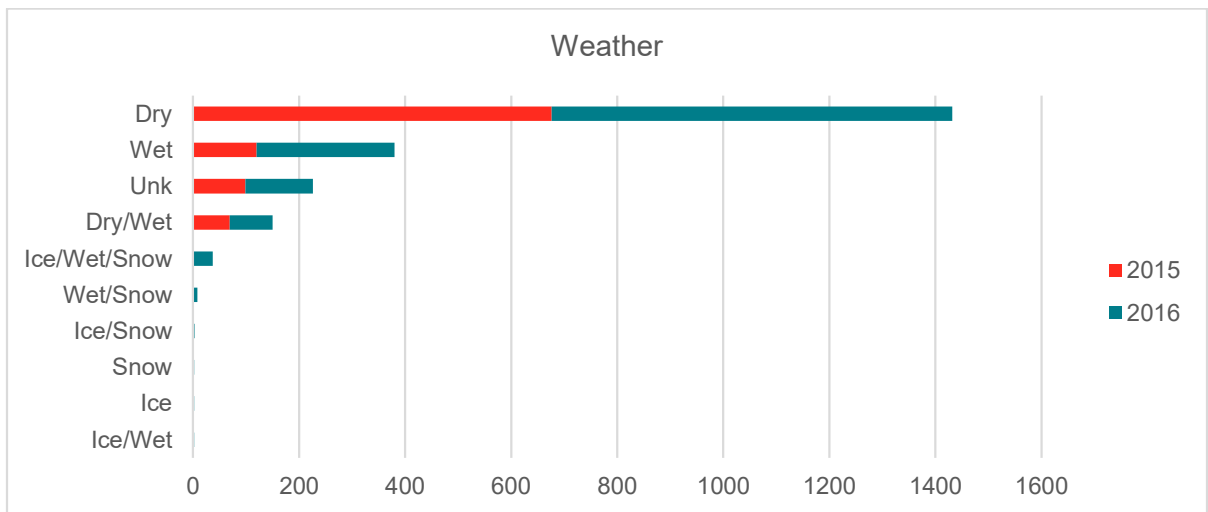
Most collisions (64%) from 2015-2016 occurred on reportedly *dry roads*. Wet roads accounted for only 17% of collisions.

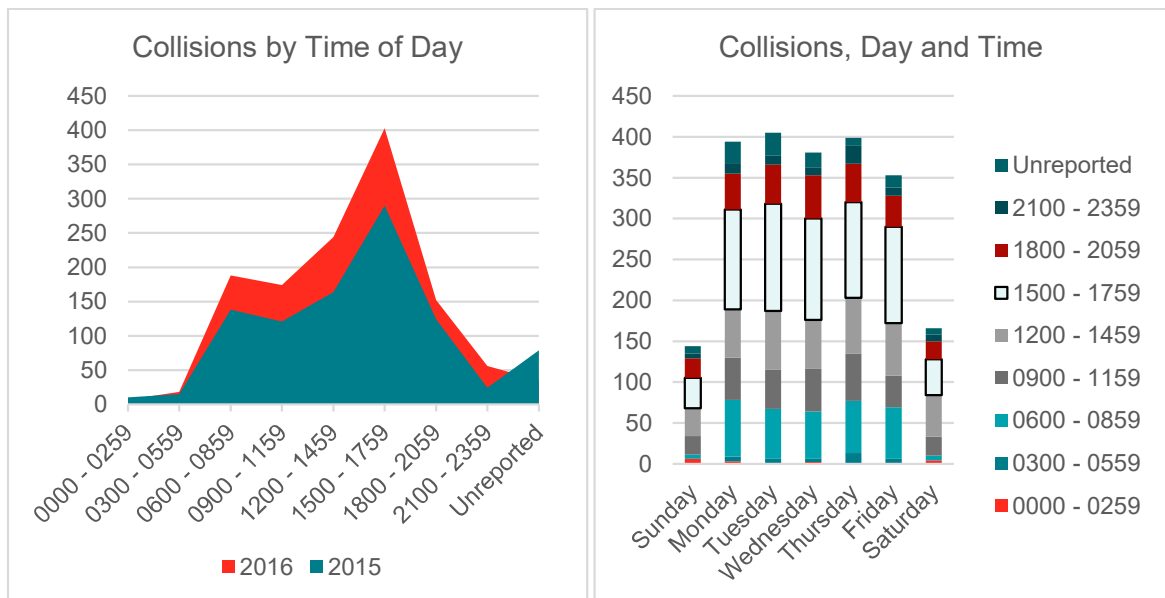
Cumulatively, the most common time of day for collisions is between 3:00pm and 6:00pm.

BSI also analyzed day of the week and found that most of the collisions occur during *weekdays*, indicating that collisions are most common during rush hour.
