Red Clover/McReynolds Creek Restoration Project Monitoring Report 2010

**Feather River Coordinated Resource Management
Plumas Corporation
Spring 2011**

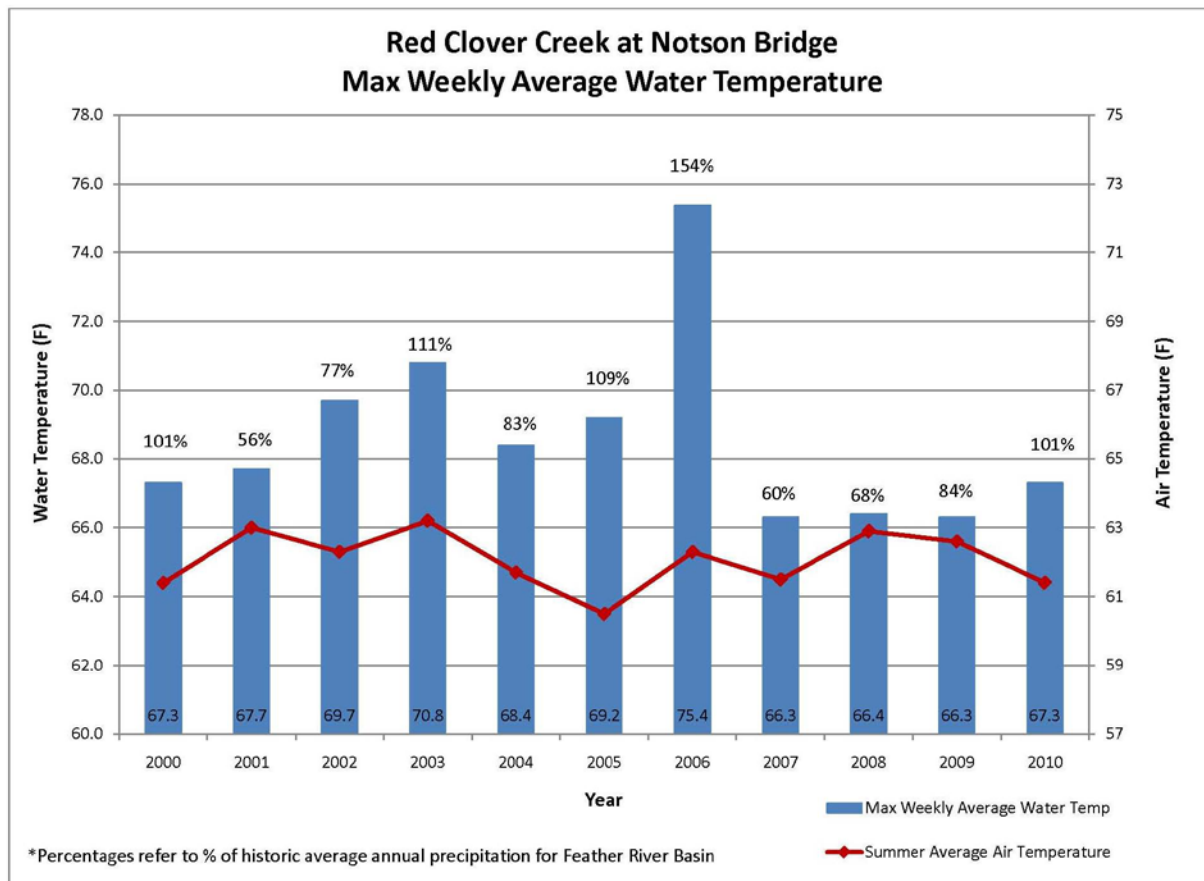
Figure 2. Maximum (max) Weekly Average Water Temperature at Notson Bridge.

Figure 2 shows the maximum weekly average water temperature at Notson Bridge, compared with summer average air temperature and historic average annual precipitation for the Feather River Basin. Summer average air temperature is an average of DWR weather stations at Antelope Lake, Doyle Crossing, Quincy, and Grizzly Ridge from June 1 through September 30. This graph shows that even though 2007 through 2010 were some of the lowest water years in the past 10 years of monitoring at Notson Bridge, they had the lowest maximum weekly average water temperatures. A comparison between 2000 and 2010, both with 101% normal annual precipitation and 61.4 °F summer average air temperature, shows that both years have the same maximum weekly average water temperature (67.3°F).

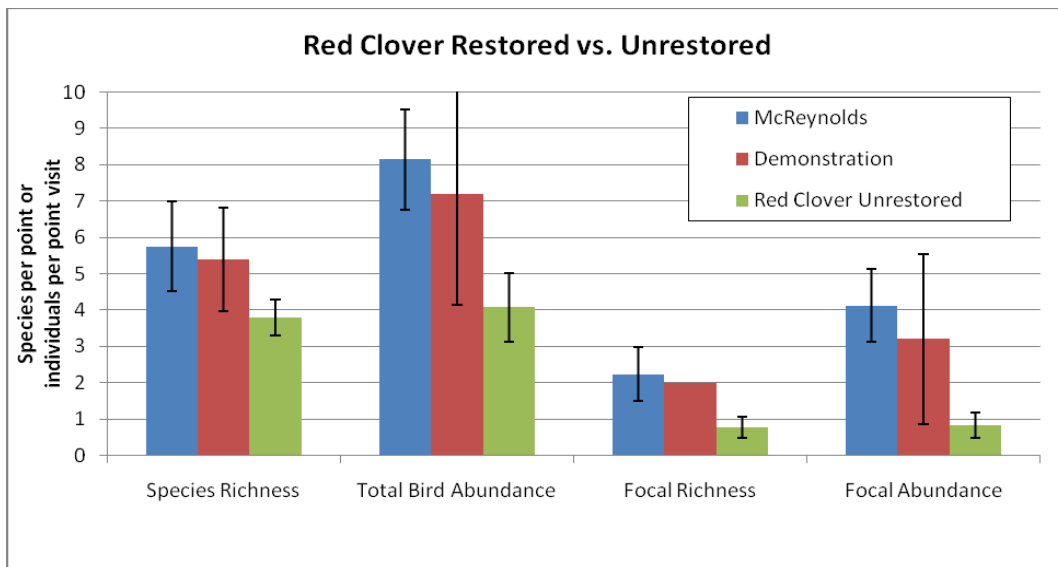
Figure 3. Red Clover McReynolds Point Count Summary: Point Richness and Abundance

Figure 3 shows that the Red Clover/McReynolds project area is significantly higher than the unrestored sites for all of the metrics. The 1985 Red Clover Demonstration project shows increase in all the metric from the unrestored sites, but due to the small sample size these differences are not statistically significant. This point count analysis was restricted to a subset of the species encountered. Species that do not breed in the study area, as well as those species that are not adequately sampled using the point count method (e.g. waterfowl, raptors, and wading birds), were not included in the analysis.
