James Fraser
Oregon Policy Advisor
Re: HB 2929 A (2023)

Illegal water storage (OWRD photos).

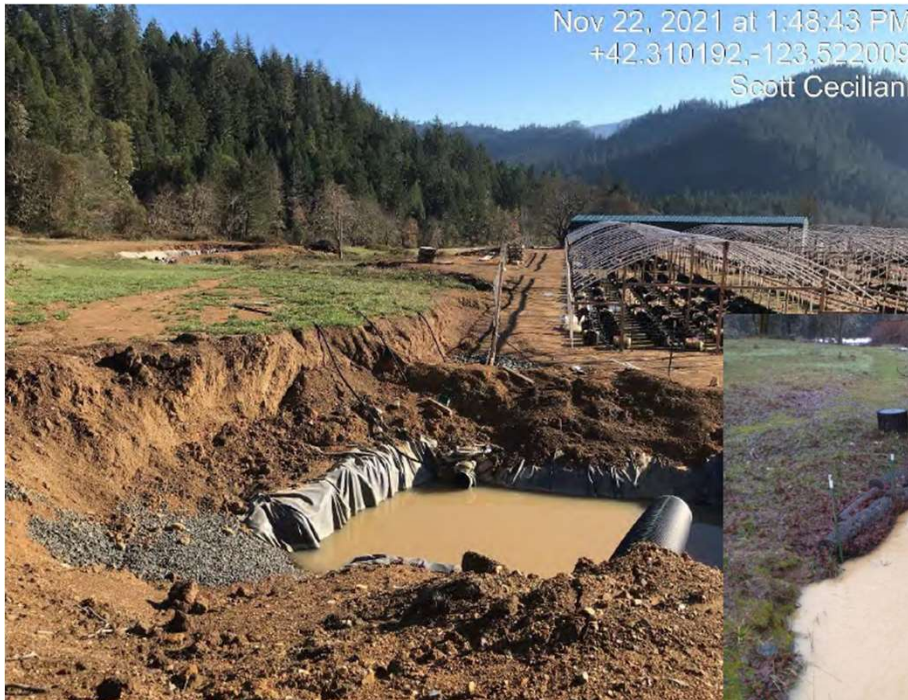
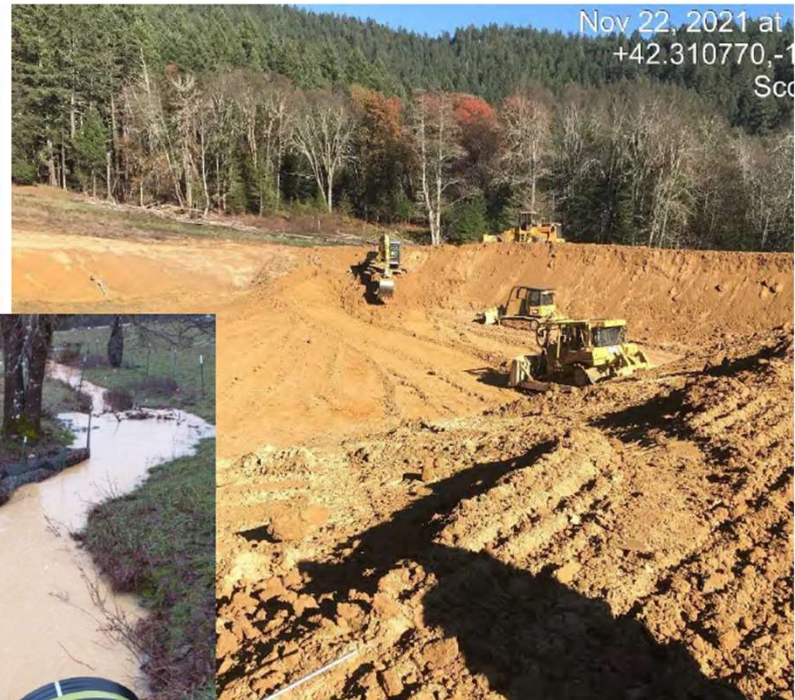
Large dam on small stream.

Summer 2019

- Coho likely stranded in ditch.
- Only second time BLM biologist has seen creek dry.
- Dry year but not declared drought.

Winter 2022

- Push up dam, diversion remains in place.
- Overtopping fish screen.

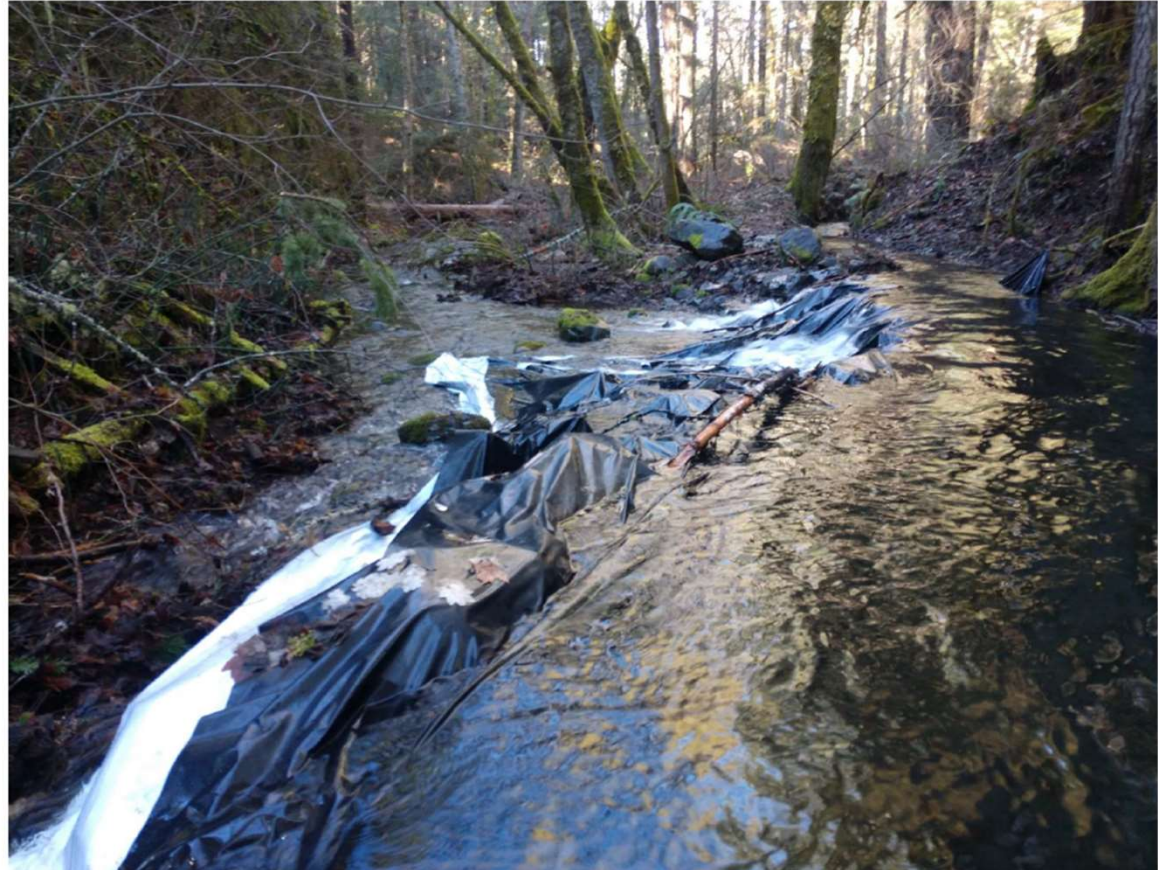
Resumption of abandoned diversion dam.

- May 2019.
- Dam rebuilt at old diversion site.
- ODFW records indicate the screen was marked “turned out” since 2011, basically means not taking water.

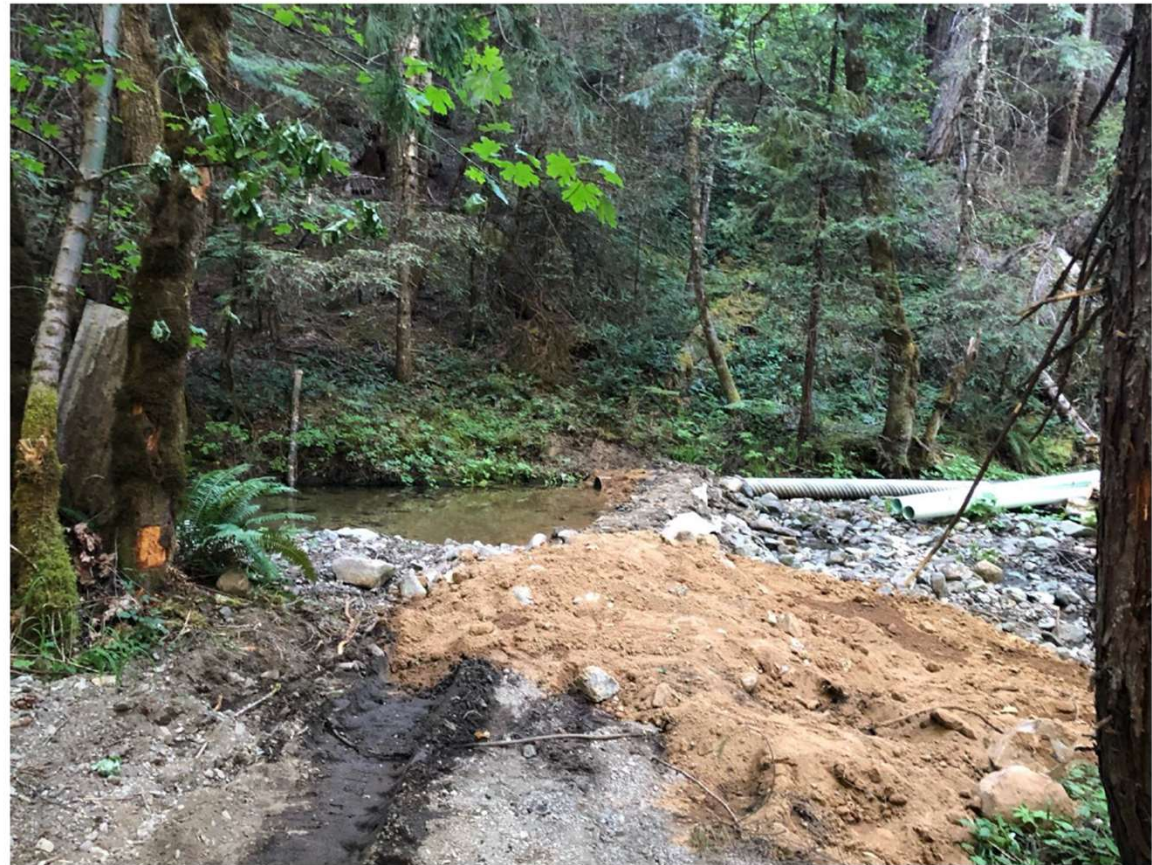
Unpermitted pumping from streams.
