**ILLUSTRATED EXAMPLES OF 5 STREAMBANK STABILIZATION PROJECTS,
WITH COMPARISON OF BEFORE AND AFTER CONSTRUCTION, ILLUSTRATING
COMMON BIOENGINEERED BANK STABILIZATION TECHNIQUES**

**FOR THE PURPOSE OF REPAIRING EROSION SITES AND RE-ESTABLISHING
RIPARIAN BUFFER FOR FISH AND OTHER SPECIES HABITAT**

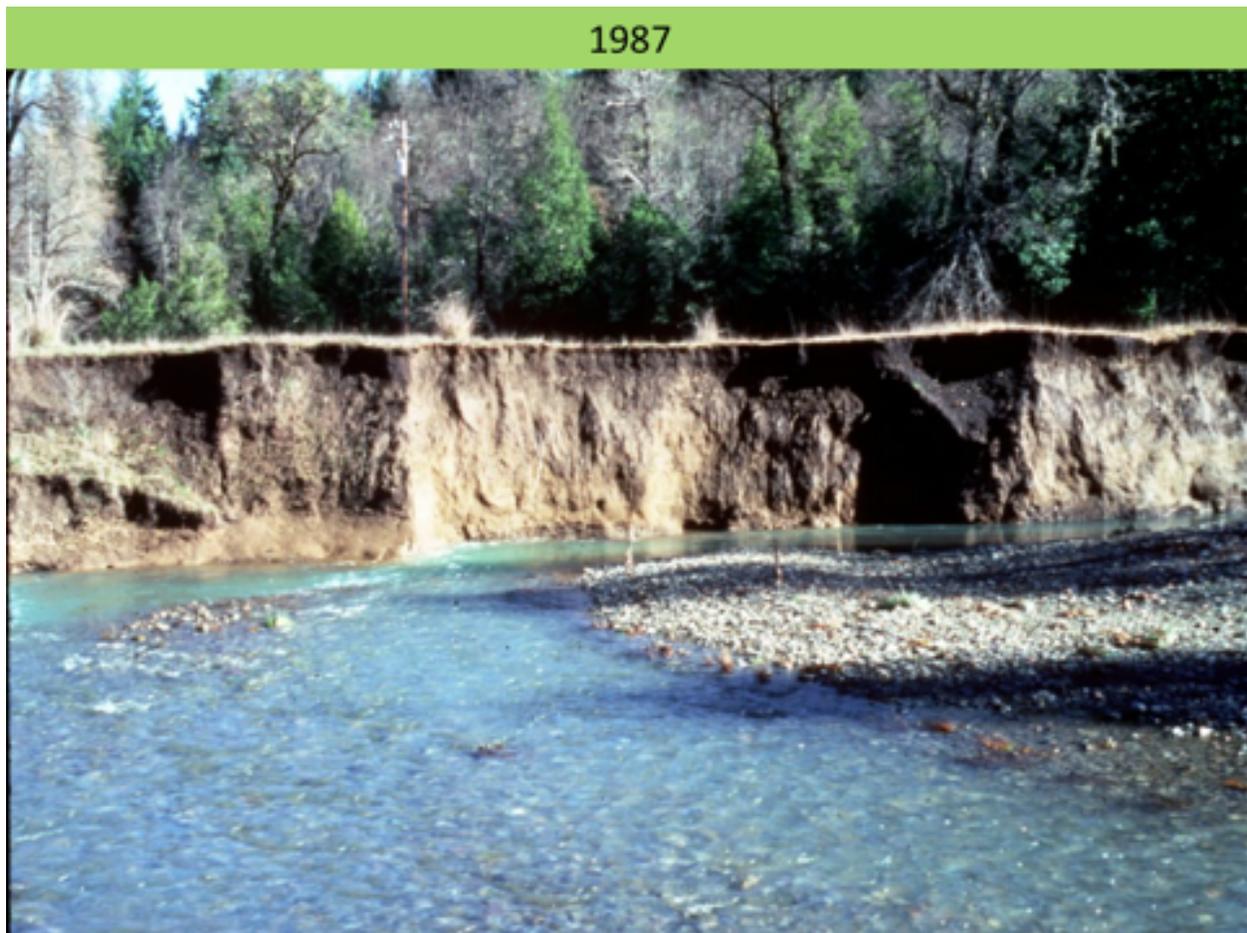
Figure 1

TEN MILE #1: HIGH ERODING BANK WITH LOSS OF RIPARIAN

A Live Willow Brush Mattress with a quarried boulder toe was installed. It was covered with a light layer of gravel to prevent desiccation and increase rooting. October, 1988.

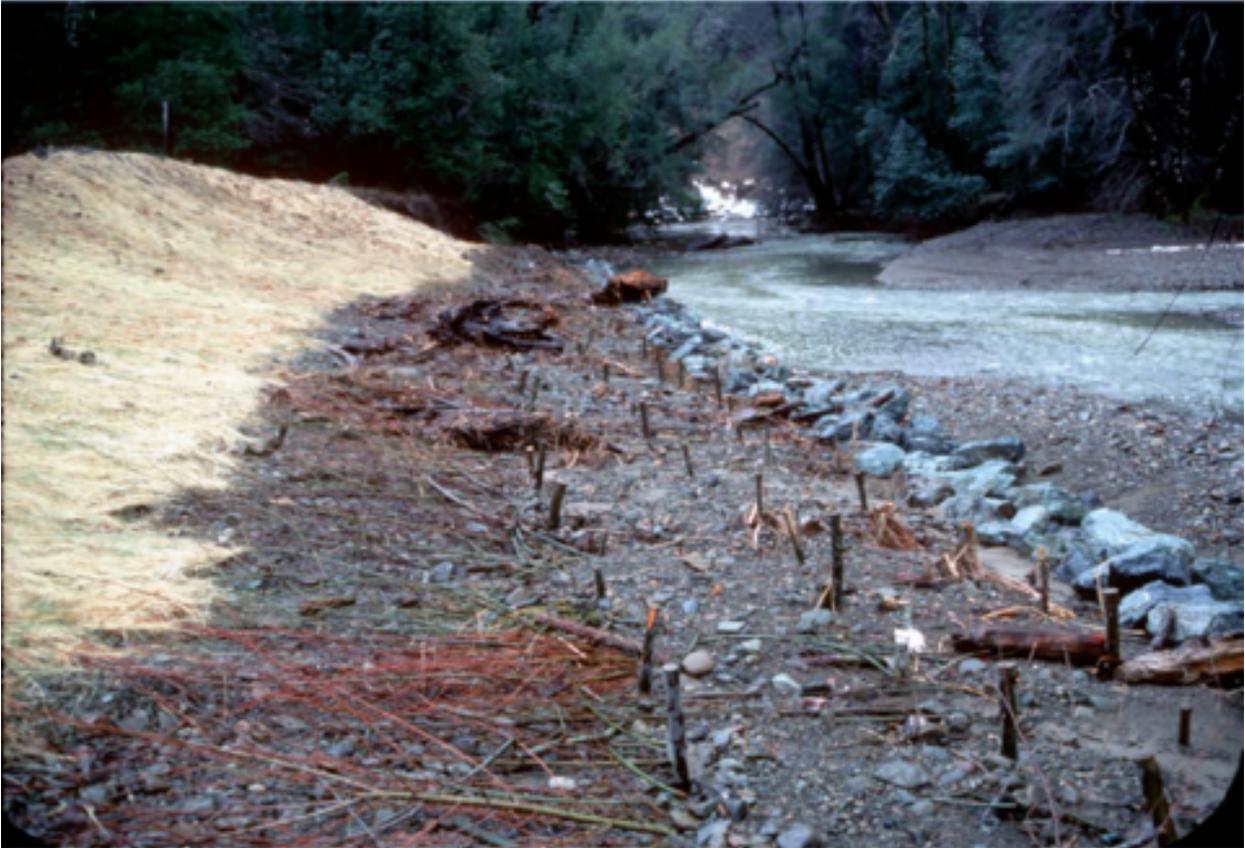
Figure 2:

TEN MILE #2: FIRST YEAR CONSTRUCTION

2003

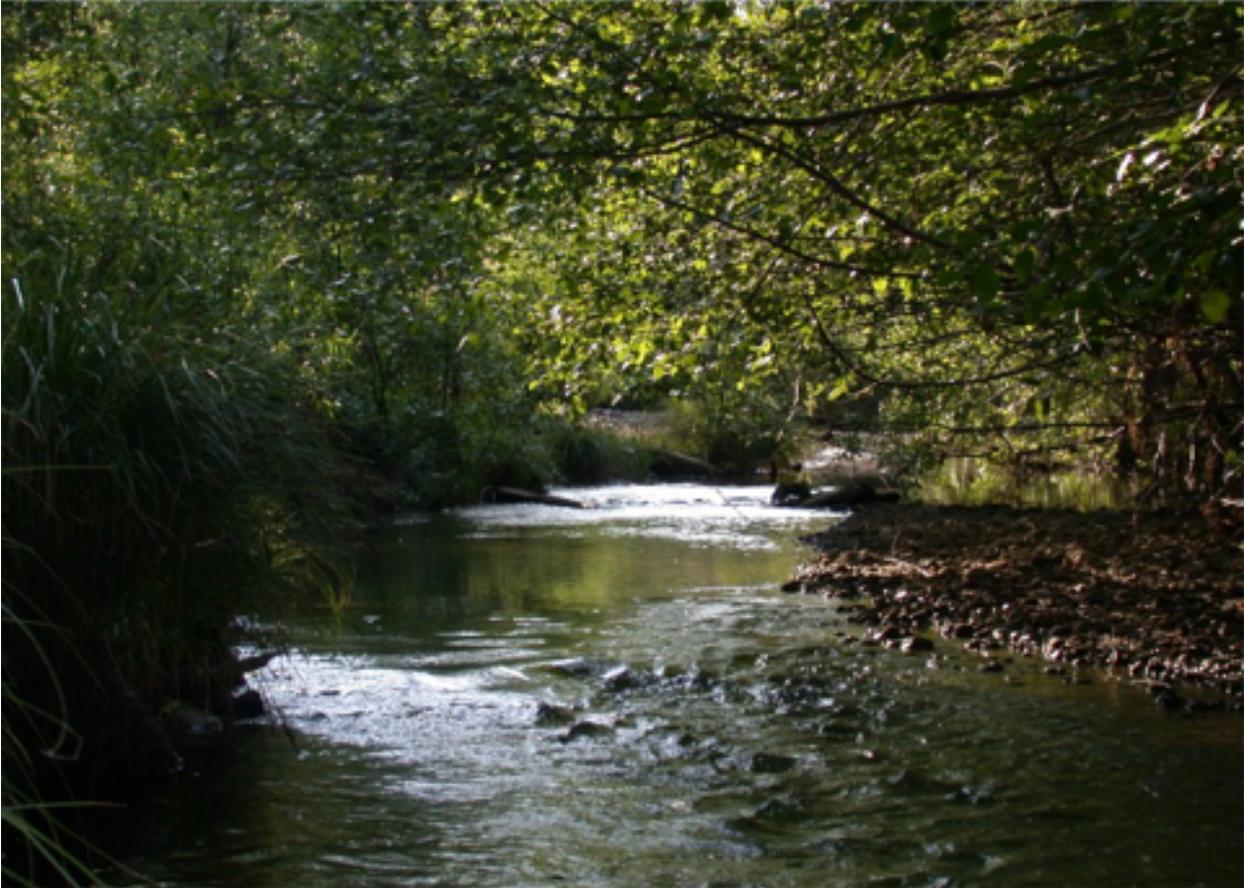
Figure 3

TEN MILE #3: EIGHT YEARS POST CONSTRUCTION: RIPARIAN COMPLEXITY HAS BEEN ESTABLISHED ALONG BANK WITH OVERHANGING SHADE

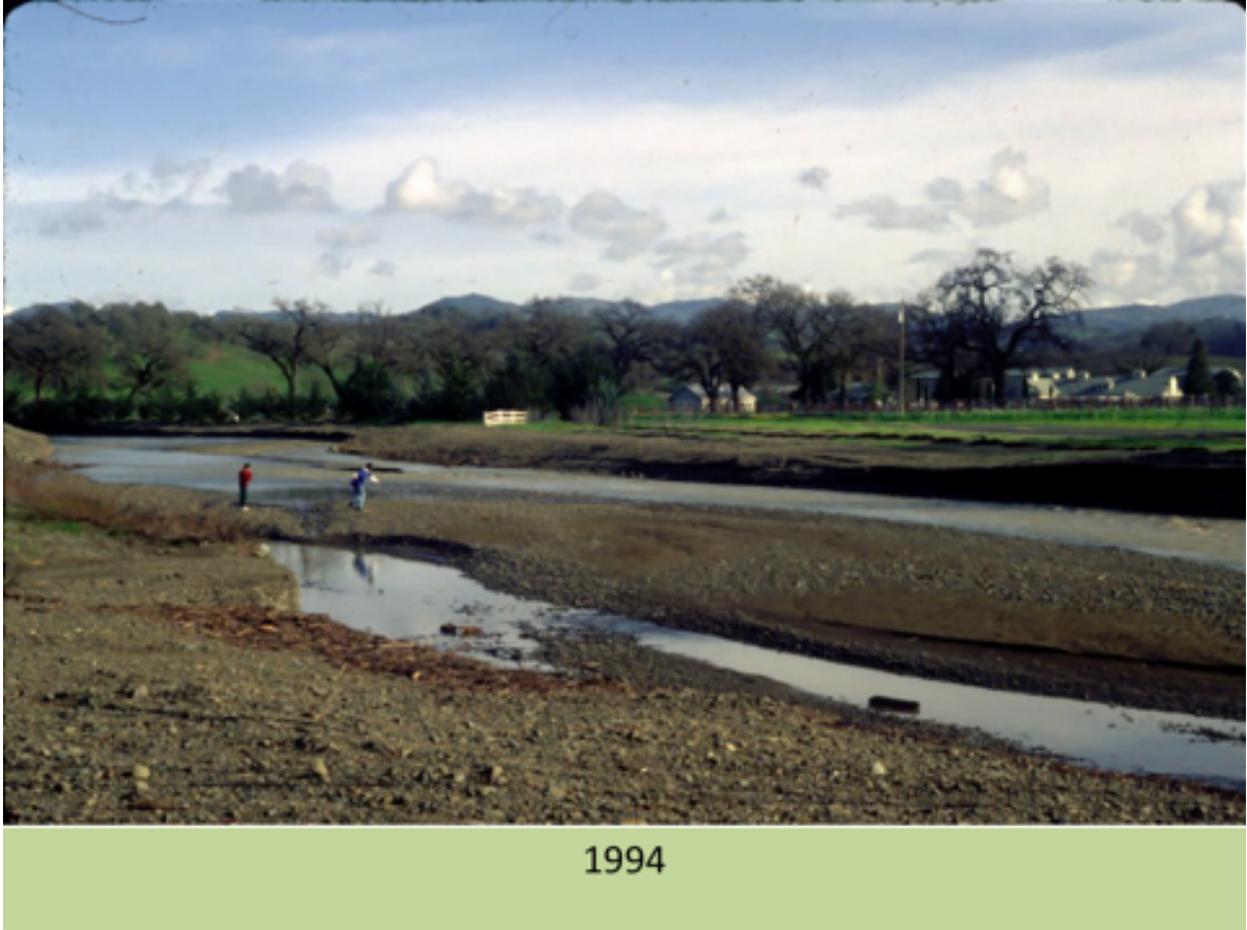
Figure 4

RUSSIAN RIVER #1: ERODING BANK AND LOSS OF HABITAT AND RIPARIAN

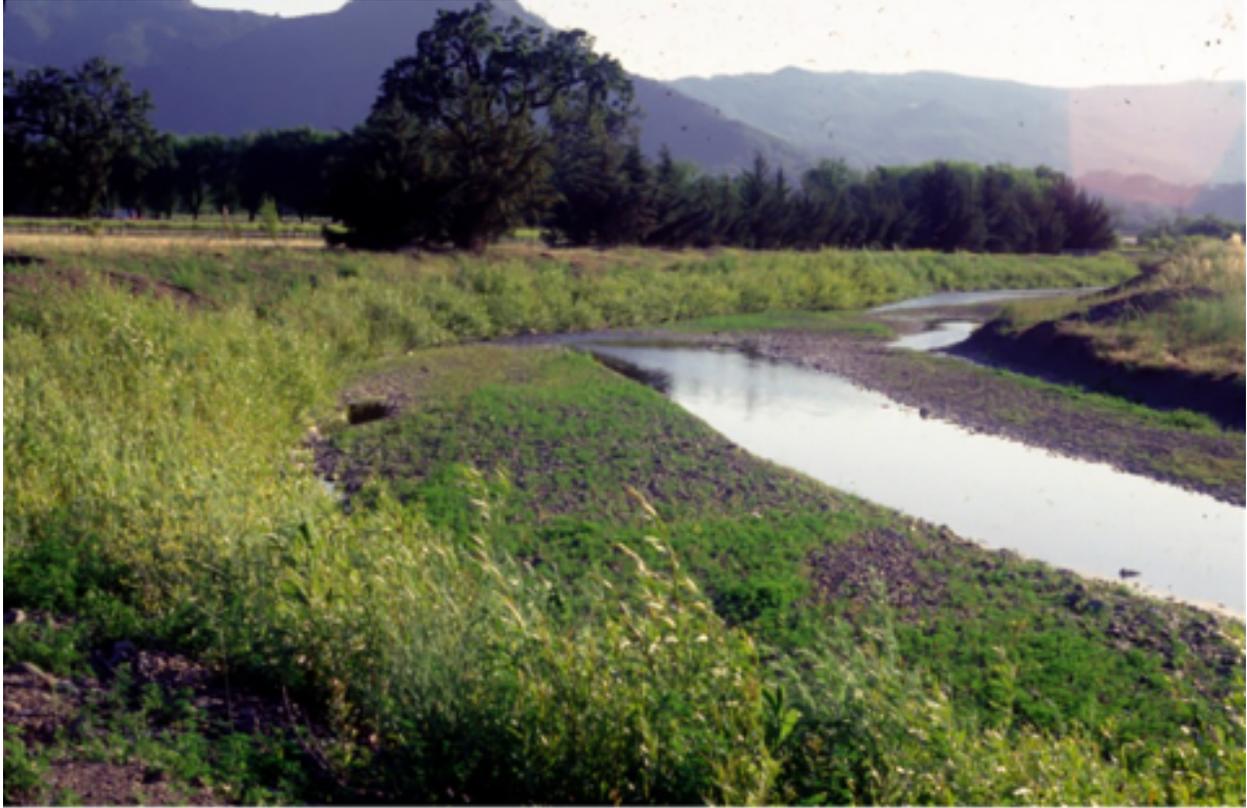
Figure 5

This is the second season's growth at the upstream end looking downstream.

RUSSIAN RIVER #2: SECOND YEAR POST CONSTRUCTION

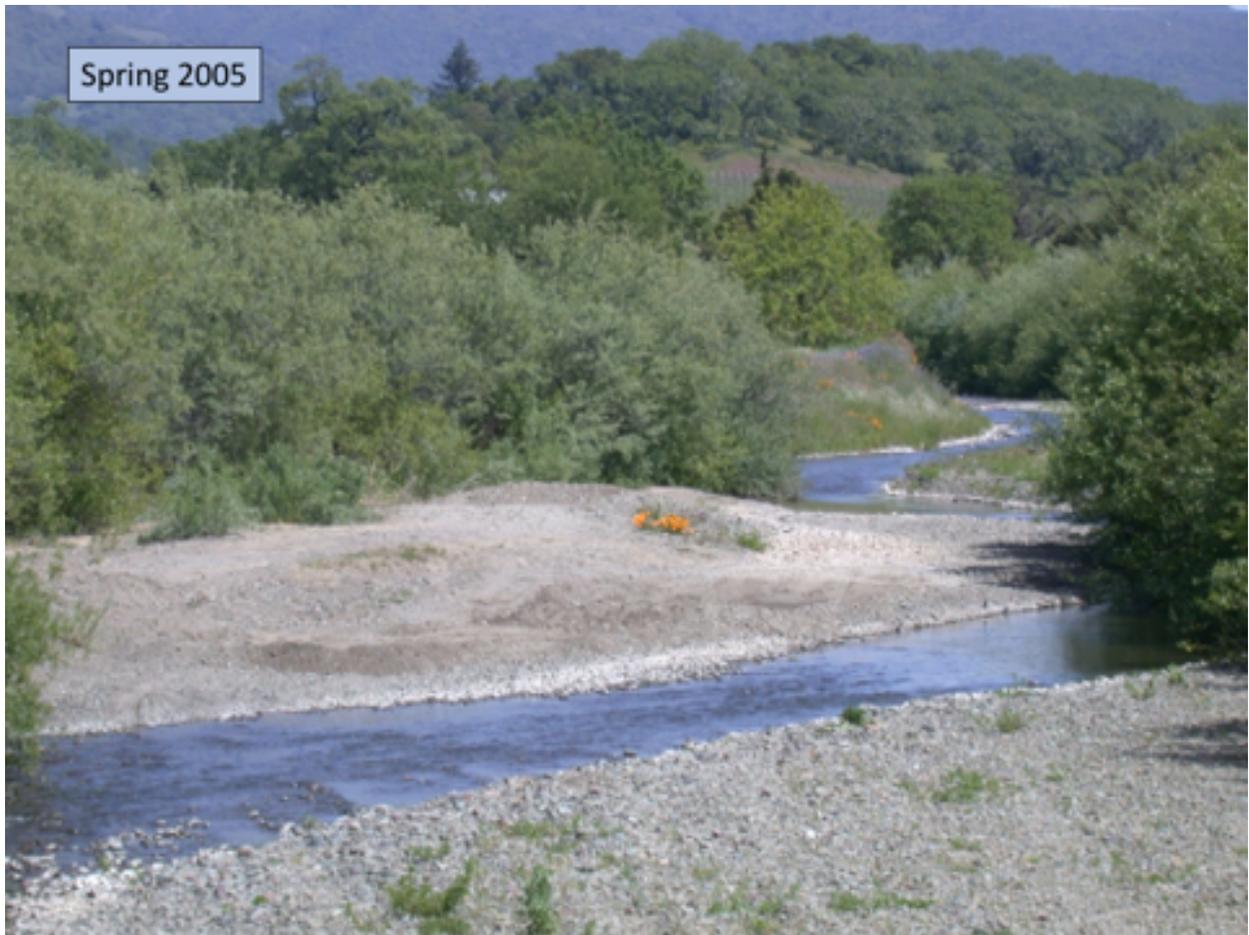
Figure 6

RUSSIAN RIVER #3: EIGHT YEARS POST CONSTRUCTION

August 2006

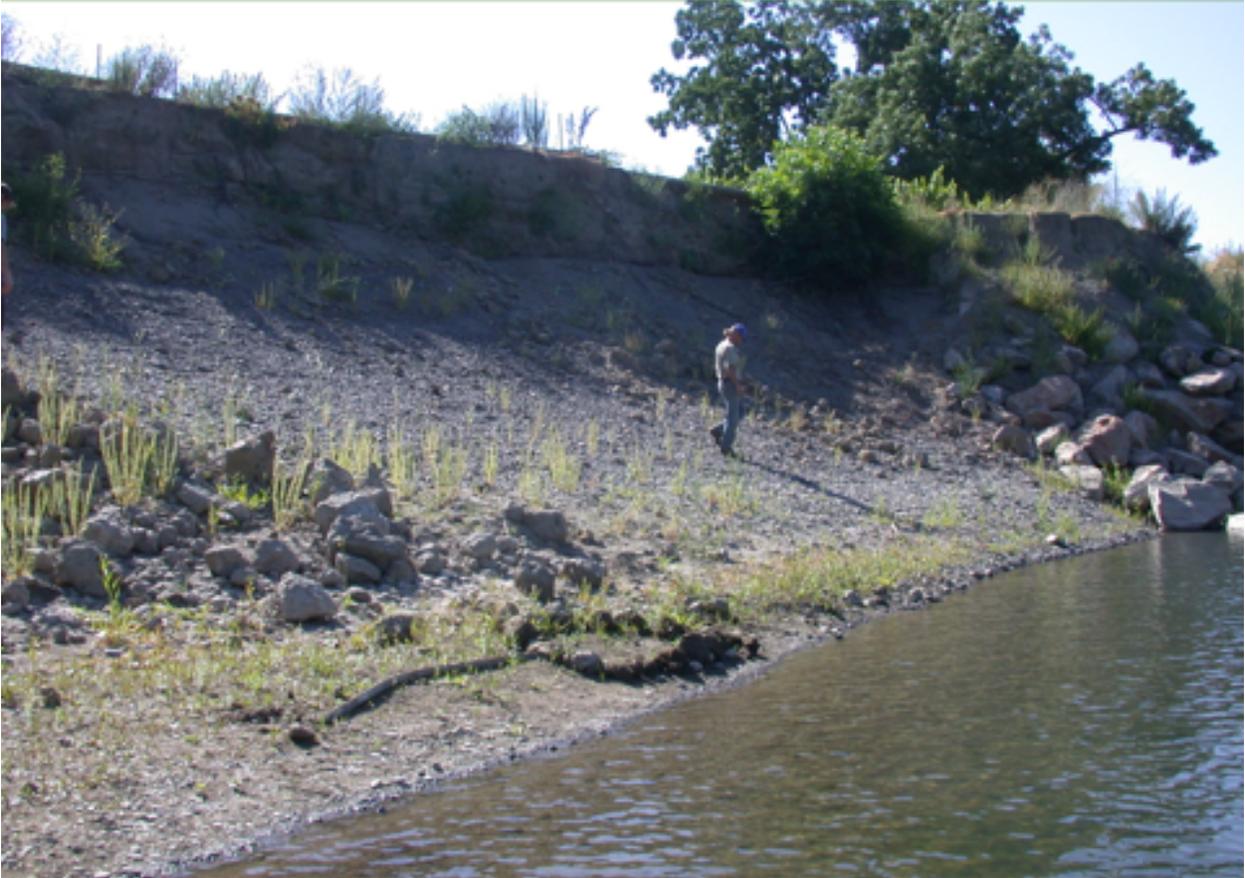
Figure 7

ROCIOLI #1: ERODING BANK; LOSS OF RIPARIAN HABITAT

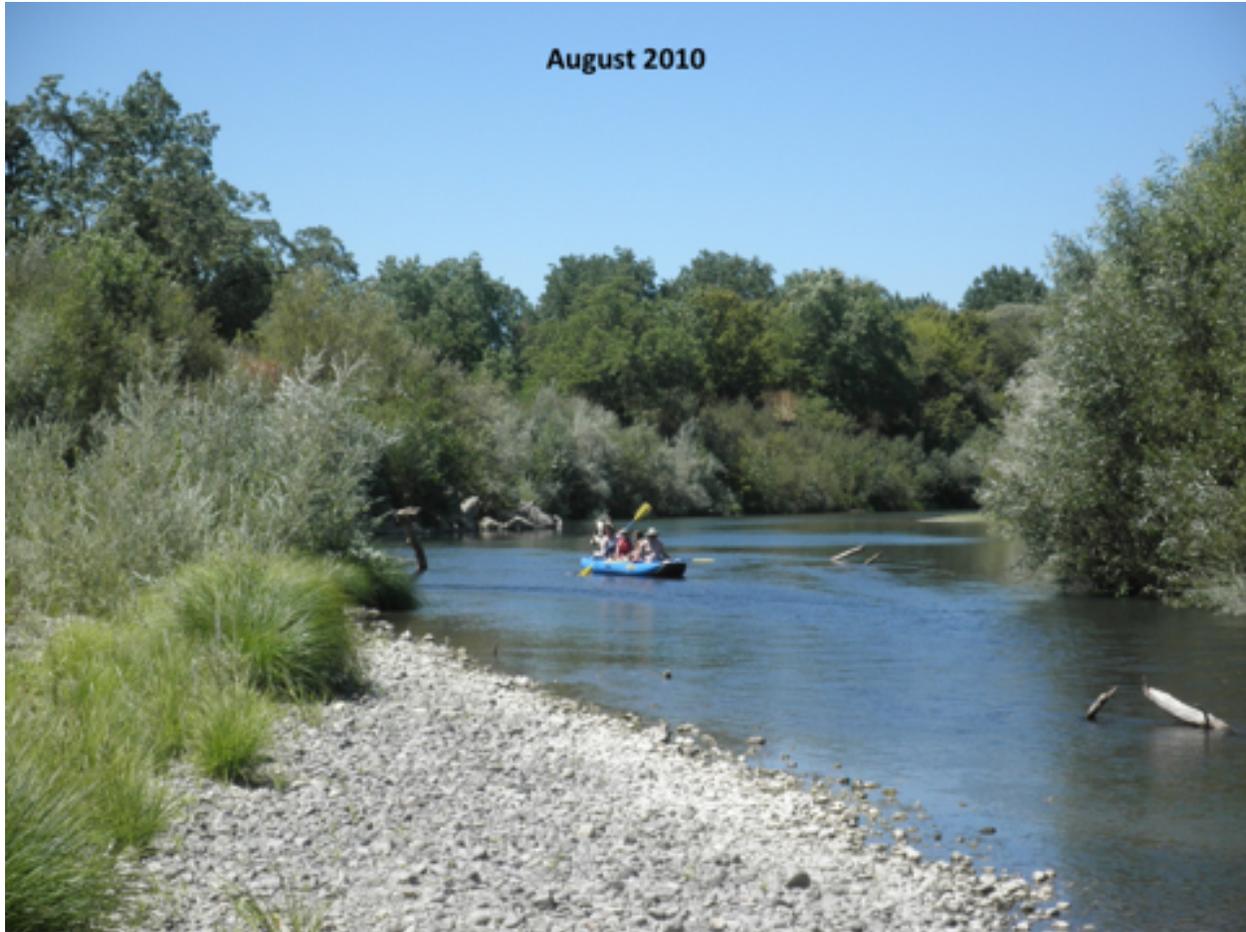
Figure 8

ROICOLI #2: FIVE YEARS POST CONSTRUCTION: RIPARIAN RE-ESTABLISHED WITH PIONEER WILLOW; BANK STABILIZED. BEGINNING OF HABITAT COMPLEXITY

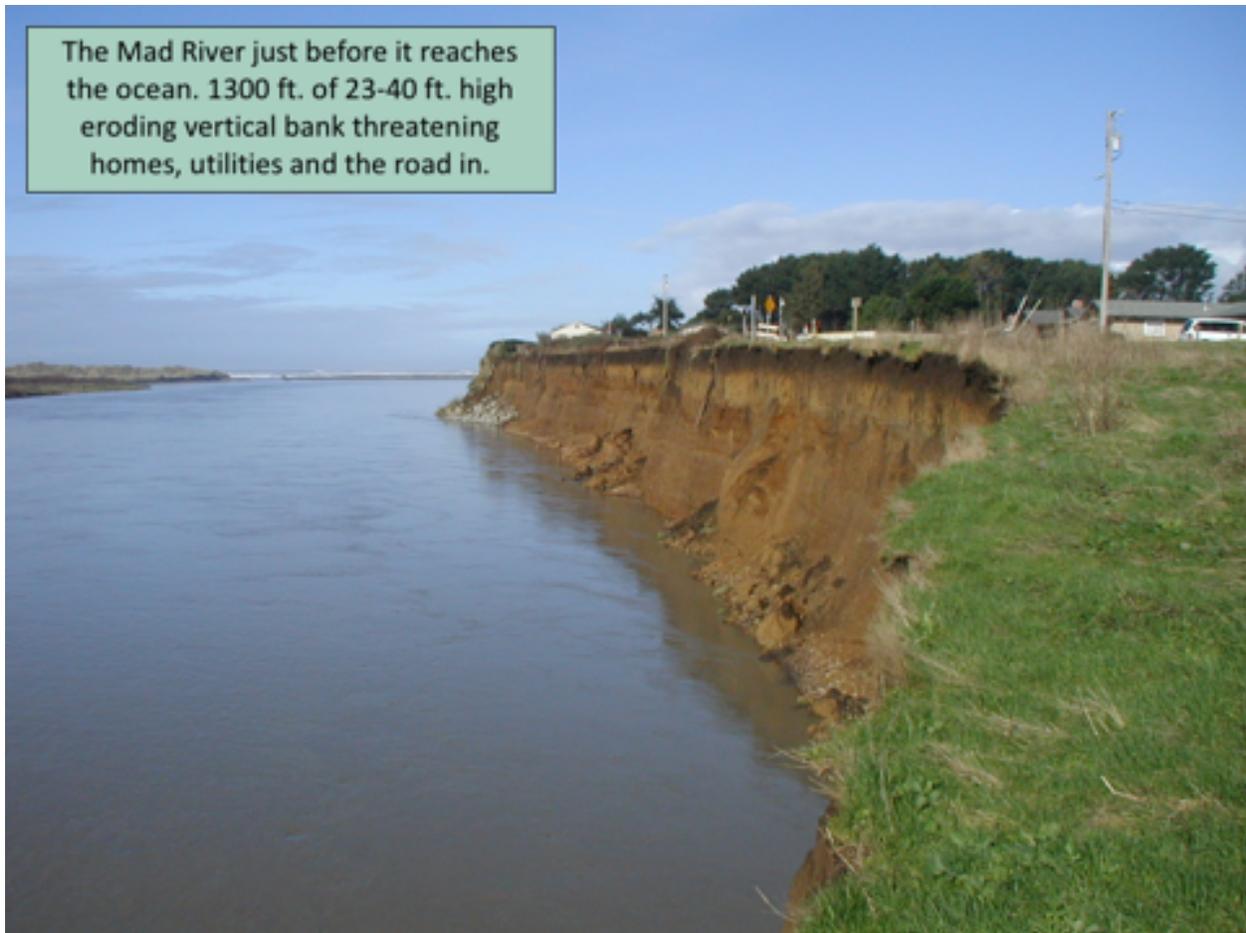
Figure 9

MAD RIVER #1: HIGH ERODING BANK

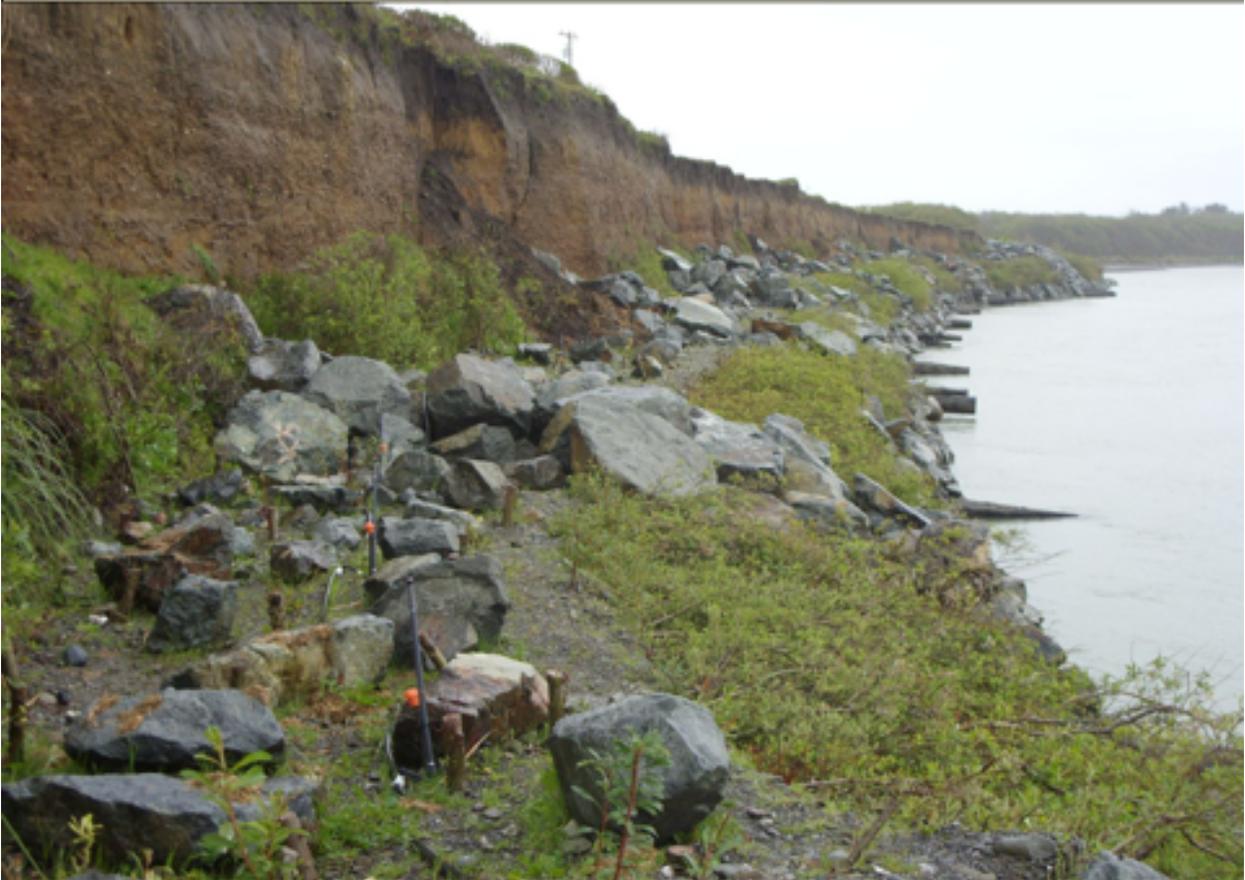
Figure 10

Returning to the site in March 2009, Spring's new growth had begun.

MAD RIVER #2: ONE YEAR POST CONSTRUCTION: START OF NEW SPRING GROWTH AMONG STRUCTURES

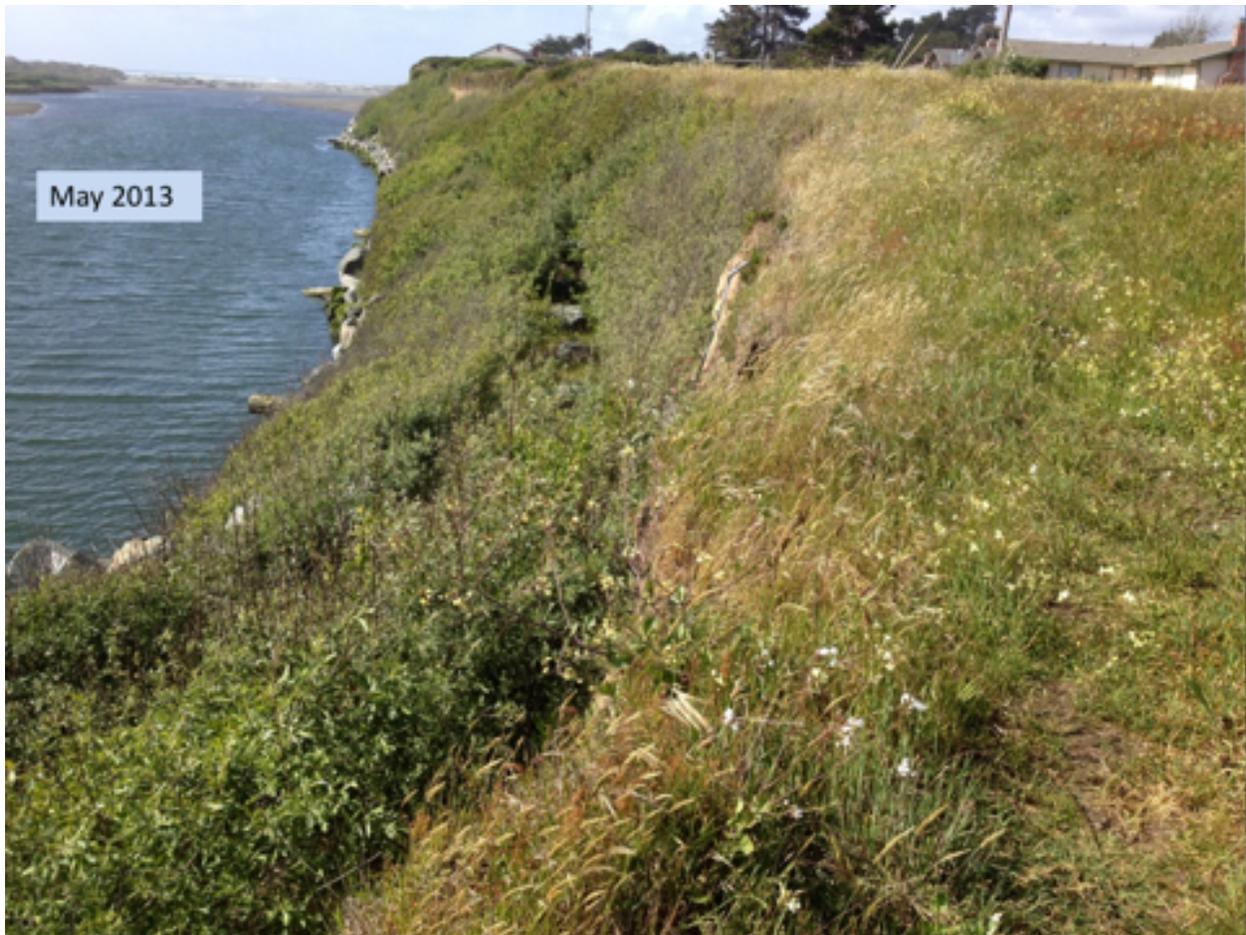
Figure 11

**MAD RIVER #3: FOUR YEARS POST CONSTRUCTION: BANK STABILIZED;
HABITAT COMPLEXITY BEGINNING TO ESTABLISH**

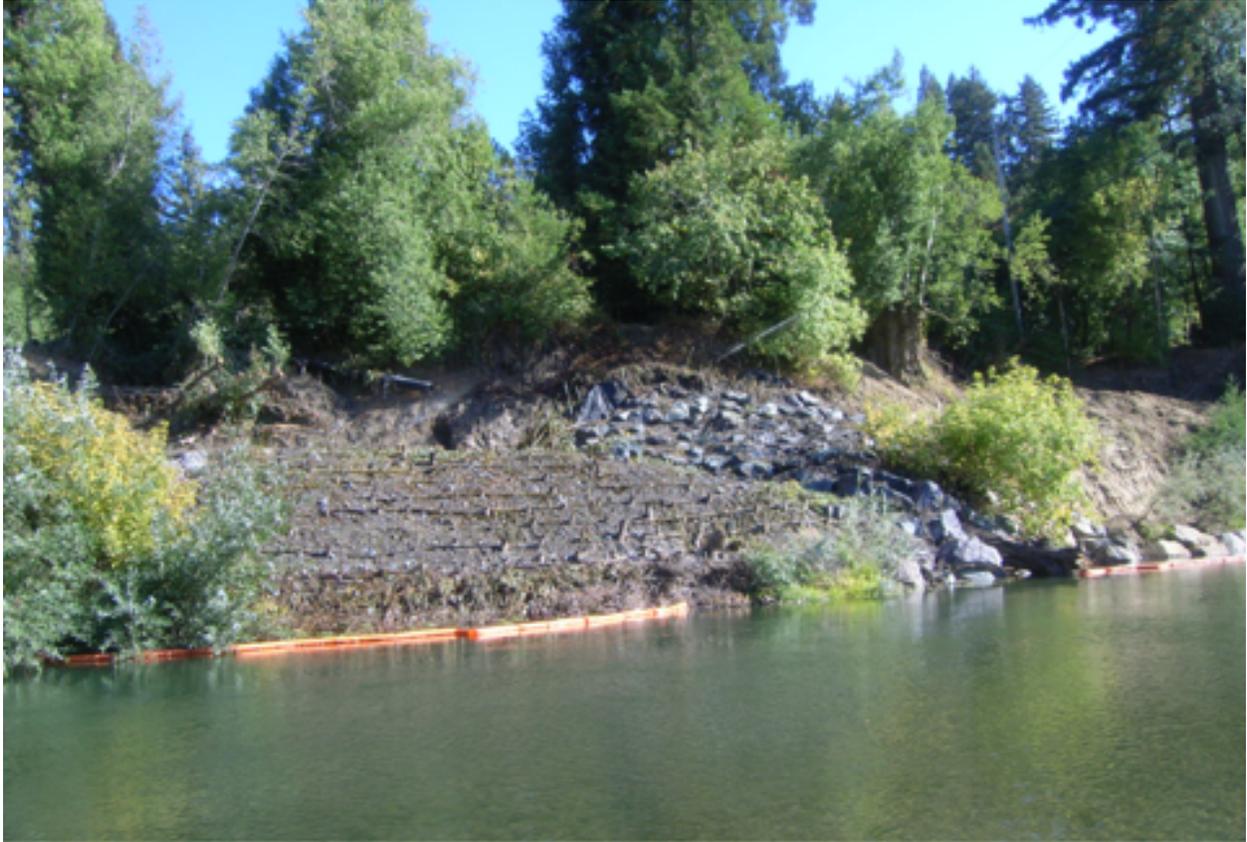
Figure 12

The reshaped section was stabilized with a Live Willow Brush Mattress, pinned down at the toe by a Woven Willow Wall. On the right, another Boulder Wing Deflector.

LIVE WILLOW BRUSH MATTRESS #1: EARLY PLANTING OF COMMON BANK PROTECTION

November 2010

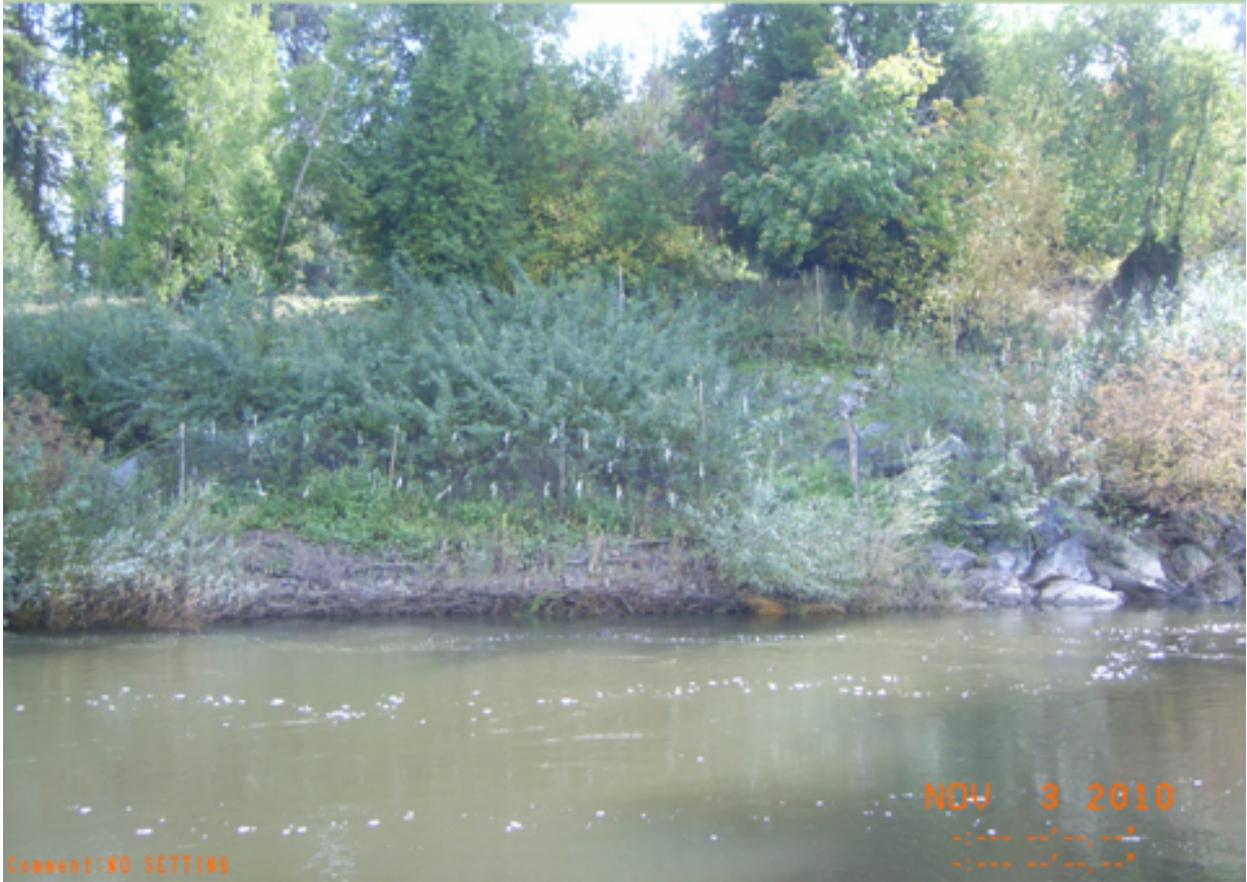
Figure 13

LIVE WILLOW BRUSH MATTRESS: ONE YEAR POST CONSTRUCTION

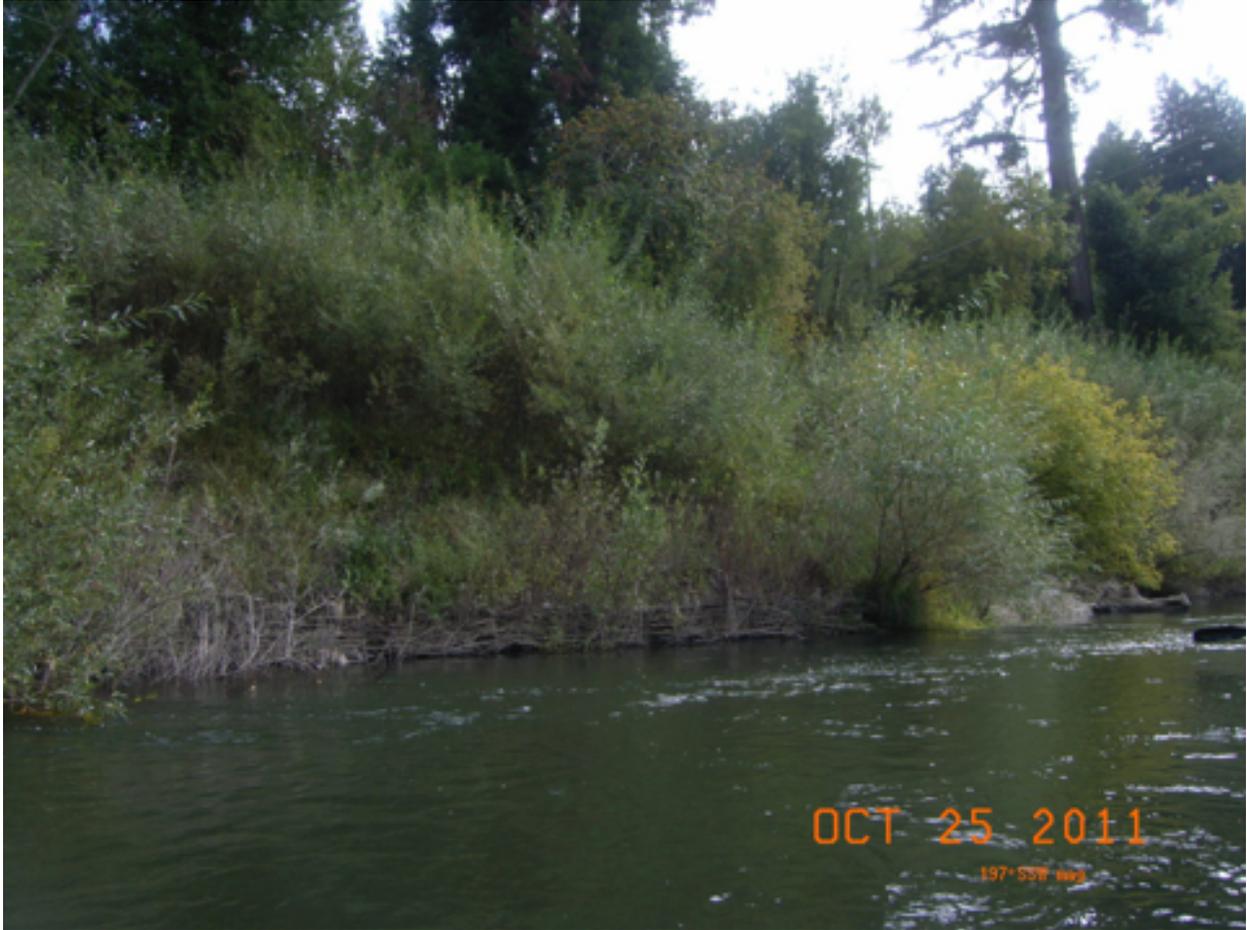
Figure 14

LIVE WILLOW BRUSH MATTRESS: TWO YEARS POST CONSTRUCTION;
