**GEOMORPHIC, HYDROLOGIC AND ECOLOGICAL
EFFECTS OF THE BEAR CREEK MEADOW
RESTORATION PROJECT: A LAYMAN'S REVIEW**

**PREPARED BY:
CHRISTOPHER T. HAMMERSMARK
&
JEFFREY F. MOUNT**

NOVEMBER 15, 2005

A framework for understanding the hydroecology of impacted wet meadows in the Sierra Nevada and Cascade Ranges, California, USA

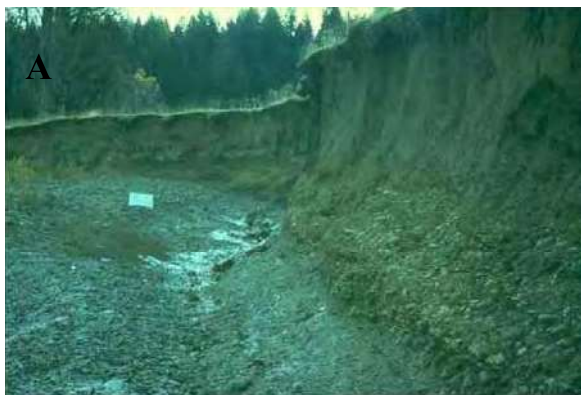
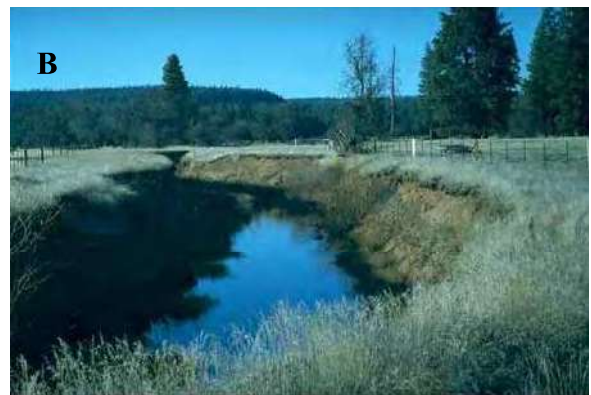
Figure 2 – **A)** Tall, near vertical unvegetated banks of the pre-restored Bear Creek channel. **B)** Prior to restoration, Bear Creek was best described as a gully (Photos: Rick Poore).

As the stream channel incised and lowered the ground water table, the stream banks progressively grew very tall and steep, and unable to support much vegetation which lead to increased instability of the stream banks (Figure 2). This instability initiated a cycle of lateral erosion of the banks, widening the channel. This lateral channel enlargement confined more water within the channel and contributed even more sediment to the Fall River. Bear Creek’s once numerous shallow, vegetated, and meandering channels had degraded into what are best described as two unstable, erosive gullies (Figure 2).

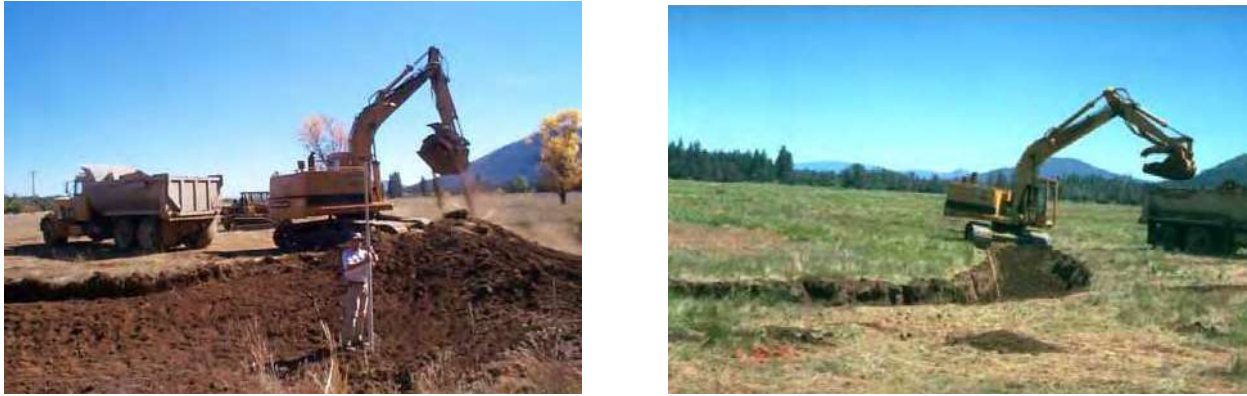
Figure 3 – Sculpting the restored channel in the summer of 1999 (Photos: Rick Poore).

derived from nearby floodplain deposits, creating several large ponds within the meadow. The restored channel was constructed using remnant channel reaches where available and practical, and the remaining reaches were sculpted with heavy machinery in the size and shape of the historic meadow channels (Figure 3). Based upon the recommendation of the expert panel, gravels were added to the restored channel to enhance fish spawning habitat and to reduce bed erosion. Upon the completion of the project, 2.2 miles of restored stream, and 42 acres of new ponds, almost ten percent of the meadow area, existed in the Bear Creek Meadow (Figure 4). These ponds consisted of two types: large ponds created by the need for fill material, and smaller linear ponds, which are remnants of the old gullies.

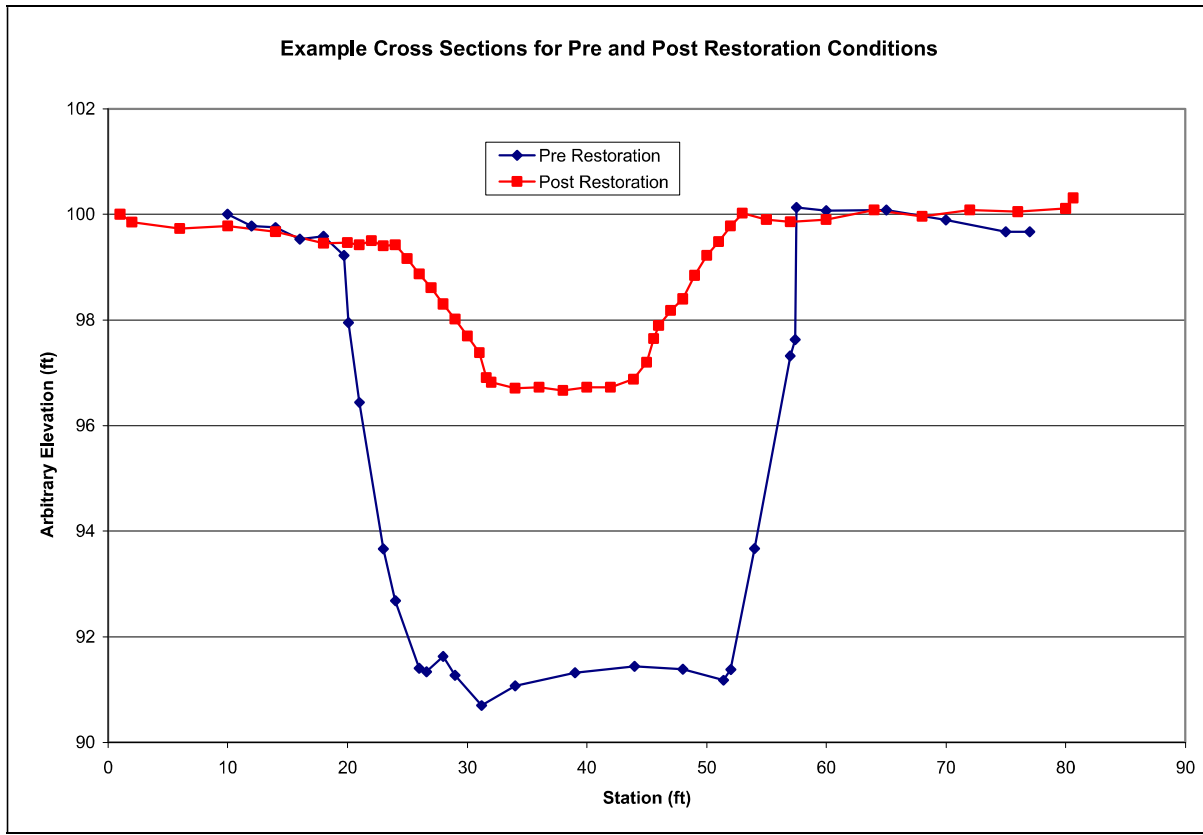
Figure 5 – Representative cross sections of Bear Creek in the pre restoration (blue with diamonds) and post restoration (red with squares) project conditions. Notice how much larger (deeper and wider) the pre restoration channel is when compared to the restored channel.

The plugging of the old, over-sized channel and creation of the new, small main channel for Bear Creek re-established the geomorphic processes typical of a meadow. Based on annual surveys of more than 20 channel cross sections (Figure 5), the sinuous, shallow channel has remained relatively stable in the period since completion of the restoration project. Rapid channel adjustments involving incision or significant lateral migration have not been widespread although minor redistribution of sediment has been observed. The causes of this sediment redistribution are under investigation by UC Davis and Streamwise, Inc., but appear to involve local excessive slope or flow confinement. The few instabilities have been addressed by Streamwise, Inc. through a variety of bank stabilization techniques.

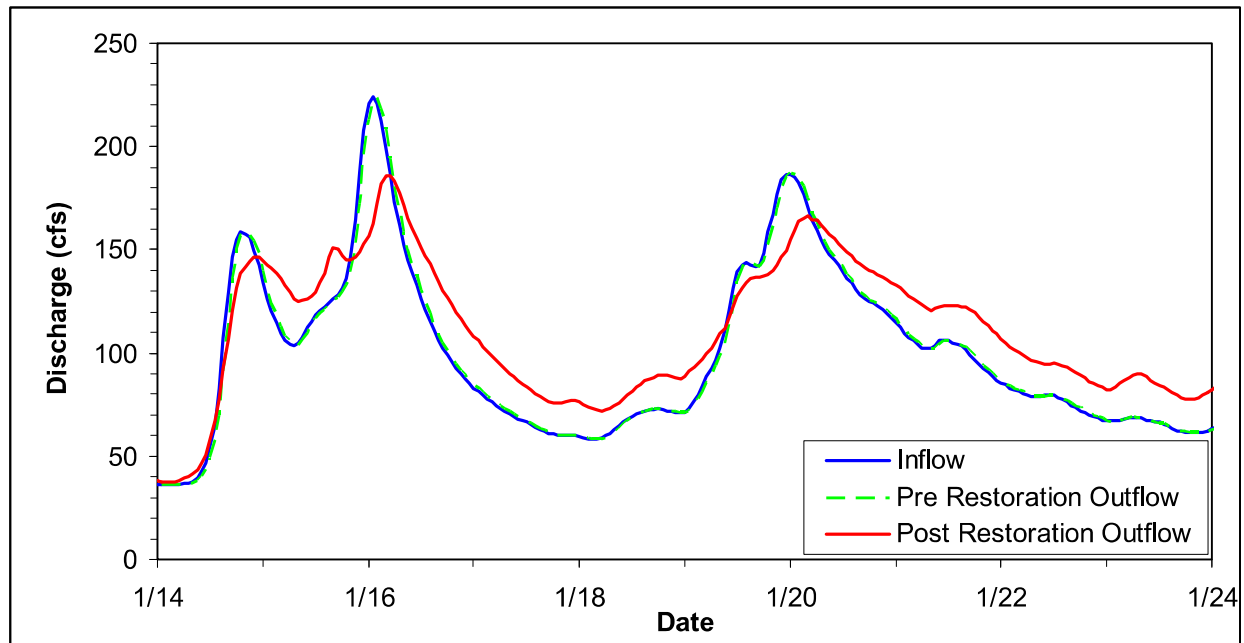
Figure 7 – Preliminary hydraulic modeling results reveal the effect of the channel restoration on the movement of several flood pulses through the meadow. In the pre-project incised condition (green dashed line) each flood pulse travels through the meadow relatively unchanged. In this case the meadow outflow (green dashed line) is very similar to the meadow inflow (blue solid line). Due to a lack of floodplain connectivity in the incised condition, flood peaks maintain their magnitude and travel through the meadow rather quickly. In the post-project, restored condition, significant attenuation and peak reduction are observed in the meadow outflow (red solid line). As water leaves the main channel and inundates the floodplain, it is slowed and temporarily stored. While some of this water flows back to the channel downstream after flowing across the floodplain, some of the water infiltrates into the meadow surface and recharges the shallow water table.

As floodplain inundation occurs, floodwaters are slowed and temporarily stored on the meadow surface before either flowing back into the channel at a downstream location, or infiltrating into the meadow, recharging the ground water table (Figure 6). One effect of this restored connection between the channel and the floodplain has been that downstream flood peaks, or the elevation of floods, have been significantly reduced. In addition, due to temporary storage of floodwaters on the floodplain, the length of time that it takes for a flood pulse to move through the meadow increased substantially, enhancing the amount of recharge to shallow ground water. Therefore, while softening the impact of floods, the restored channel-floodplain connection has also greatly enhanced ground water conditions. Quantifying the magnitude of these changes is the subject on going research by UC Davis researchers; however some preliminary results illuminate some anticipated trends (Figure 7).

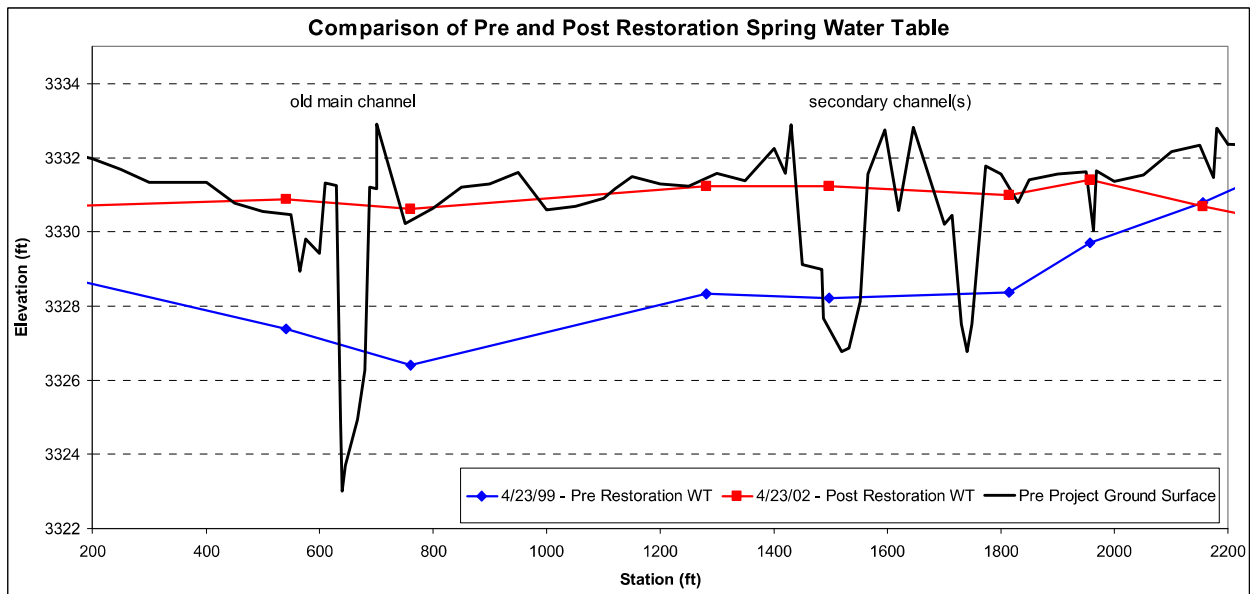
Figure 8 – Comparison of pre- (blue line) and post-restoration (red line) water table elevations in late April for ground water transect B. Transect B traverses the valley roughly half way down the meadow. The pre-restoration ground surface is provided to show the locations of old main channel and secondary channels, in addition to allowing the comparison of the restoration’s influence on the depth to the water table. Note that the pre-restoration water table slopes toward the old main channel, as it acted as a drain for the meadow’s ground water.

In the pre-project state, the deeply incised gully intercepted the ground water table and effectively drained it (Figure 8). The ground water surface sloped toward the gully and, during low flow conditions; ground water would discharge into the gully and be carried into the Fall River. Plugging the gully with soil eliminated this ground water drain, allowing the ground water table throughout the meadow to recover. This coupled with the frequent flooding of the floodplain and recharge of the meadow aquifer through the relatively shallow restored channel has restored ground water throughout the meadow to conditions that are roughly similar to those prior to channelization. Preliminary calculations indicate that currently during the spring, the meadow stores 195 acre-feet of water more than it did during pre-project conditions (an acre-foot is 325,851 gallons of water, roughly equivalent to the water necessary for a single household for one year).

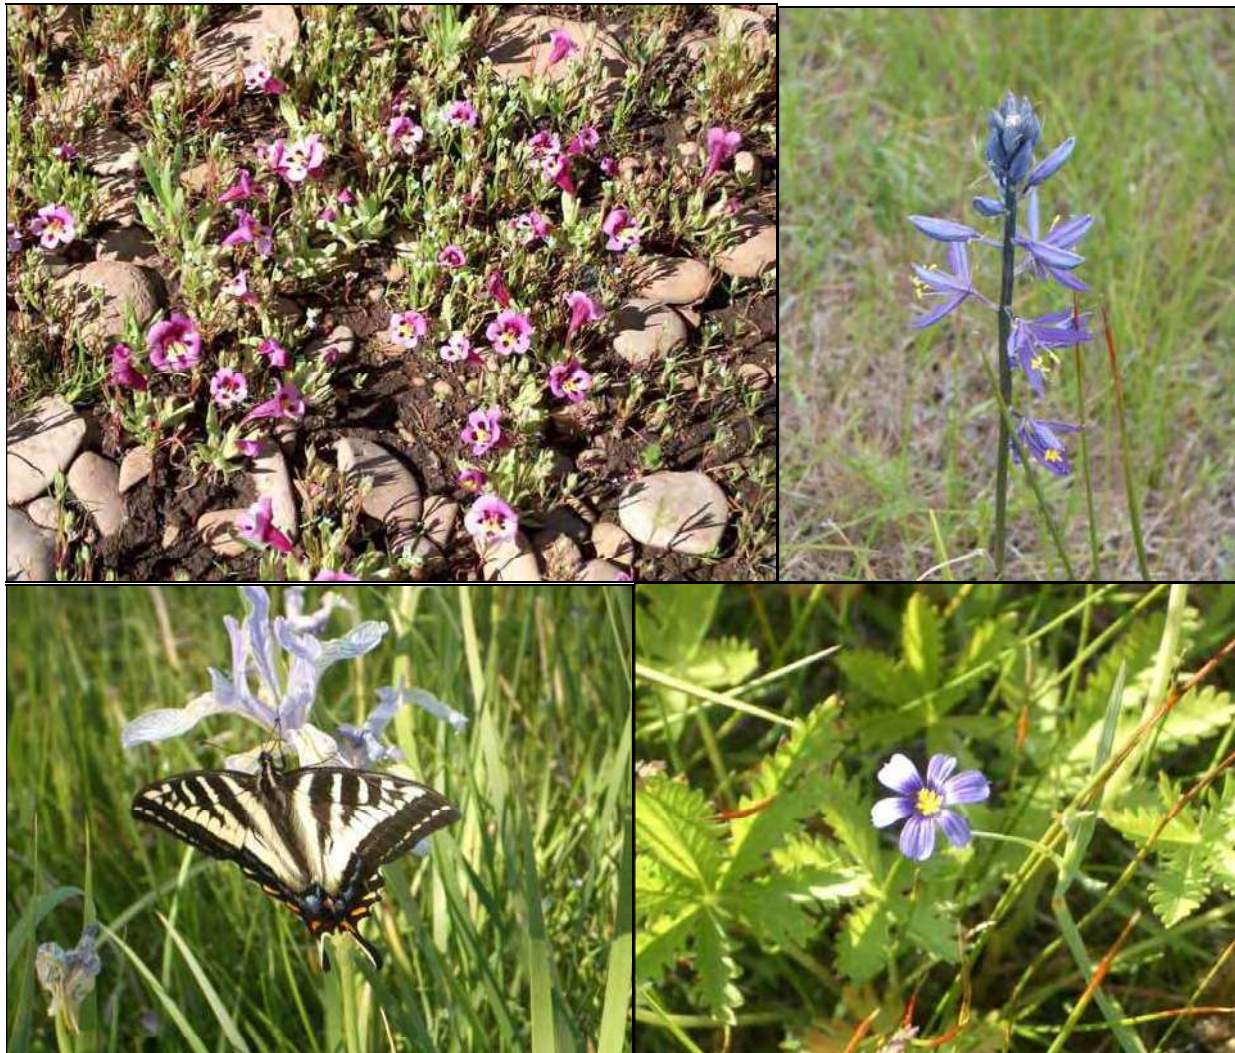
Figure 9 – A selection of native wildflowers found in the meadow. Clockwise from top left *Mimulus tricolor* (tri-colored monkey flower), *Camassia quamash* (camas), *Sisyrrinchium bellum* (blue-eyed grass), *Iris missouriensis* (western blue flag) with butterfly (Photos: Chris Hammersmark).

plants are best seen in early June when an exceptional display of a variety of native wildflowers occurs due to the increased soil moisture (Figure 9).

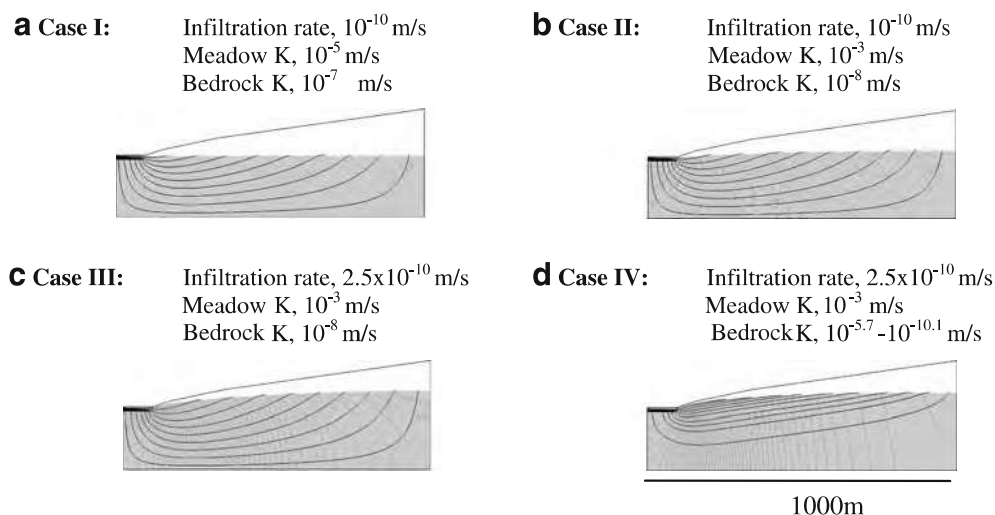
Fig. 4 Regional groundwater flow to the meadow system represented as a cross-sectional flownet through the watershed with *darker lines* representing flowpaths and *lighter lines* representing equipotentials. Cases I-IV are described in the text and illustrate the geologic control of the watershed on the magnitude of groundwater discharging to the meadow as well as the proportion entering as basal and marginal influges

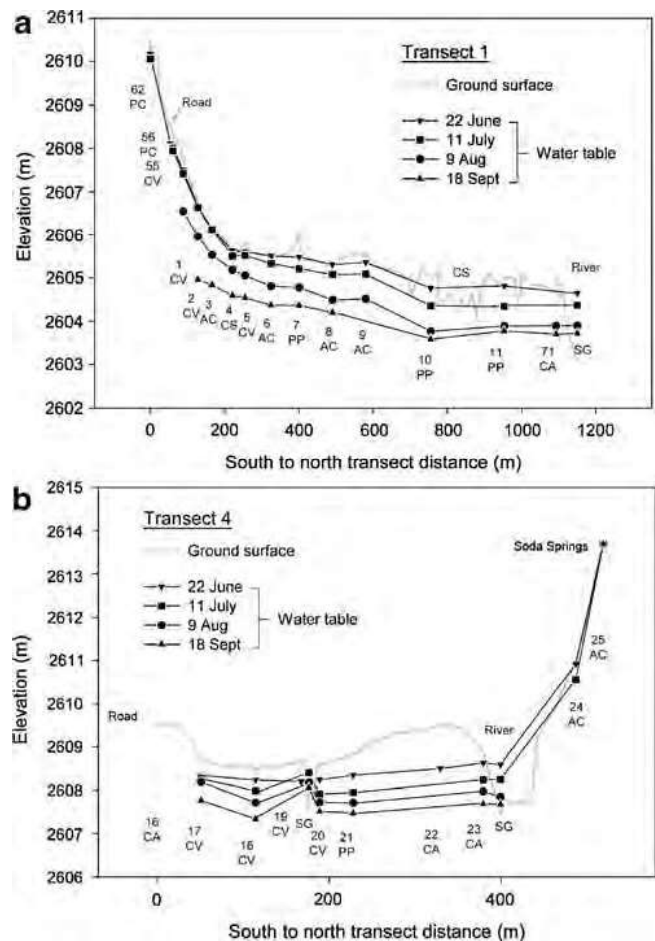
Fig. 7 Groundwater measurements on four dates in 2006 for water level and vegetation monitoring transects **a** T1 and **b** T4 shown on the photograph of Tuolumne Meadows in Fig. 1. The letters beneath the well numbers indicate the vegetation composition as follows: *Carex vesicaria-Salix eastwoodiae* (CS), *Aster alpigenus-Carex subnigricans* (AC), *Ptilagrostis kingii-Polygonum bistortoides* (PP), *Calamagrostis breweri-Vaccinium caespitosum* (CV), *Carex filifolia-Antennaria corymbosa* (CA) and *Pinus contorta-Carex rossii* (PC). Modified from Cooper et al. (2006)

between 0 and 100 m distance along this transect, where the depth to the water table is the greatest. From 100 to 1,000-m distance along the transect, level meadow areas were dominated by the *Aster alpigenus-Carex subnigricans* community, while communities dominated by *Ptilagrostis kingii* and *Calamagrostis breweri* occurred on raised surfaces that had slightly deeper summer water tables.

Several water sources supply Tuolumne Meadows: the Tuolumne River supplied by its entire watershed, small tributary streams from sub-watersheds, and groundwater from local hillslope aquifers. Along transect 1 (Fig. 7a), vegetation in the region from 800 m to the river is hydrologically connected to and supported by the river. The region between 0 and 800 m is supported by groundwater from local hillslope moraines and bedrock, and the groundwater flow direction is toward the river.

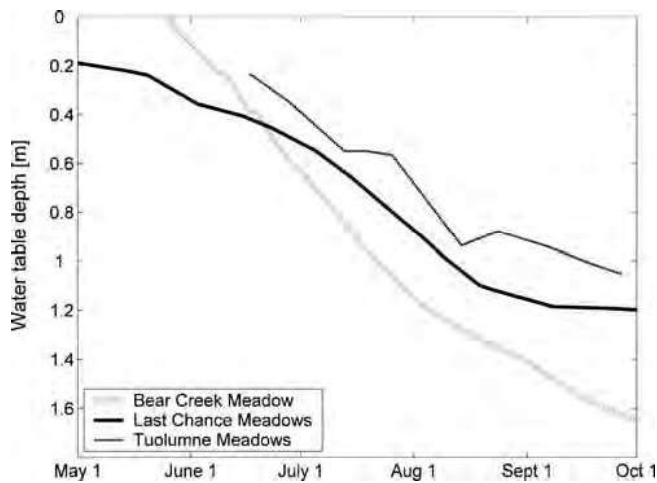
Fig. 9 Observed mean water-table depth hydrograph (multi-year average) for sedge and rush dominated wet-meadow communities at Bear Creek, Last Chance, and Tuolumne Meadows

While the observations are limited, they appear to be consistent with the predicted effects of soil texture and elevation on vegetation threshold hydrographs. First, Fig. 9 shows a general shift to a higher water table at later dates (shift to the right) as elevation increases from Bear Creek, to Last Chance, to Tuolumne Meadows. Second, the shallowest late season water-table depths are found at the site with the coarsest soil, Tuolumne Meadows. Bear Creek, with silty-clayey loam soils, has the deepest mean hydrograph, and Last Chance, with predominantly silts, has an intermediate hydrograph, even though a large soil textural difference is not evident between the sites. It is unclear whether the slightly higher clay content at Bear Creek could account for the downward stretching of the water-table hydrograph that was observed.
