EXPERT REPORT

DAVID J. ERICKSON

Community Association for Restoration of the Environment, Inc., Friends of Toppenish Creek, and Center for Food Safety, Inc.,
v.

(E.D. Wash. No. 1:19-CV-3110-TOR)

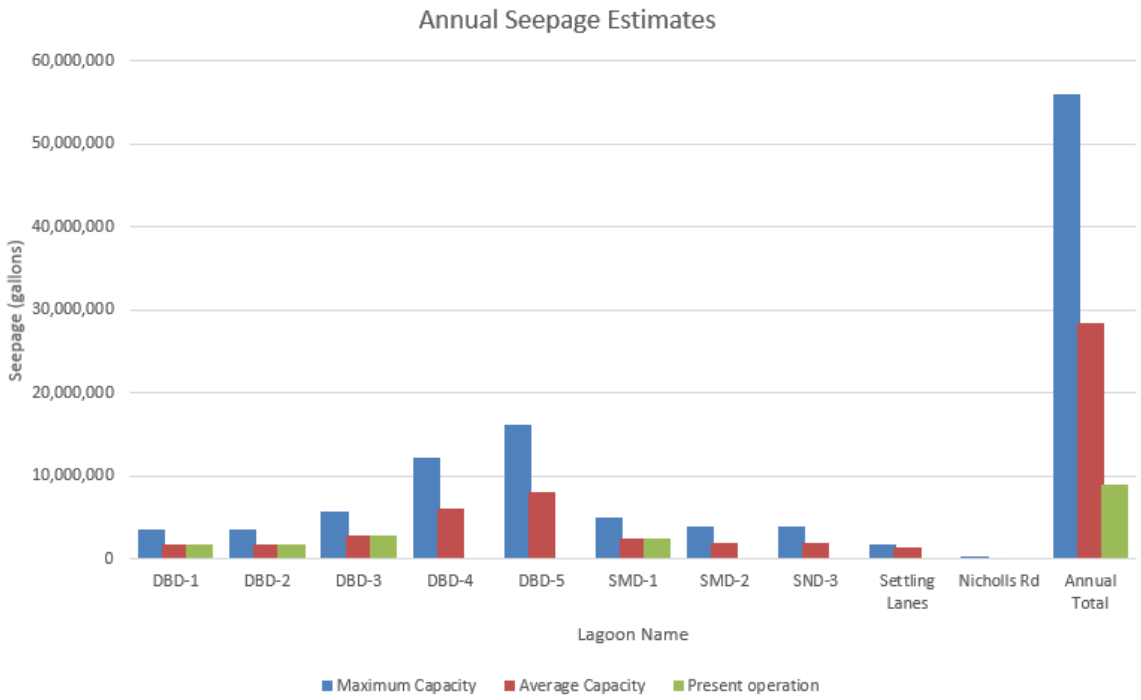
52. The graph below compares each of these estimates.

53. For all lagoons calculations here, the permeability is assumed to be 1 X 10^{-6} cm/s. None of the lagoons contains any type of geosynthetic liner; each was instead constructed into the ground using a native soil-lined bottom and no documentation on compaction. The Dairies' Dairy Nutrient Management Plans claim that their lagoons comply with the Natural Resource Conservation Service ("NRCS") 313 standards for manure storage impoundments,[14] which is the aforementioned number assumed here. The NRCS standard requires waste storage impoundments to be located on soils that have a permeability "that meets all applicable regulation, or the pond

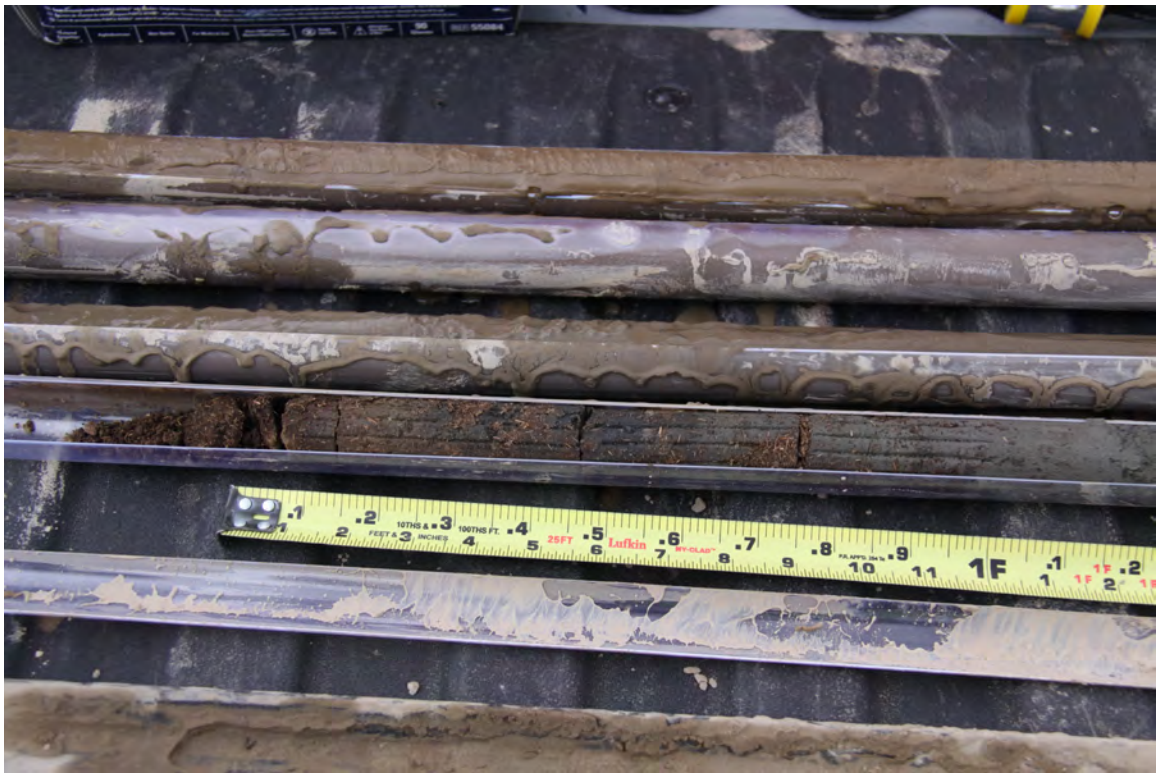
58. Similarly, soil samples from the compost area at SMD (SMD-CA1) show high TKN into and below the water table and high nitrates changing to ammonia with depth. Both compost areas are source areas for groundwater contamination.

Image: Sample from DBD Compost area with 1' of compacted manure

Image: Leachate at SMD Compost Area seeping into the ground

73. The leachate could be used to maintain the proper moisture content for composting, but should not be allowed to enter the subsurface. Commercial compost operations are required to conduct composting and compost handling on concrete surfaces with storm water collection systems. They are also required to maintain the integrity of the concrete through routine crack and joint sealing. The compost area at DBD is very flat and seepage will always be an issue without an impermeable liner under the compost.

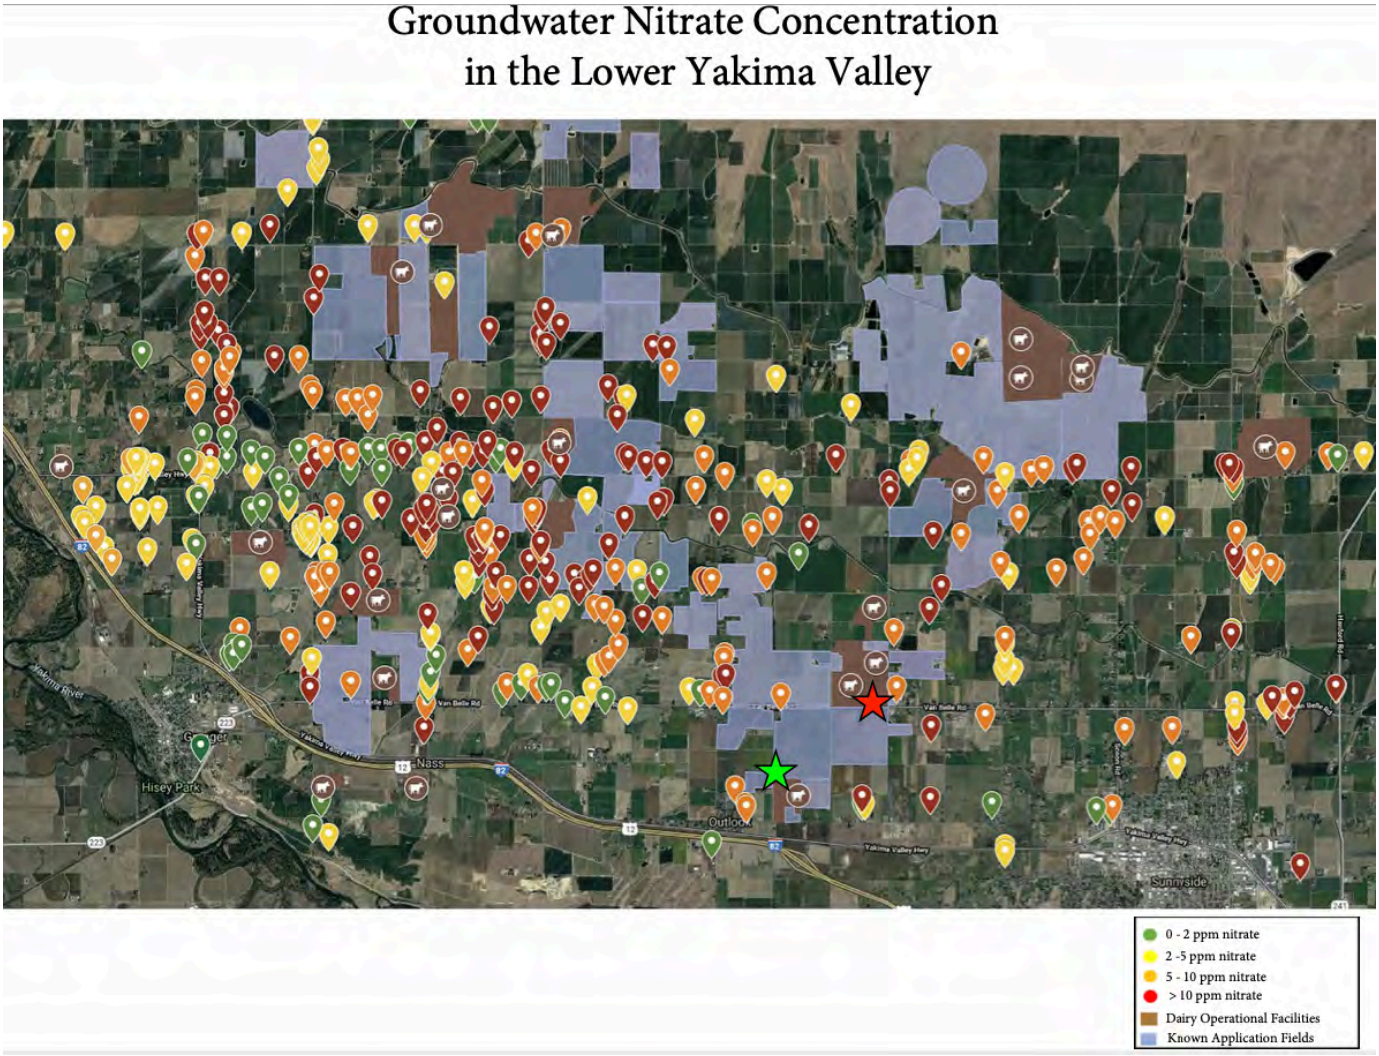
Image: Clean Drinking Water Project Results

are the primary contaminant of concern tested by the CDWP. Wells in the vicinity of DBD and SMD have shown contamination above the 10 mg/L Safe Drinking Water Act standard, while others have shown the presence of nitrate above 2 mg/L. Generally speaking, nitrate contamination above 2 mg/L is likely human caused. This information, summarized in the maps attached hereto. Some homes have tested above 100 mg/L for nitrate, which is an alarmingly high number. This information further supports my conclusions that DBD and SMD are contributing to the nitrate contamination of the overall area as are other dairies in the area. Due to confidentiality agreements between the CDWP and some of the residents, all specific locations are not available. But the detections in the general locations do provide further support for the fact that nitrates are moving off the DBD and
