SB 747: Independent oversight is the key to making transit safety the first priority.

The SW Baseline Road crossing in Beaverton, scene of four preventable deaths on Portland's MAX system.

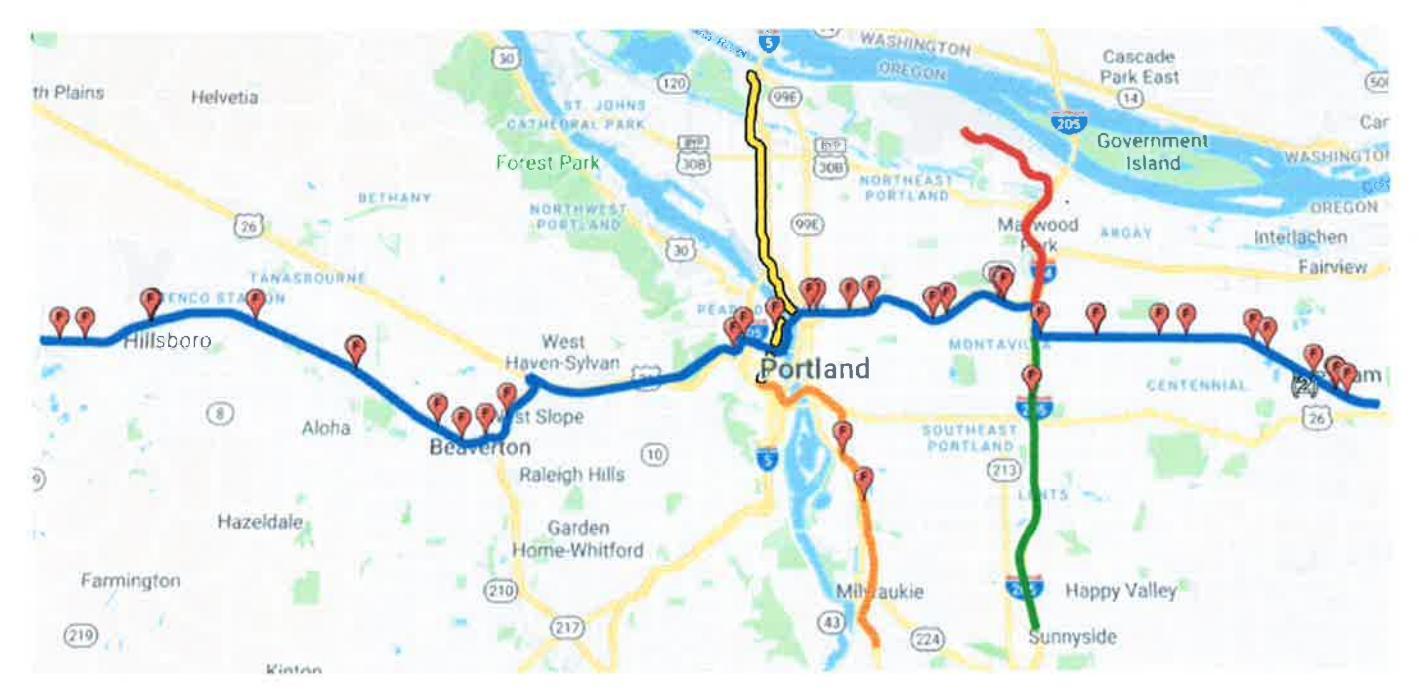
Figure 1. Map showing MAX fatality locations

It is immediately obvious that most fatalities occur on the east-west Blue and Red lines, running from Hillsboro to Gresham. Only four deaths happened on the Green, Orange, and Yellow lines. None have happened on the Red Line route from the Gateway Transit Center to the Portland Airport.

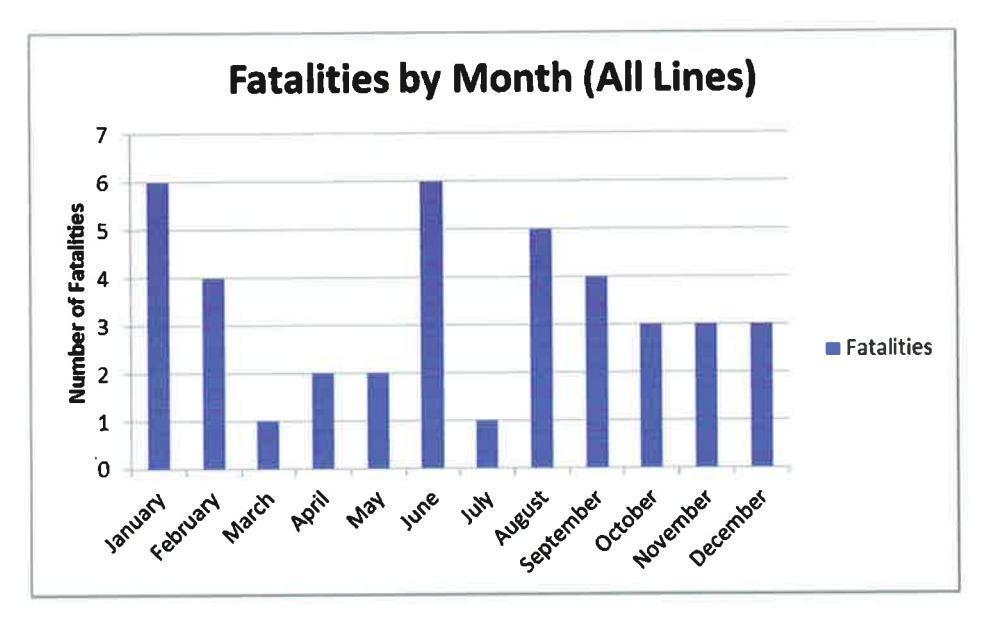
Figure 7. Summary of fatalities by month

There is no clear pattern as to when fatalities happen during the year. Below (Figure 7) is a chart showing the number of fatalities per month. However, there is a possible explanation for fatalities increasing in January and June through September. Short days and cold, poor weather in January could make accidents more likely since busy times on the system are during dark hours. In the clear summer months, sun glare could be contributing to an inability of operators or pedestrians to see each other. Poorer weather in the fall and the loss of Daylight Savings Time could contribute to more deaths in October, November, and December compared to the spring months. More investigation is needed to understand if these theories have merit.

- 17. Look at the time of day for fatalities to find out if the sun's position, weather, or inadequate lighting could be a factor.
- 18. Three systems in other states have fatality rates well under half that of MAX (Figure 16, above). Practices and design at these should be examined to learn if they can be adopted in Portland.

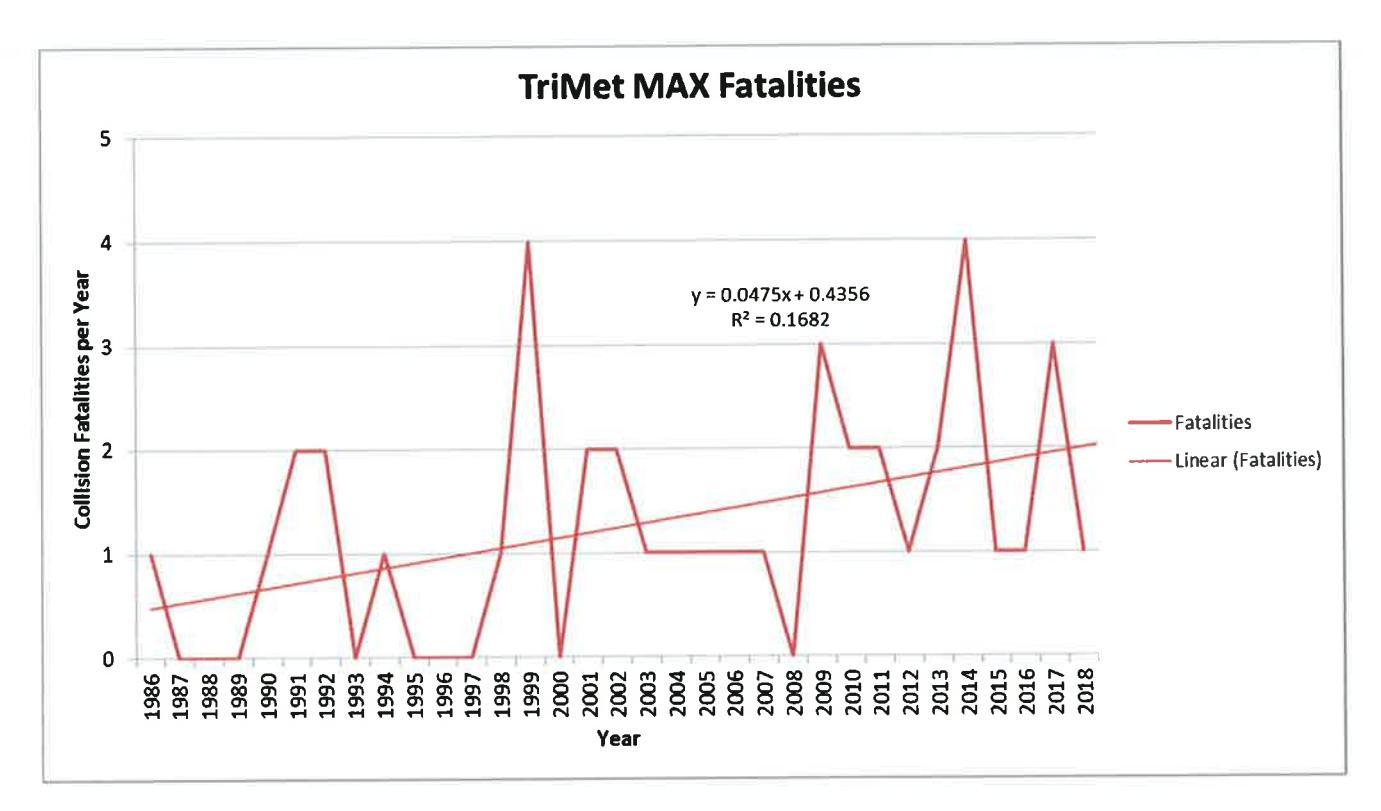
Figure 8. Fatality trend by year

Fatalities appear to be increasing over time. The last year with zero deaths was 2008, and before that, in 2000. Using a linear correlation, fatality counts per year have quadrupled over the history of the system.

The increase is not simply due to the addition of more train lines. Only four fatalities have occurred on northsouth lines, and in 1999 which had four fatalities, only the Blue Line was in operation. Nor is it explained by population changes. During the time period of the chart, the metro area's population increased by 72%.⁵

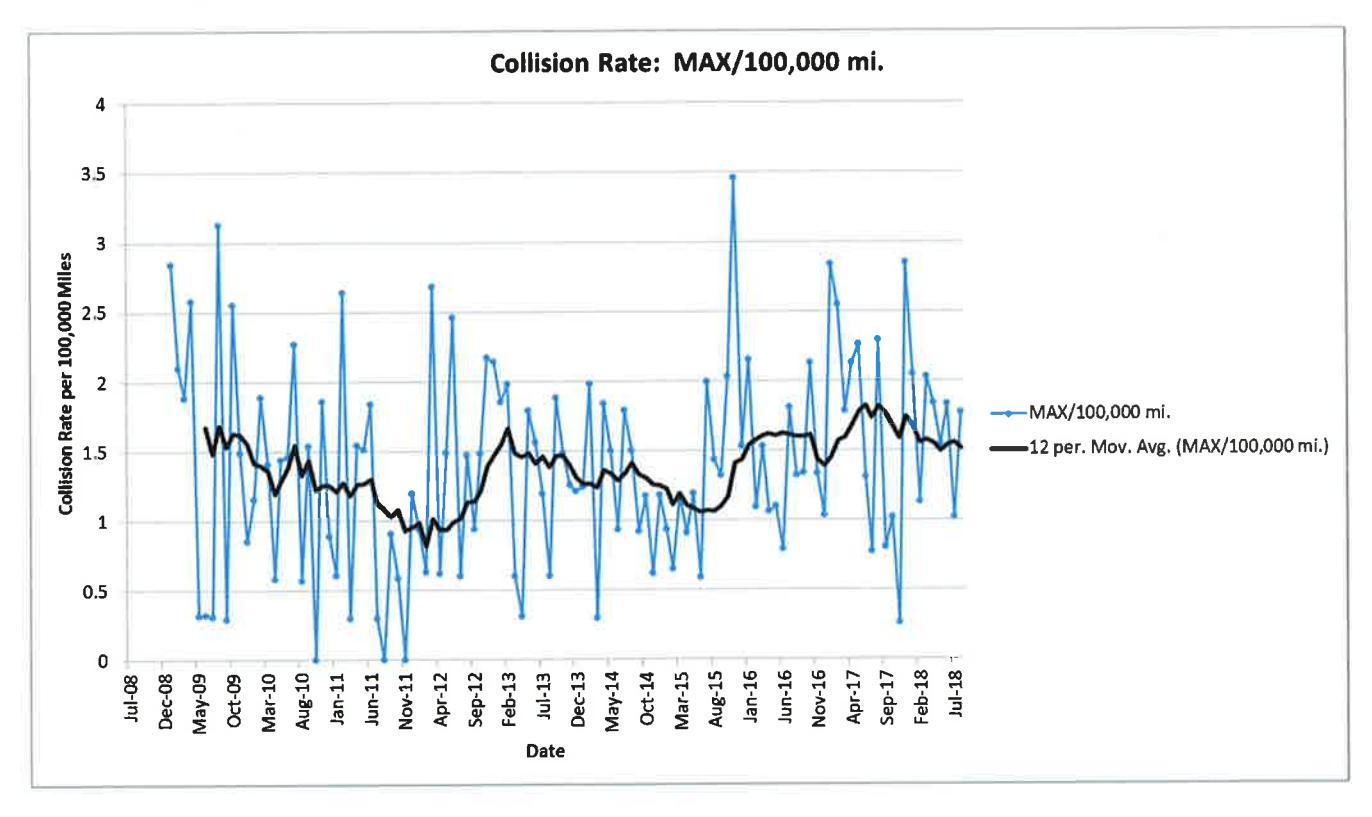
Figure 10. MAX collision rate by month with 12-month moving average

TriMet also introduced new work rules in June 2013 to eliminate back-to-back shifts for train operators in an effort to reduce fatigue. However, this change appears to have had no effect on the fatality rate. The fatality rate is increasing while the collision rate remains relatively constant. (Figure 10, below)

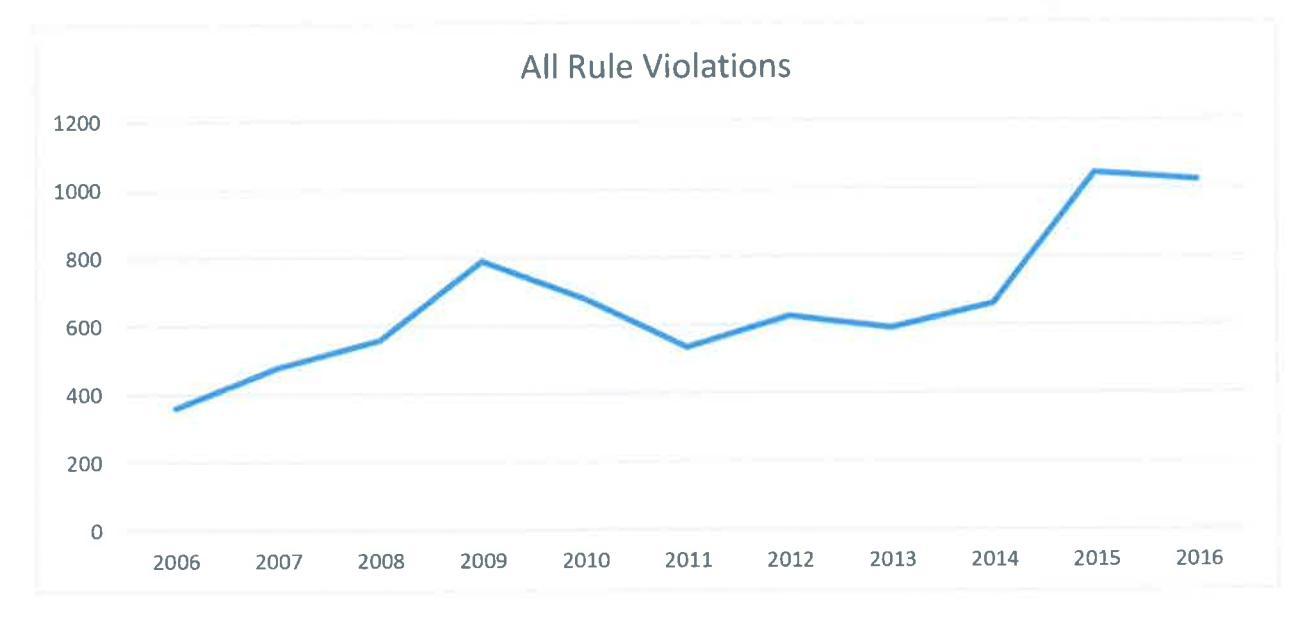
Figure 11. (Flanigon) MAX Operating Rule Violation Trend (note: 2016 is a partial year)

A December 2016 compliance audit by Michael T. Flanigon found that rule violations for train operators tripled from 2006 to 2016.⁷ However, the violations were not tied to any fatalities. There was a non-injury collision with a car in February 2013 at a Hillsboro rail crossing from one violation.

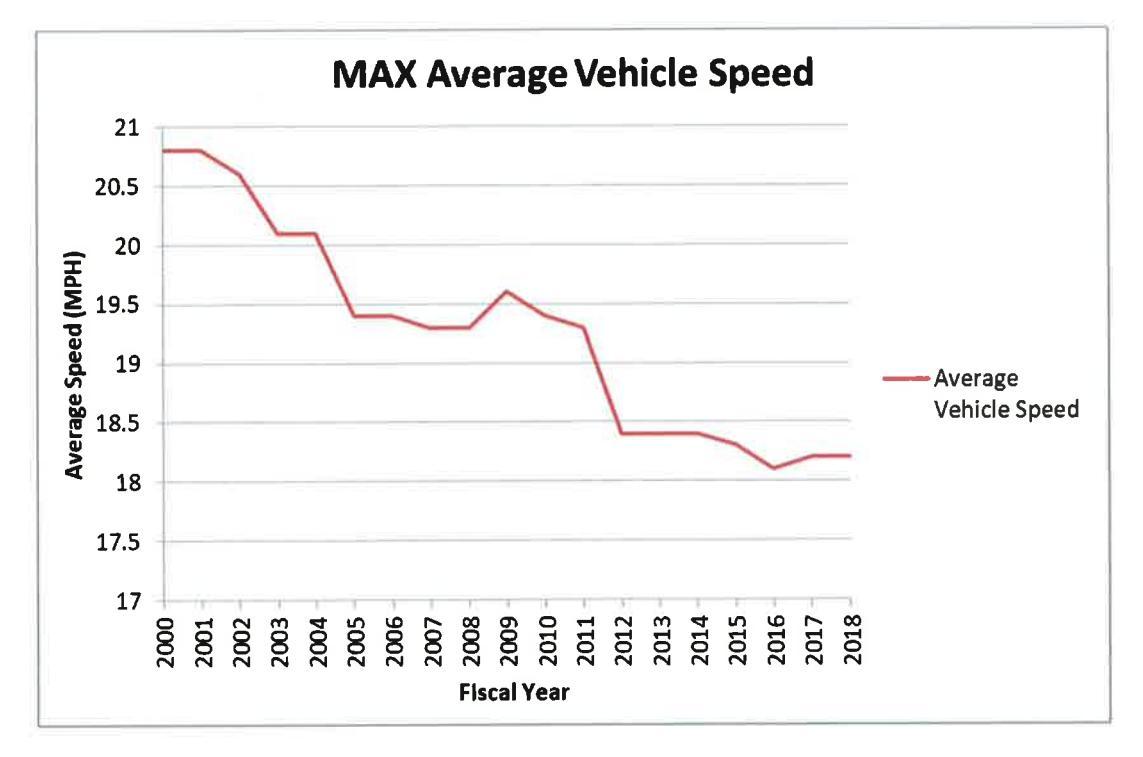
Figure 12. System-wide average vehicle speed

From 2000 until now, the average train speed has steadily decreased from 20.8 to 18.2 miles per hour. Slower speeds should improve safety, but they too don't seem to be having a positive effect.

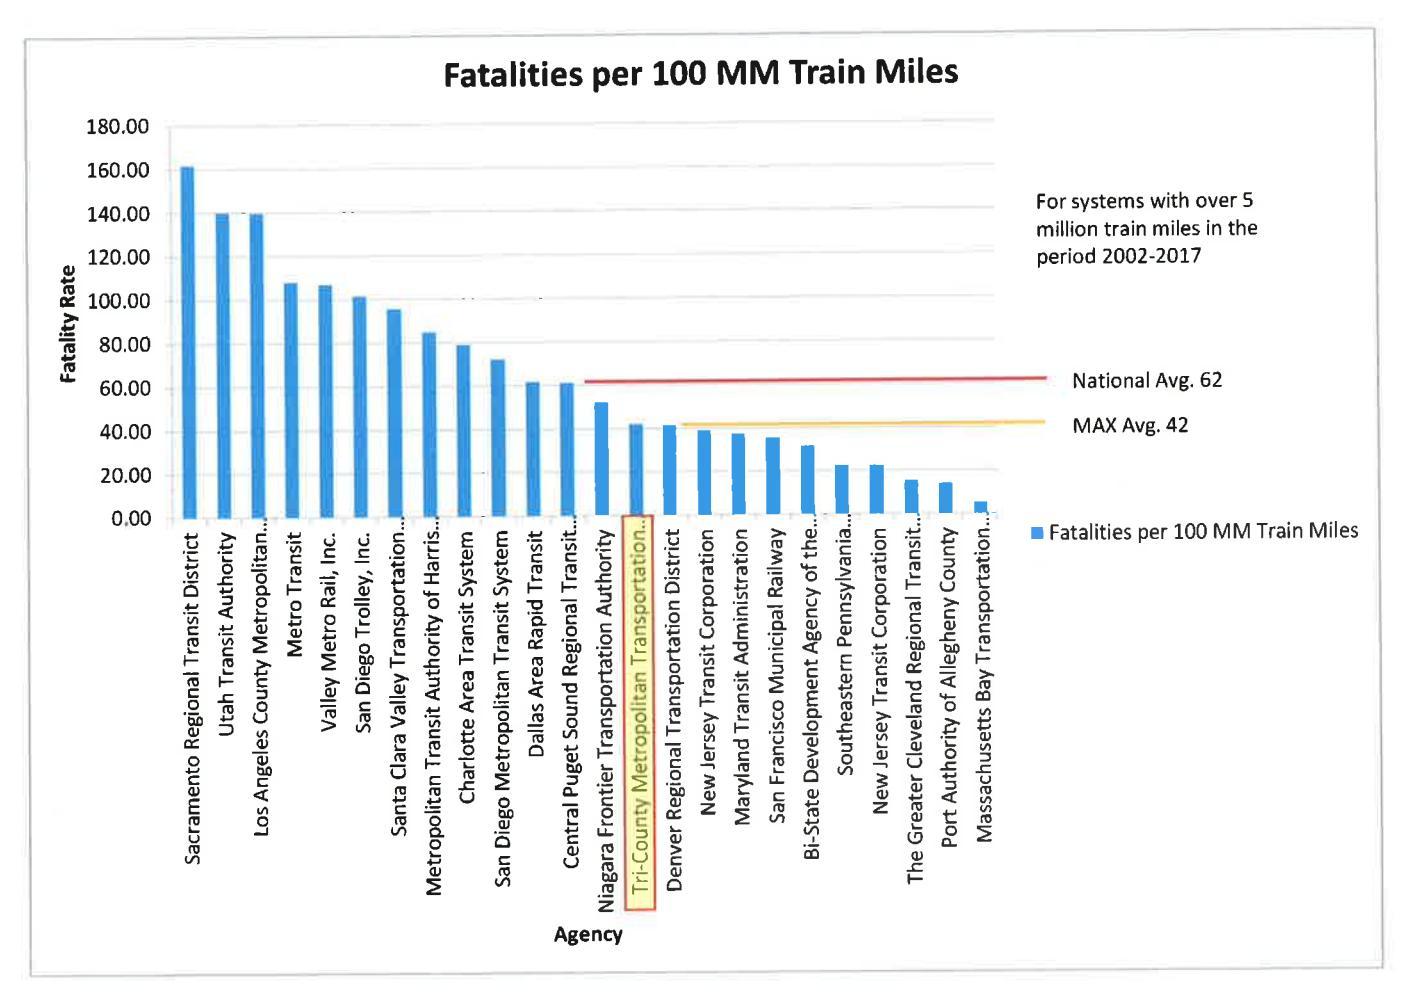
Figure 16. Average fatality rates per 100 million train miles for MAX and other light-rail systems in large cities

Data from the National Transit Database were examined to see how MAX compares to other light-rail systems.⁸ Only systems with more than 5 million total train miles in the years 2002-2017 were included. Deaths of employees and passengers were excluded for consistency. The MAX fatality rate is 32% lower than the average for these systems (Figure 16, below.)

There were discrepancies between the data from the US Transit Database and records provided by TriMet. One death was under-reported in 2002 and again in 2006. In 2013, a death on the WES heavy-rail line was reported as a light-rail death. In 2014, one death was over-reported, classified as "other vehicle occupant." For the period 2002-2017, two deaths were under-reported and two were over-reported, so the total cancels out. While the result doesn't change the outcome of this analysis, the discrepancies should be corrected. Because heavy-rail design tends to be safer, including WES fatalities and miles in federal reports makes overall safety look better than it is.

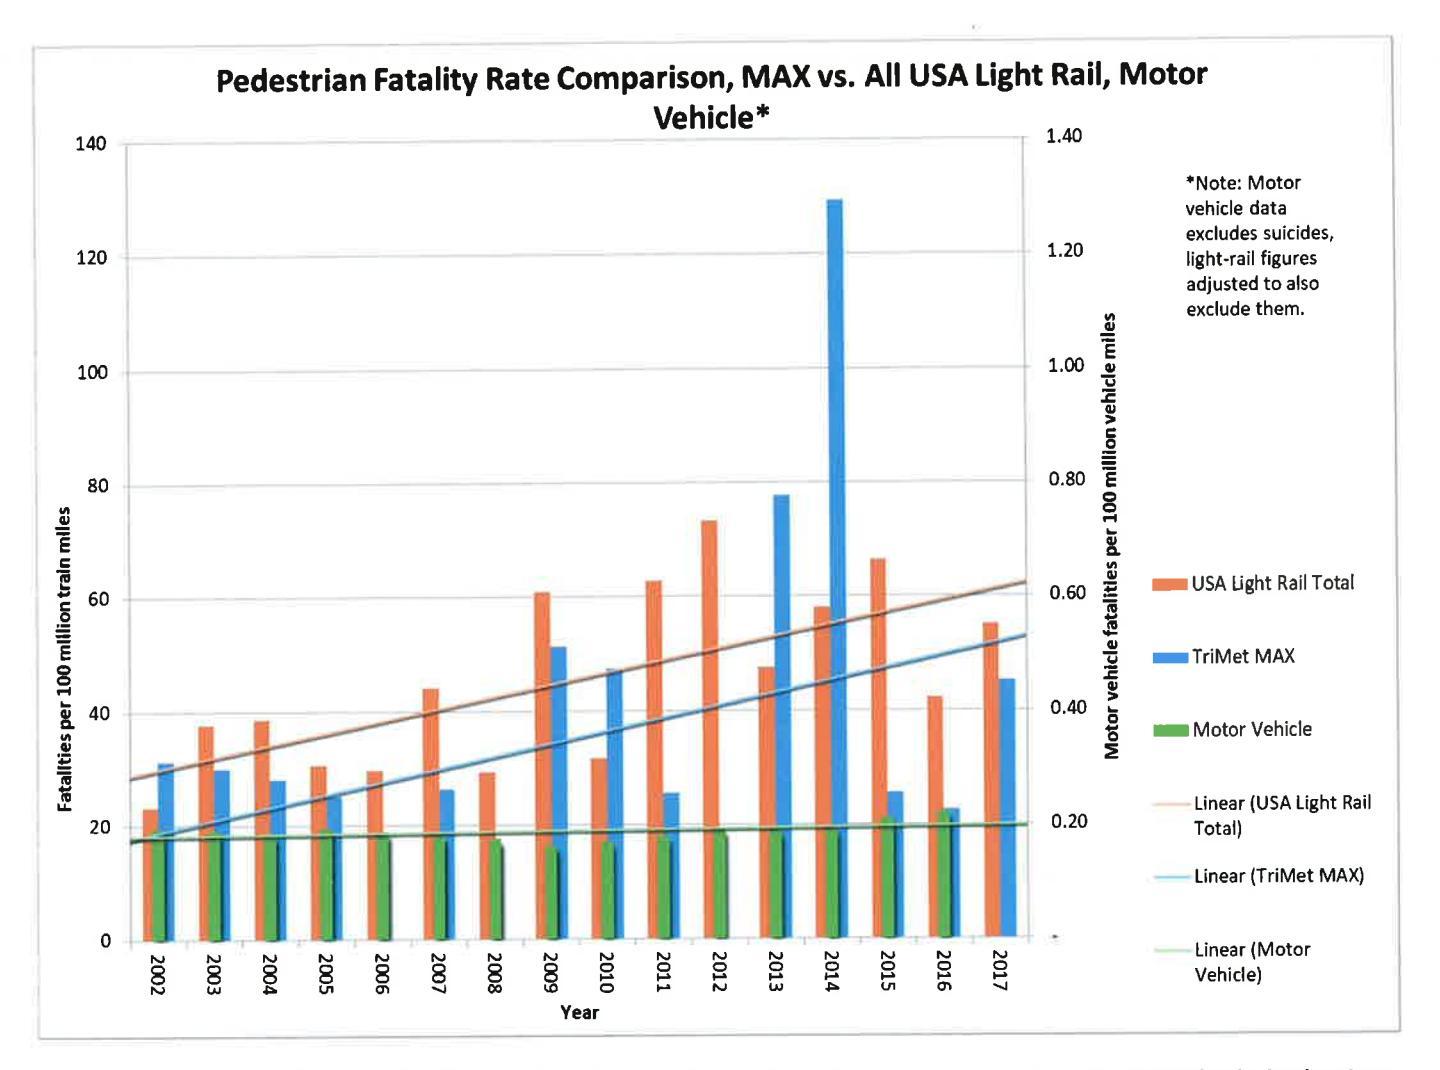
Figure 17. Comparison of MAX fatality history with light-rail systems nationwide and non-occupant motor vehicle deaths (pedestrians and cyclists)

Fatality rate trends were also examined to compare MAX with other light-rail systems and to automobile traffic. Over time, MAX fatalities and those on other large light-rail systems are increasing at a similar rate. This finding indicates that the increase in deaths is not unique to MAX. In the chart (Figure 17) below, notice that motor vehicle non-passenger fatalities⁹ are plotted on a separate axis with a range that is 100 times smaller than for light rail. Also note that the data were adjusted by train revenue mile, so increases in the number of train miles due to growth are not responsible for the observed increase. When considering automobile-caused fatalities for pedestrians and cyclists, national figures were used instead of those for Portland only because the national numbers were broken out for pedestrians and cyclists, which are roughly 1/5 of total automobile-caused deaths. Also, even though Portland streets are considered to be 10-15% more dangerous than streets nationwide for pedestrians, danger can vary widely by geography within an urban area so the national data offer a larger sample size. The slightly higher local difference in Portland doesn't alter the overall conclusion of substantially higher fatality risk for trains vs. automobiles. The automobile-caused fatality statistics exclude suicides, so the figures for MAX and light rail nationwide were also adjusted to exclude them.

While rail transit has always been considered and promoted as a safer mode of travel for passengers than using an automobile, quite the opposite is true for people who are not physically on a train. When MAX fatality rates per vehicle mile are compared to those for automobiles, a troubling picture emerges. The risk of death per vehicle (train) mile for a pedestrian or cyclist by collision on the MAX system is 296 times higher than it is on a roadway around cars and trucks, based on a five-year moving average calculated in 2017 of the data in Figure 17. This indicates a glaring need for safety improvements on MAX and for light-rail systems in general. This is an interesting finding when considering that MAX train operators are highly trained professionals subject to drug testing and routine medical exams. The likely cause for MAX fatality rates being so much higher than for auto traffic is not train operators, it is system design and operational procedures.

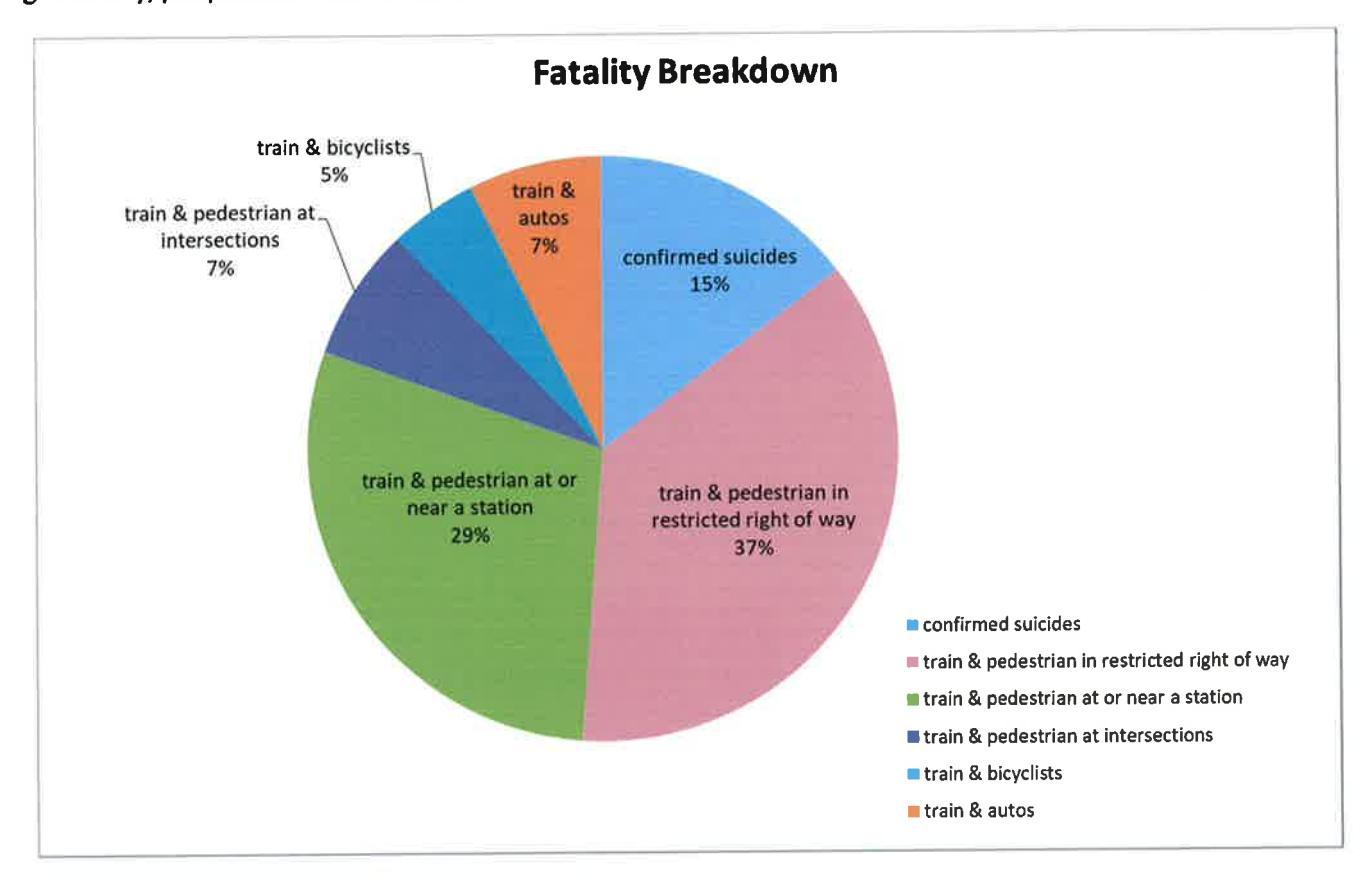
Figure 18. Breakdown of fatality types

Looking at the circumstances of MAX fatalities as classified by TriMet, the top three are people in the restricted right of way, people at or near a station, and suicide.

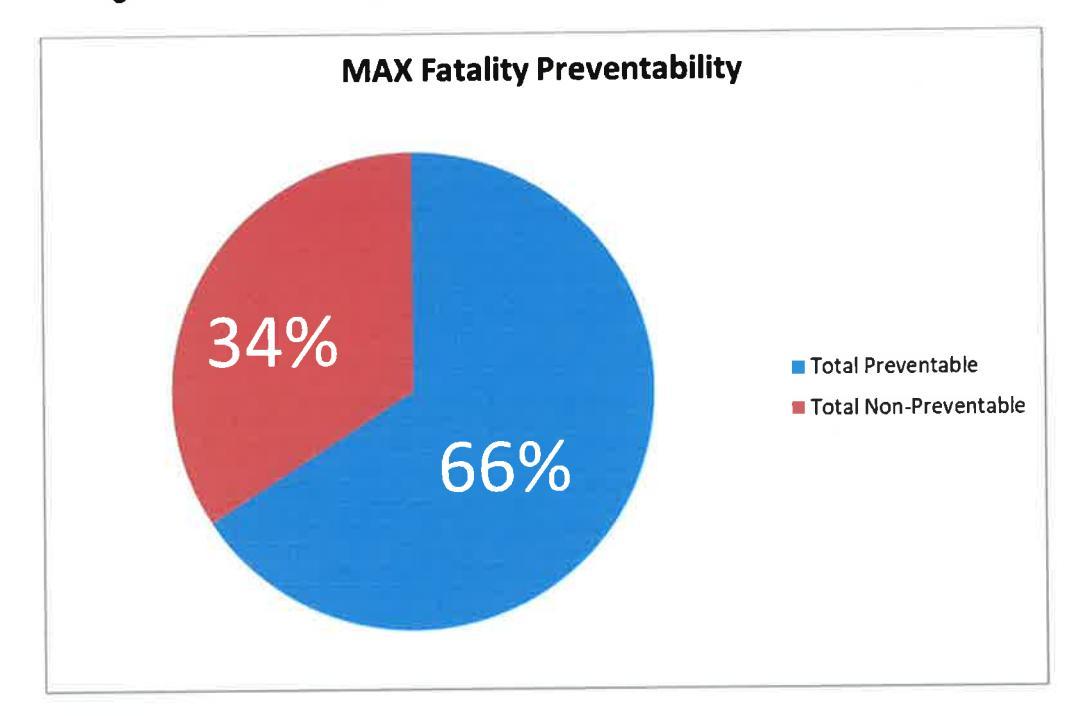
Figure 19. Estimated preventability of fatalities appearing to be the result of operational and/or design issues

As fatalities were examined, it became clear that many were preventable through design changes at stations and intersections or grade crossings, or by modifying the operational procedure to have a train operator stop before pedestrian crossings at either end of a station and then enter the station at a crawl. This change would allow operators to safely stop if a pedestrian were in the crossing area or in an unsafe location on the platform. Today, trains only brake as they approach a station and come to a stop at the platform. Each fatality was graded as preventable or not if those changes were made. The result: 67% of deaths could be prevented by design improvements or stopping the train at pedestrian crossings and then entering the station at a crawl. This figure still has uncertainty because TriMet did not provide detailed investigations of each incident. However, at the very least these changes should be seriously considered as it could greatly reduce fatality risk on the system.

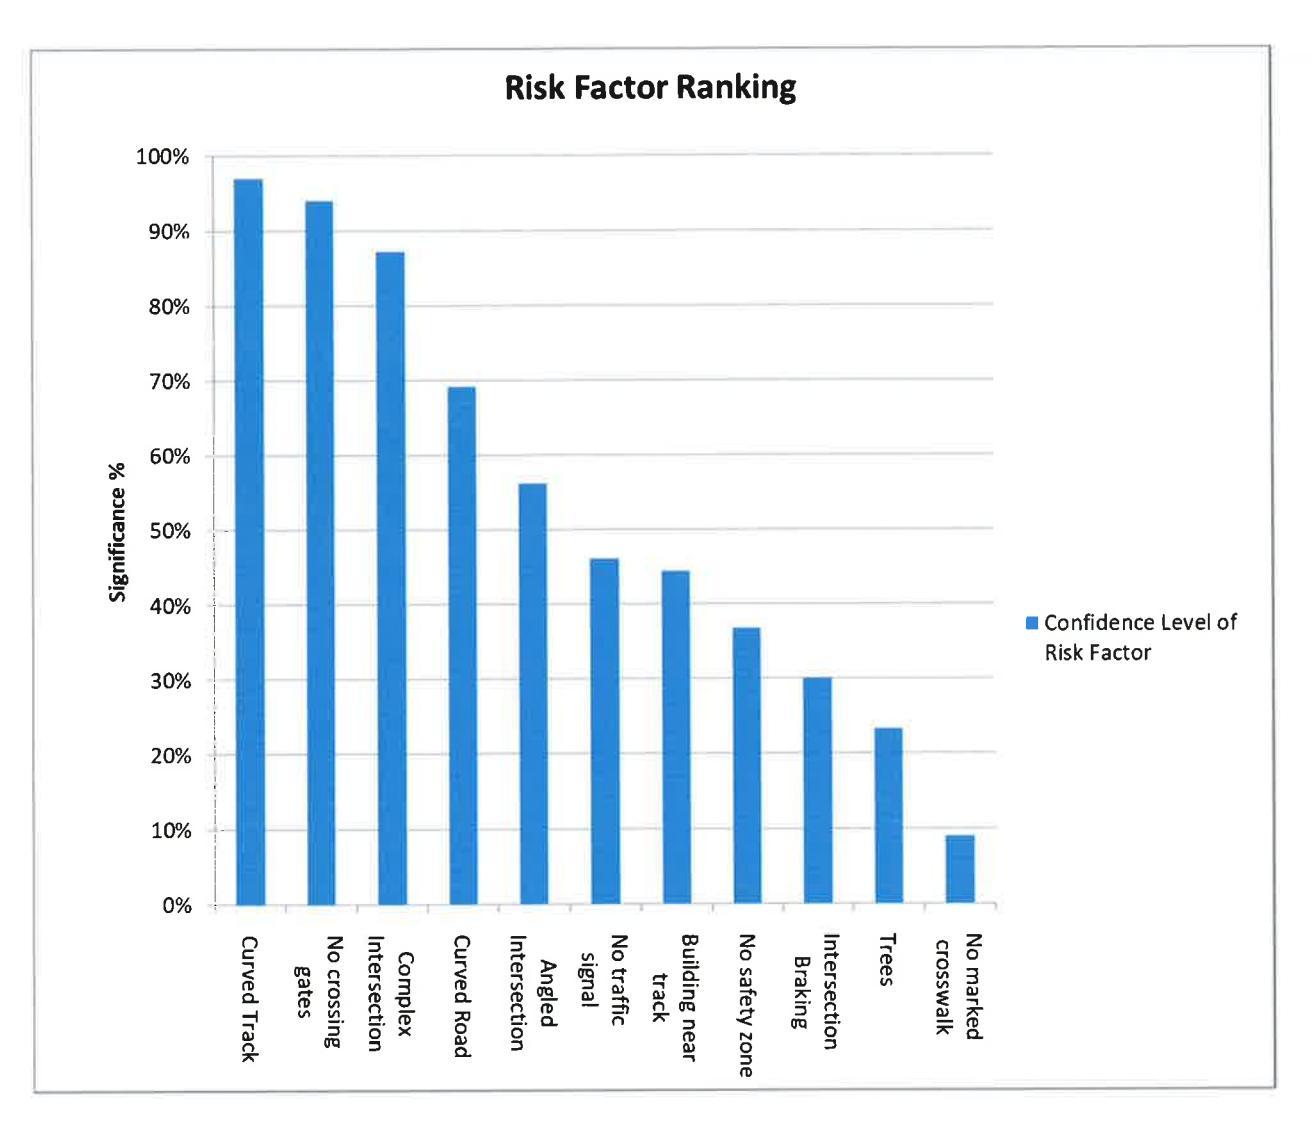
Figure 20. Significance ranking of fatality risk factors at Blue Line stations

To further understand risk factors for fatalities, likely risk factors were identified at each station along the Blue Line and then analyzed for frequency and multiple risk factor convergence. Stations were grouped into two populations: those without fatalities and those with them. Next, the statistical significance of the percentage of stations in each group with a particular factor present was calculated. The results are ranked in Figure 20 below. The most significant factors (> 70% confidence level) were a curved track, no crossing gates, and a complex intersection. Other factors had less than a 70% confidence level. It is likely that in the future, some factors might increase in confidence level because currently there are about twice the number of stations without fatalities as those with them, limiting the sample size in the latter group. A curved road is likely significant as it is present at the Baseline Road crossing, but was not a station site so it was excluded from the analysis.

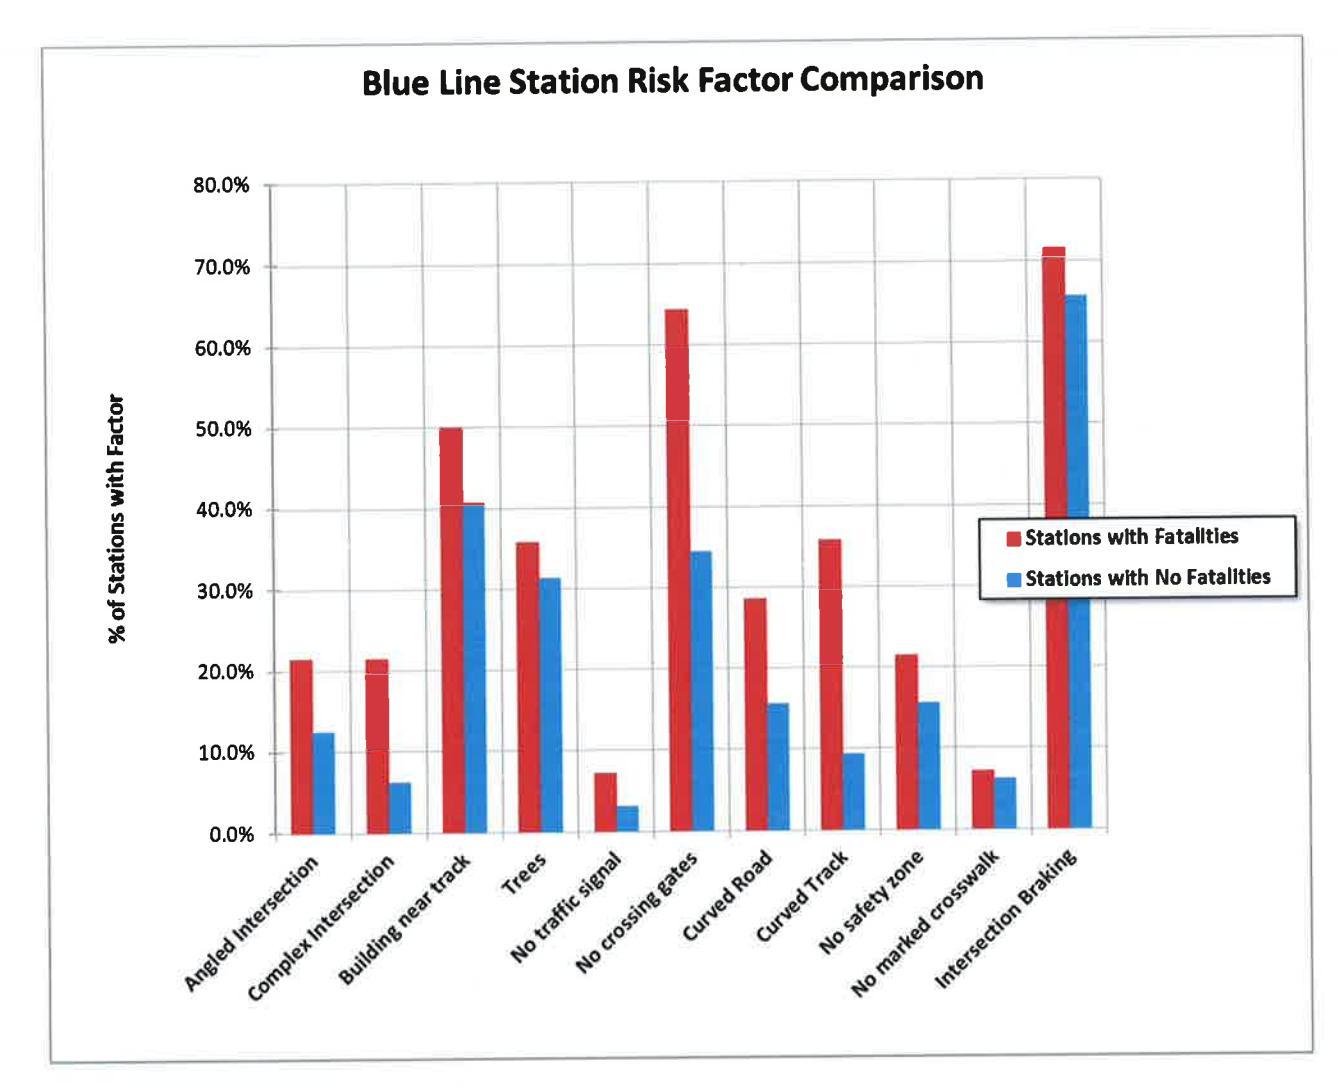
Figure 21. Risk factor breakdown for stations with and without fatalities

The number of individual risk factors at stations with and without fatalities is summarized in Figure 21 below. This is not an exhaustive list of risk factors. Two that are likely important but not accounted for include train speed and number of riders per day at a station. TriMet did not supply those data in the records request, but they should be included in a future examination of risk in order to inform safety upgrade decisions.

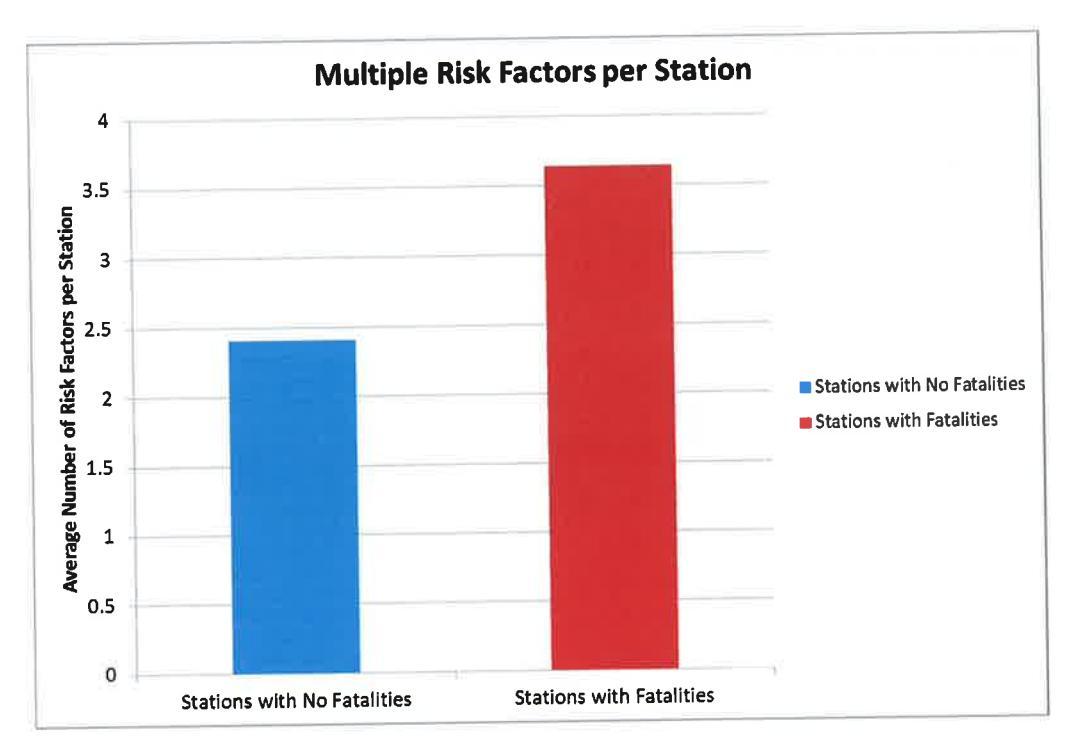
Figure 23. Significance of multiple risk factors at stations

The number of risk factors was higher at stations with fatalities compared to those without them at 96.4% confidence (Figure 23, below).
