Joint Committee on
Ways and Means
Subcommittee on Capital Construction
Oregon State Capitol
Public testimony
Date: Time: April 19, 2019 12:00 P.M. HR E
900 Court Street NE, Room H-178, Salem, Oregon 97301
Phone: 503-986-1828
Email: jwmcc.exhibits@oregonlegislature.gov

Willamette Falls Canal and Locks
Independent Condition Assessment and Recommendations for
Recommissioning

Prepared for:
Willamette Falls Locks Commission (WFLC)

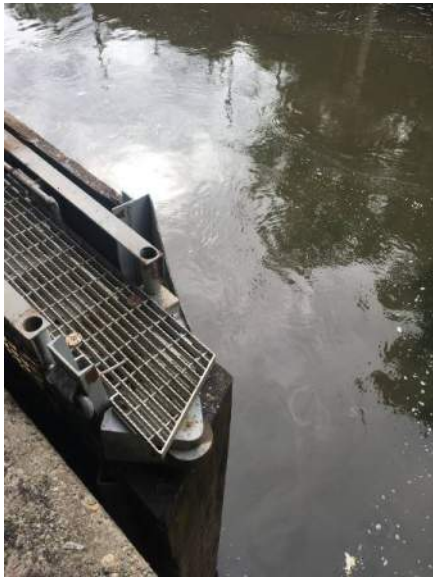
anchorage that utilizes short anchor rods installed in keyed slots in the lock wall. See Photo #3 for the roller arrangement, Photo #4 for the quoin block and Photo #6 for the gudgeon anchorage.

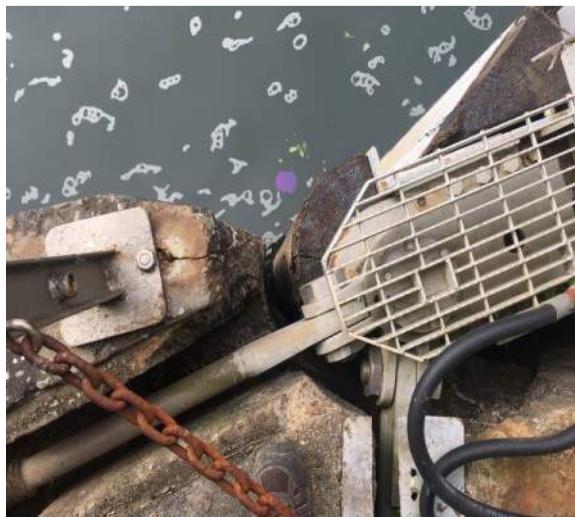
The gate's gudgeon anchorage system functioned as designed. With the gate closed, each gate leaf was firmly seated between the miter and quoin blocks and the gudgeon anchors appeared to be unloaded. As soon as the gates started to open, a gap opened between the quoin post and the quoin block, transferring the gate's dead weight to the gudgeon anchor bars. (See Photo #5 and #6 for typical condition.)

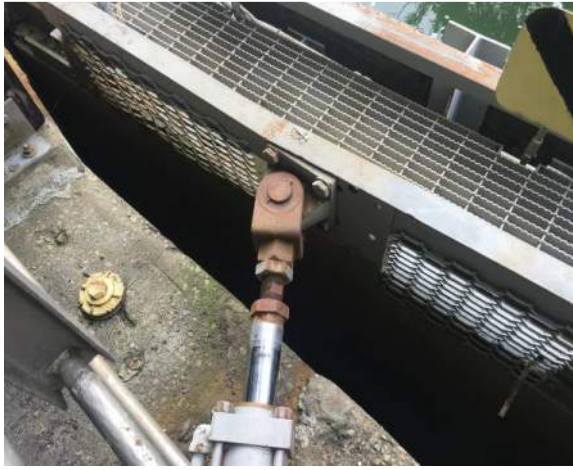
Photo #7

The gate hydraulic operating cylinders appear to be National Fluid Power Association (NFPA) standard tie rod type industrial cylinders. The cylinders are connected to the gate via standard clevis and a short threaded rod with lock nuts. This arrangement allows the length of the cylinder to be adjusted to fine tune the location of the gate in the open position. Based on the cylinder's paint system and the use of threaded piping for the rod and blind end fluid connection, these cylinders were likely installed prior to 1970. Although some surface rust is apparent on the rod end connections and cylinder bodies, the cylinders are in relatively good condition and should provide reliable service if the system is put back in operation. That being said, these cylinders are well past the typical service life that would be expected and should be replaced or fully refurbished in the near future. This situation will be exacerbated by the current "care-taker" status of the facility, which dramatically limits the number of gate operations (cylinder extend/retract cycles) seen by each cylinder. (See Photos #7 and #8 for typical cylinder condition.)

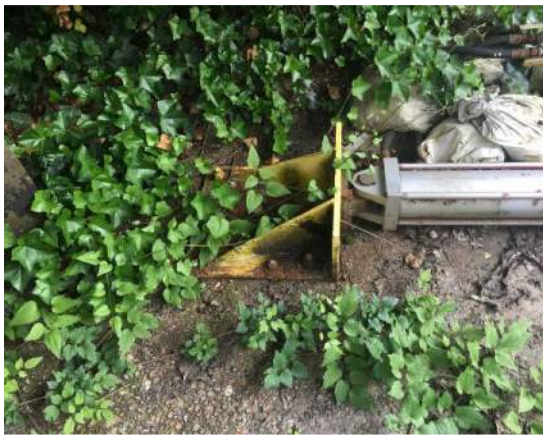
Photo #9

On the lock wall, the miter gate cylinders are attached to steel brackets installed directly onto native stone. The steel brackets appear to be in good condition, solid and well anchored. (See Photo #9)

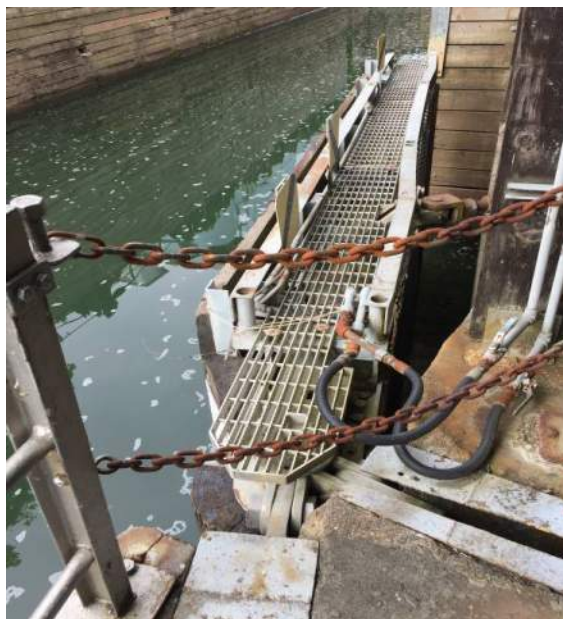
Photo #12

This lock was created by cutting into the native rock, with the side walls comprised of timber facing in front of the native rock. This lock is bound by Miter Gate 1 on the downstream side and Miter Gate 2 on the upstream side. Gate 1 is kept in an open position, and Gate 2 is kept in a closed position. Total design lift on this lock is 20.5 feet. See photo #1 for an overall view of Lock 1 and photo #2 for Miter Gate 1 in the closed position. See photos #12 & #13 for close ups of Gate 1 in the open and closed positions.

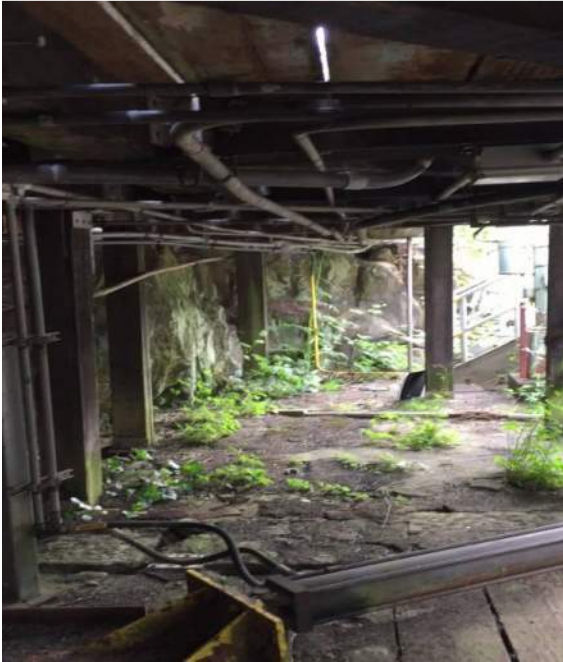
Photo #14

Generally the anchor rods parallel to the lock chamber appear to be anchored to the lock wall and are readily accessible. The Corps has noted concern about the condition of the anchor rods used by the lateral gudgeon bars. Large portions of these anchor rods are not visible and cannot be visually assessed. To address this concern, two options may be undertaken. One would be to excavate around the anchor, where there is access, to the point at which the anchor is embedded in concrete (and should be corrosion free within the grout surrounding the anchor); or Two would be to perform a tension pull test on the anchor to verify its capacity. A third potential option would be to abandon the anchor completely and provide a new drilled in anchor with a known capacity. Note that access to the gudgeon anchors on the Corps side of the lock is difficult due to an existing framework of utilities supported by a timber boardwalk. See Photo #14.

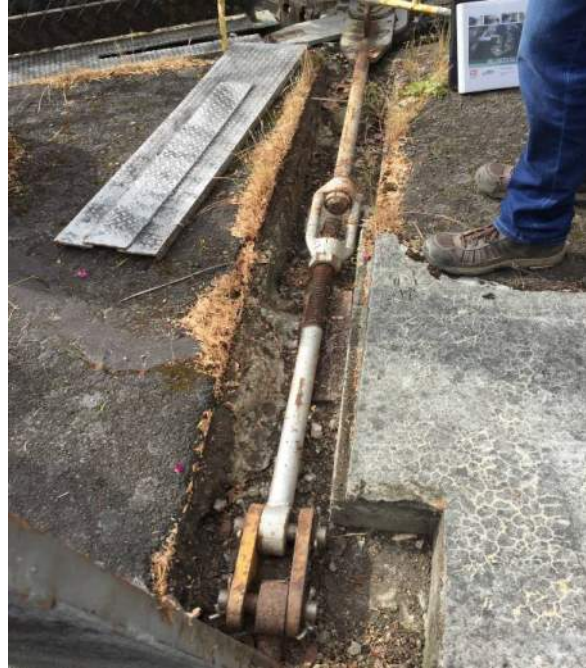
Photo #15

Gate #3 is similar in construction to the other gates but is 19'- 5 3/8" tall. As this gate was operated, the lateral gudgeon anchor on the Corps side visibly displaced several inches upward as the gate leaf came back to the fully open position. In this position, the tension on the lateral anchor is relieved, and therefore the gudgeon anchor is free to relax. This may be indicative of the ground anchor not being fully embedded and likely requires some maintenance prior to any re-opening of the lock. The area around this anchor is free of obstructions and could easily be excavated to allow further investigation of the below ground condition. (See Photo #15)
