Willamette Falls Canal and Locks

Independent Condition Assessment and Recommendations for Recommissioning

Prepared for:
Willamette Falls Locks Commission (WFLC)

Prepared by:
KPFF Consulting Engineers
1601 Fifth Avenue, Suite 1300
Seattle, WA 98101
(206) 382-0600

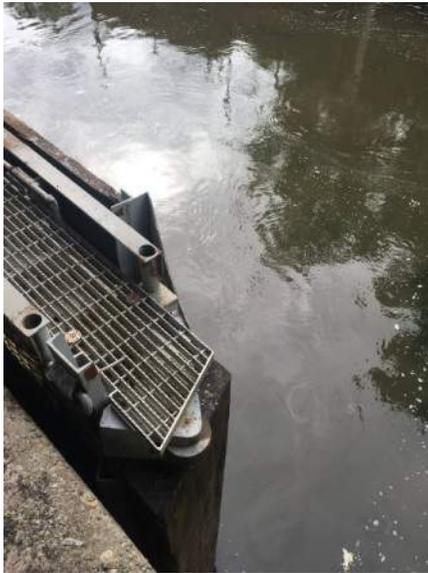
anchorage that utilizes short anchor rods installed in keyed slots in the lock wall. See Photo #3 for the roller arrangement, Photo #4 for the quoin block and Photo #6 for the gudgeon anchorage.

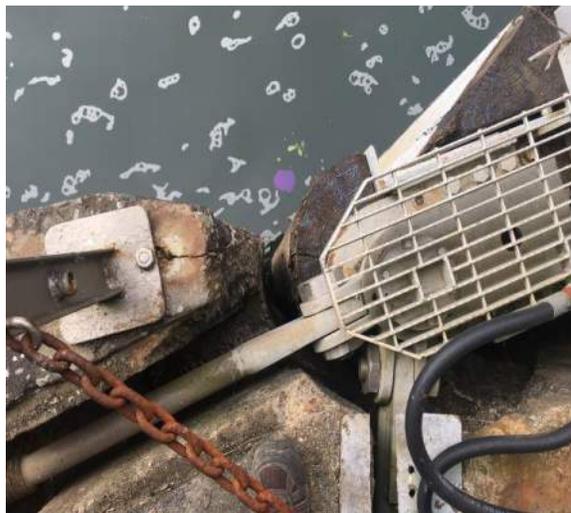
The gate's gudgeon anchorage system functioned as designed. With the gate closed, each gate leaf was firmly seated between the miter and quoin blocks and the gudgeon anchors appeared to be unloaded. As soon as the gates started to open, a gap opened between the quoin post and the quoin block, transferring the gate's dead weight to the gudgeon anchor bars. (See Photo #5 and #6 for typical condition.)

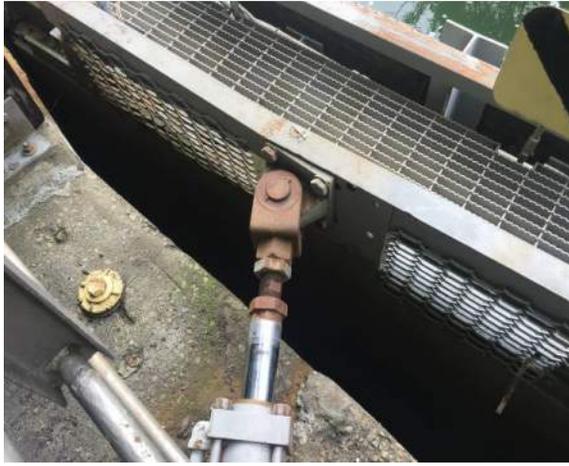
Photo #7

The gate hydraulic operating cylinders appear to be National Fluid Power Association (NFPA) standard tie rod type industrial cylinders. The cylinders are connected to the gate via standard clevis and a short threaded rod with lock nuts. This arrangement allows the length of the cylinder to be adjusted to fine tune the location of the gate in the open position. Based on the cylinder's paint system and the use of threaded piping for the rod and blind end fluid connection, these cylinders were likely installed prior to 1970. Although some surface rust is apparent on the rod end connections and cylinder bodies, the cylinders are in relatively good condition and should provide reliable service if the system is put back in operation. That being said, these cylinders are well past the typical service life that would be expected and should be replaced or fully refurbished in the near future. This situation will be exacerbated by the current "care-taker" status of the facility, which dramatically limits the number of gate operations (cylinder extend/retract cycles) seen by each cylinder. (See Photos #7 and #8 for typical cylinder condition.)

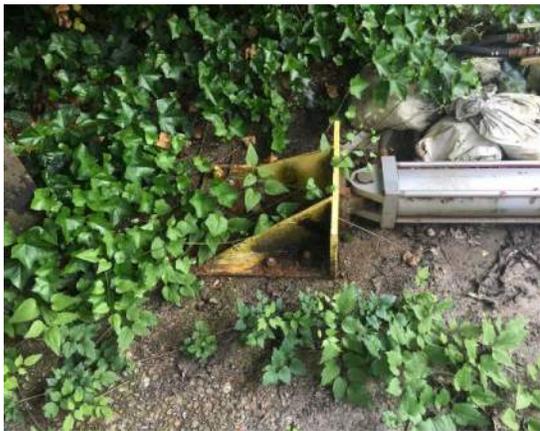
Photo #9

On the lock wall, the miter gate cylinders are attached to steel brackets installed directly onto native stone. The steel brackets appear to be in good condition, solid and well anchored. (See Photo #9)

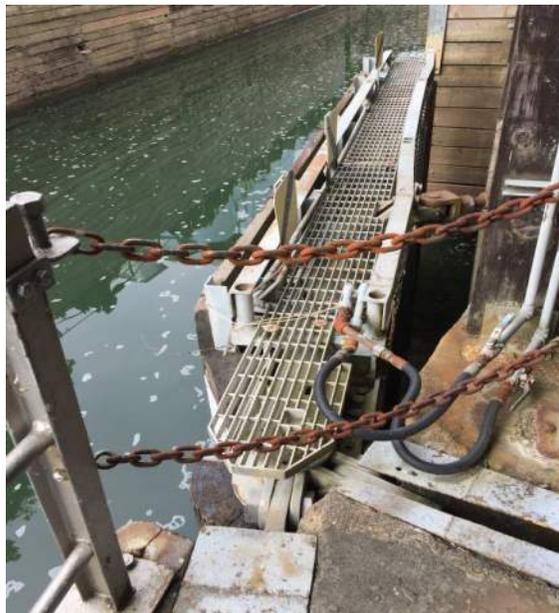
Photo #12

This lock was created by cutting into the native rock, with the side walls comprised of timber facing in front of the native rock. This lock is bound by Miter Gate 1 on the downstream side and Miter Gate 2 on the upstream side. Gate 1 is kept in an open position, and Gate 2 is kept in a closed position. Total design lift on this lock is 20.5 feet. See photo #1 for an overall view of Lock 1 and photo #2 for Miter Gate 1 in the closed position. See photos #12 & #13 for close ups of Gate 1 in the open and closed positions.

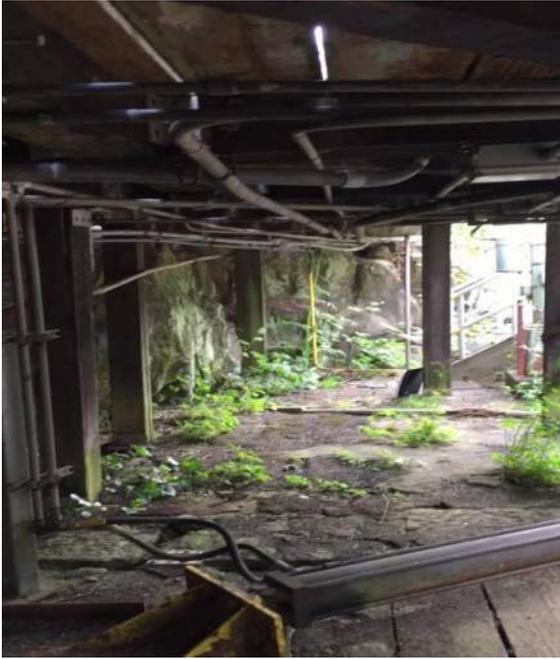
Photo #14

Generally the anchor rods parallel to the lock chamber appear to be anchored to the lock wall and are readily accessible. The Corps has noted concern about the condition of the anchor rods used by the lateral gudgeon bars. Large portions of these anchor rods are not visible and cannot be visually assessed. To address this concern, two options may be undertaken. One would be to excavate around the anchor, where there is access, to the point at which the anchor is embedded in concrete (and should be corrosion free within the grout surrounding the anchor); or Two would be to perform a tension pull test on the anchor to verify its capacity. A third potential option would be to abandon the anchor completely and provide a new drilled in anchor with a known capacity. Note that access to the gudgeon anchors on the Corps side of the lock is difficult due to an existing framework of utilities supported by a timber boardwalk. See Photo #14.

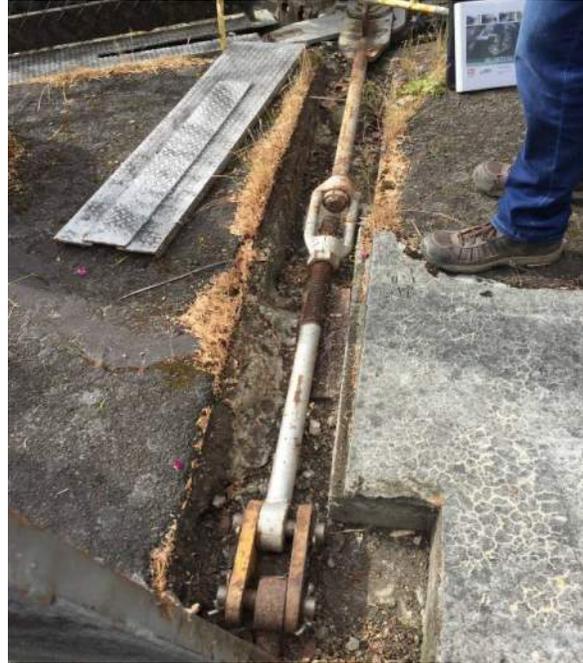
Photo #15

Gate #3 is similar in construction to the other gates but is 19'- 5 3/8" tall. As this gate was operated, the lateral gudgeon anchor on the Corps side visibly displaced several inches upward as the gate leaf came back to the fully open position. In this position, the tension on the lateral anchor is relieved, and therefore the gudgeon anchor is free to relax. This may be indicative of the ground anchor not being fully embedded and likely requires some maintenance prior to any re-opening of the lock. The area around this anchor is free of obstructions and could easily be excavated to allow further investigation of the below ground condition. (See Photo #15)

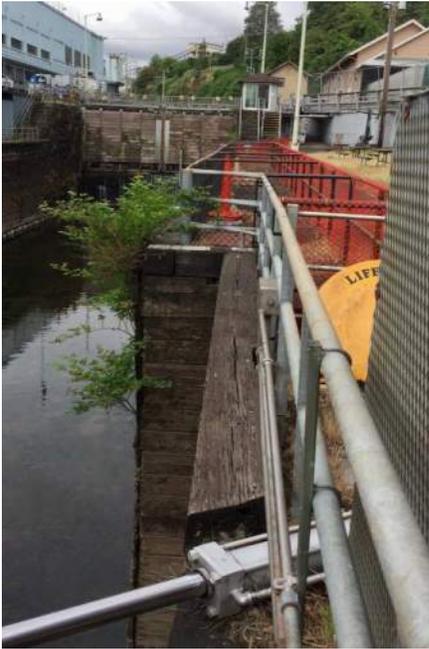
Photo #16

This lock is bound by Gate 3 on the downstream side and Gate 4 on the upstream side, both kept in a closed position. It is our understanding that this lock was constructed with stacked ashlar masonry block and then backfilled. The lock walls are faced with timber fendering for their full height. There appears to be a several foot gap between the face of masonry and the timber facing, with the timber wall being built out several feet away from the masonry with timber cribbing and framing. On the Corps side of the lock, the downstream approximately 100 feet of ground surface adjacent to the lock wall has washed out. According to Corps staff, water got between the face of masonry and the backside face of the timber facing and washed out most of the backfill between these surfaces. There is currently orange fencing in place to keep people from walking in this area. See Photo #16.
