March 24, 2023

**OREGON STATE POLICE
STRATEGIC MASTER FACILITIES PLAN
FIRST PHASE**

EXECUTIVE SUMMARY

**OREGON STATE POLICE
STRATEGIC MASTER FACILITIES PLAN
SECOND PHASE**

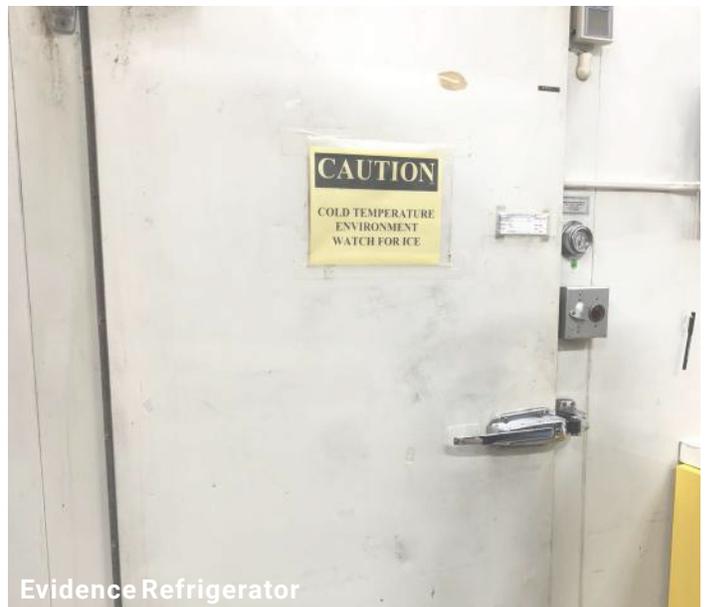
Generator

The Springfield facility is not equipped with a backup generator at this time. There is a generator on site, but it is non-operational. This means that there is no backup power or emergency lighting provided on site. If the building were to experience a power outage due to a storm, system failure, or other event, OSP operations would be completely shut down at this location and critical evidence could be lost. Evidence storage freezers and refrigerators, Forensic Services Lab freezers and refrigerators, patrol operations, and the server room are all spaces that would benefit from being equipped with emergency backup power.

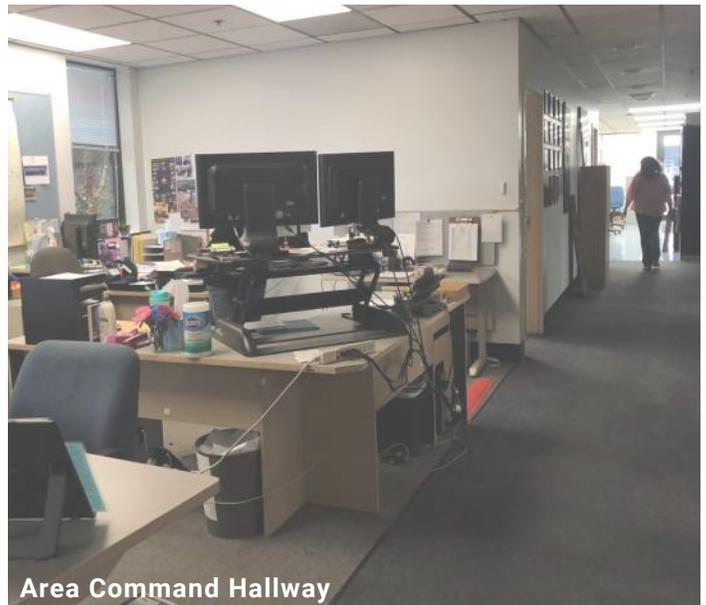
Area Command Hallway

The overall building environment has not been noticeably updated over the years. Both the HVAC system and the roof are at or nearing the end of their service life. Much of the furniture is still the original furniture, and has not been upgraded to meet current OSP standards. Carpet is installed in high traffic areas such as the main Area Command hallway and locker rooms, which is difficult to keep clean. The original acoustical ceiling tile and fluorescent lights remain. Several storage spaces and print/copy areas have been reclaimed for offices, leaving storage in less efficient locations and some offices without access to daylight.

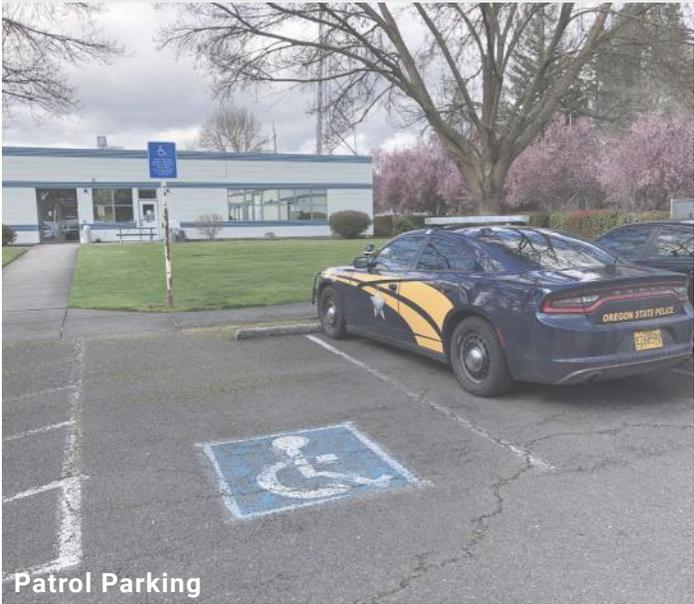
Patrol Parking

Patrol operations are spread throughout the facility. This distance between functions limits an officer's response time and reduces connected, collaborative interactions among staff. The secure parking area provides no covered parking for patrol vehicles, which is essential to keeping the vehicles primed and ready to go in all weather conditions. Furthermore, there is a lack of dedicated evidence vehicle storage.

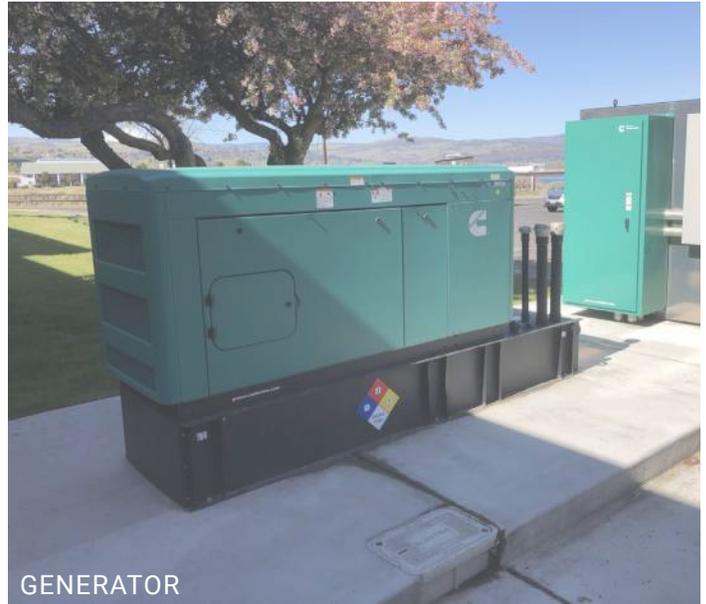
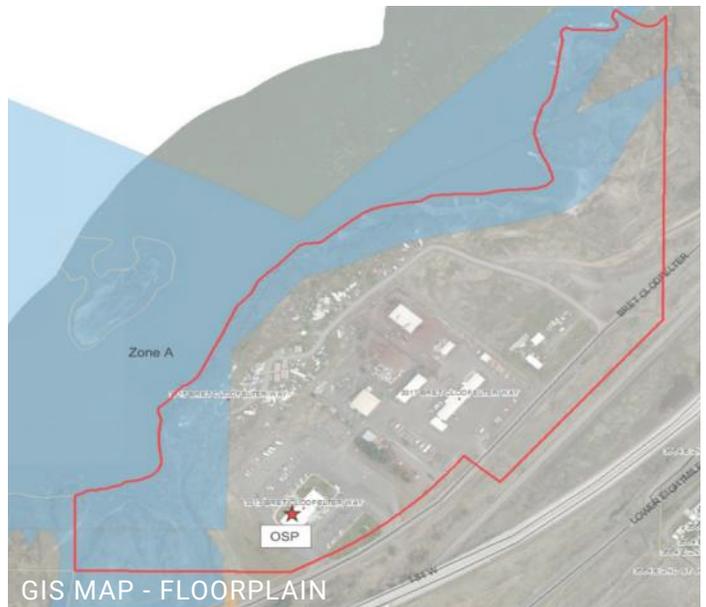
In terms of resiliency, this site is on a dead-end road and there are concerns about potential flooding limiting OSP's response pathways as the floodplain extends over NE Bret Clotfelter Way. Although the building itself is out of the floodplain zone, the lack of access to the facility and potential parking lot flooding is a risk to OSP operations in the region.

The facility is not constructed to meet Essential Facility seismic standards. Additionally, the building is not sprinklered, which puts both staff and evidence at risk in the event of a fire.

A diesel generator was recently installed in partnership with ODOT. Currently it supplies backup power to OSP, ODOT, and DMV operations in the building. Yet the generator only covers a portion of OSP's facility needs, so during a power outage OSP cannot sustain full-capacity operations.

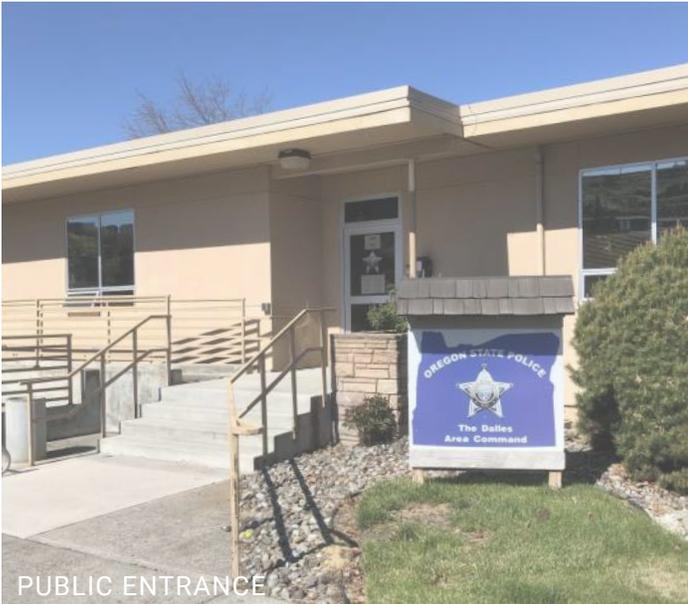
PUBLIC ENTRANCE

The glazing at the lobby transaction window is not ballistically-rated. There are no public restrooms available, and there is no public interview room off the lobby for private conversation. To access the restrooms, members of the public must walk through the DMV portion of the building or be escorted through the OSP secure area. This is both inefficient and a security risk for OSP staff.

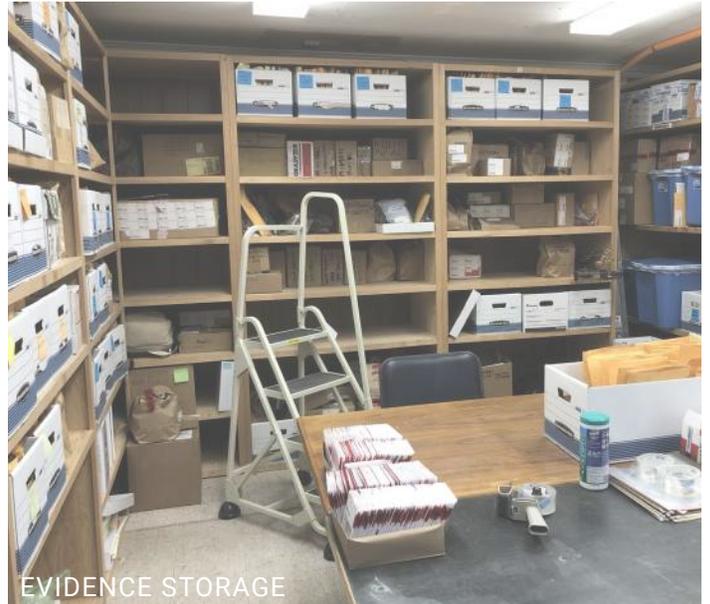
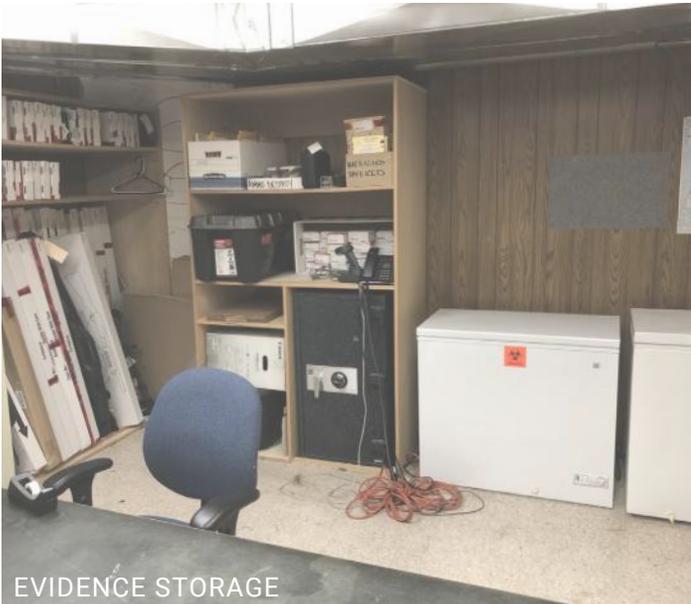
EVIDENCE STORAGE

Evidence flow is another key issue at this Area Command. Officers process evidence downstairs. The evidence technician then needs to bring the evidence upstairs for intake processing, and then back downstairs to storage outside of the secure area. Additionally, the evidence storage area does not have proper ventilation and there does not appear to be enough area for evidence processing or general storage. Other tenants in the building have complained about drug storage smell.

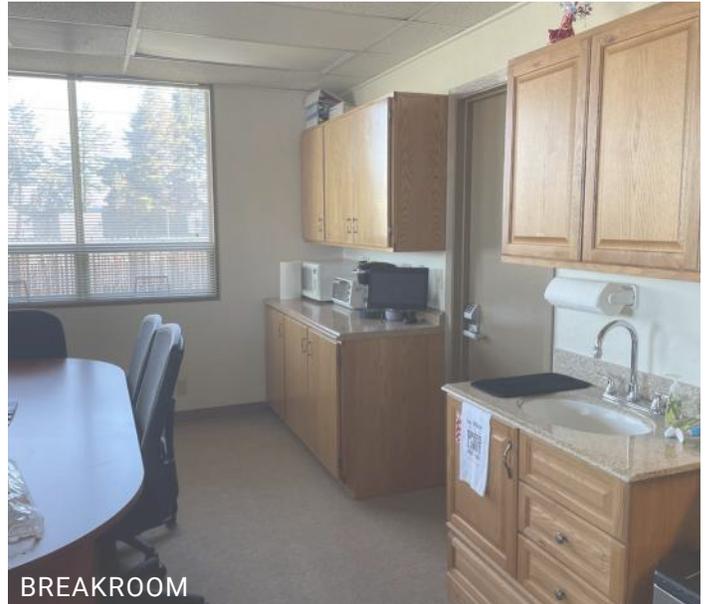
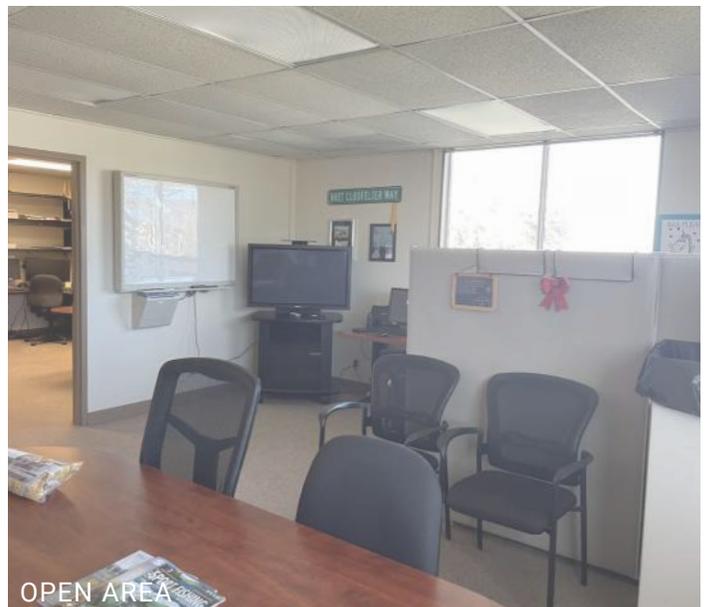
The overall building environment has noticeably not been updated over the years. The original acoustic ceiling tile and fluorescent lights remain throughout the space. There is a generic open area that functions as a breakroom, small meeting area, and space for workstations. Due to lack of space, evidence is sometimes sorted at the breakroom table, which is a safety risk for officers.

The women's locker room is inadequate in its current condition, and there is a need for a wellness room in order to meet OSP's equity standards. The existing men's locker room lacks ventilation. Additionally, the HVAC system does not provide adequate or evenly distributed service throughout the entire building. As a result, workspaces can be stuffy and uncomfortable without proper ventilation. This is especially an issue in the basement spaces. In basement rooms there is also a lack of windows and natural light, which is proven to affect staff productivity and wellness.

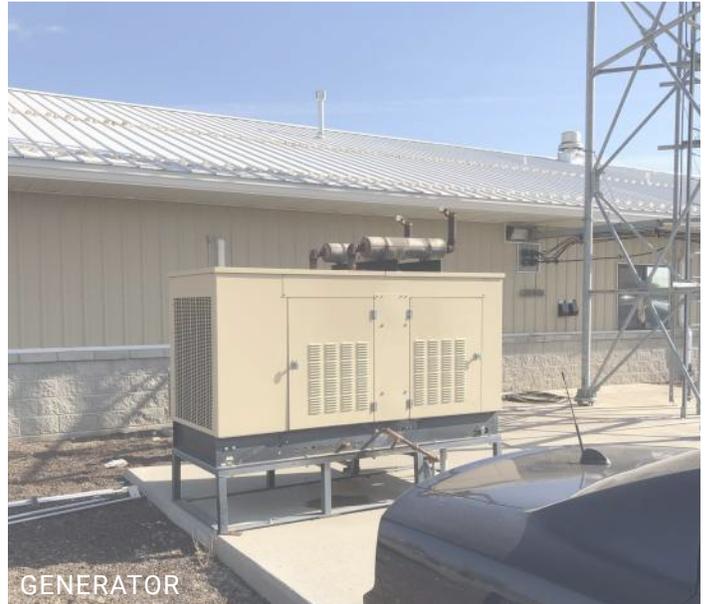
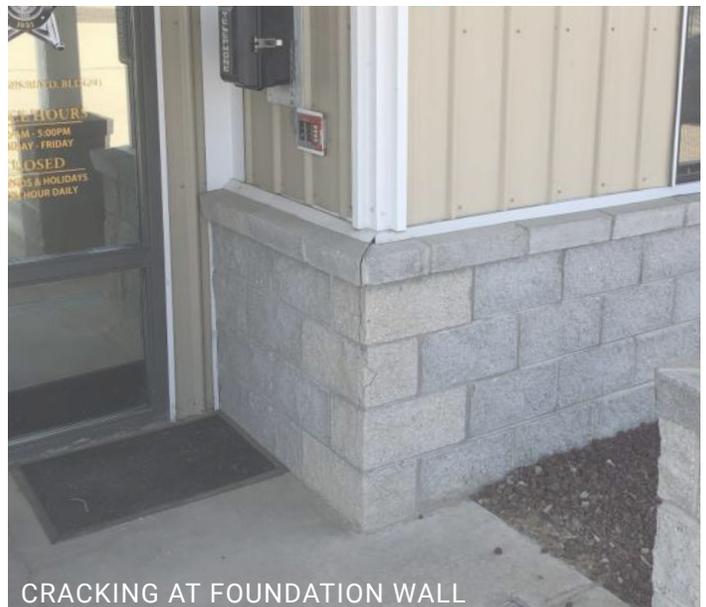
When the Ontario area experiences strong storms, the building is located at the lowest topographical point of the site where water collects. The lack of proper drainage and ability to divert this water has led to flooding in the building, including into critical infrastructure like the IT/server room and secure evidence storage. The building also lacks the structural capacity to support the designated snow load for the region, which led to a recent roof collapse. Snow fall is a typical part of Ontario winters and staff is forced to monitor the accumulation and remove the snow from the roof as necessary to keep the roof from collapsing again.

In the event of a power outage, the facility shares a small natural gas generator with the ODOT site. Currently it is only sized to provide 20% electrical capacity, which does not support emergency OSP operations out of the facility. The building is also not constructed to Essential Facility construction standards. In addition, there are noticeable cracks in the CMU foundation walls. In the event of the earthquake, OSP would not be able to utilize the facility to support emergency operations.

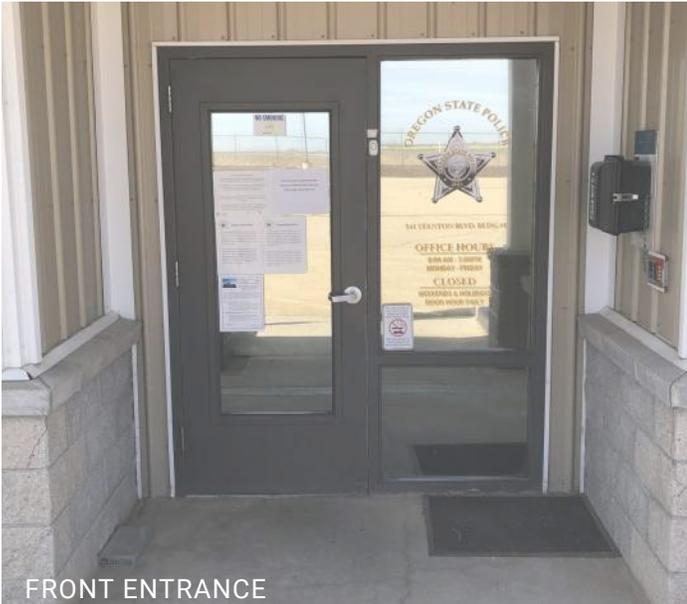
FRONT ENTRANCE

The building exterior does not include any safety measures to protect staff in the event of a deliberate assault on the facility. The building lacks vehicle deterrents and is constructed of light-gauge framing making it a risk for vehicular attacks. There is also no exterior building ballistics in the wall assembly or exterior ballistic rated glazing. The lack of physical security barriers is magnified by the fact that the facility has no exterior cameras to monitor the perimeter and actively assess a situation from the interior.

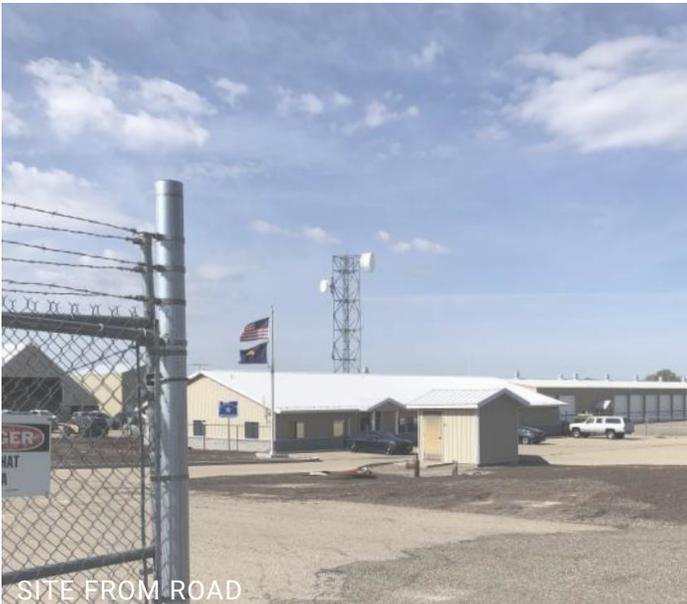
SITE FROM ROAD

The site has a perimeter fence, but since it is shared with ODOT, there is a large volume of traffic coming in and out. The volume and frequency of traffic results in the gates often being left open. This security issue of opened gates is compounded by the lack of easy public wayfinding to the front. In turn, this confusion leads to the members of the public mistakenly utilizing the parking area dedicated for patrol vehicles. The lack of secure parking is a security concern for staff. There is also an issue securing long-term vehicle evidence onsite.

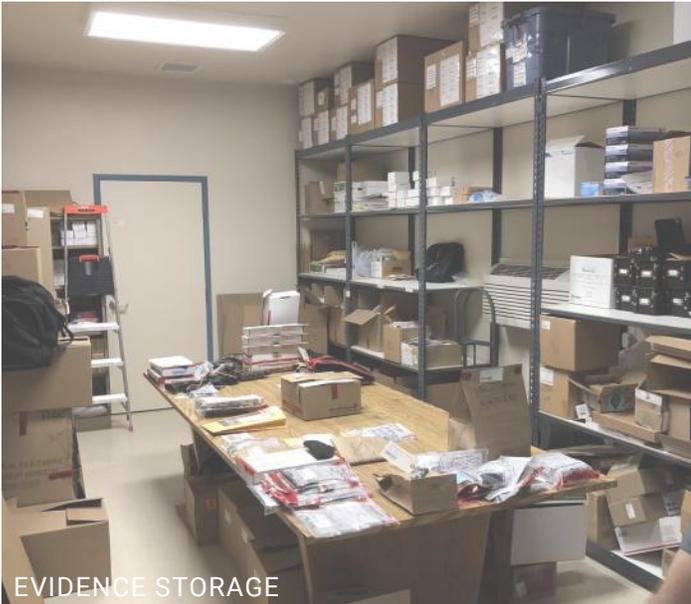
EVIDENCE STORAGE

The facility has a secure storage space for evidence, but it is not sized to meet the storage demands. It also floods in storm events. The space is served by wall-mounted mechanical units. These units are undersized to ventilate the stored substances, and are a security risk since they can easily be removed, allowing access into a secure evidence area.

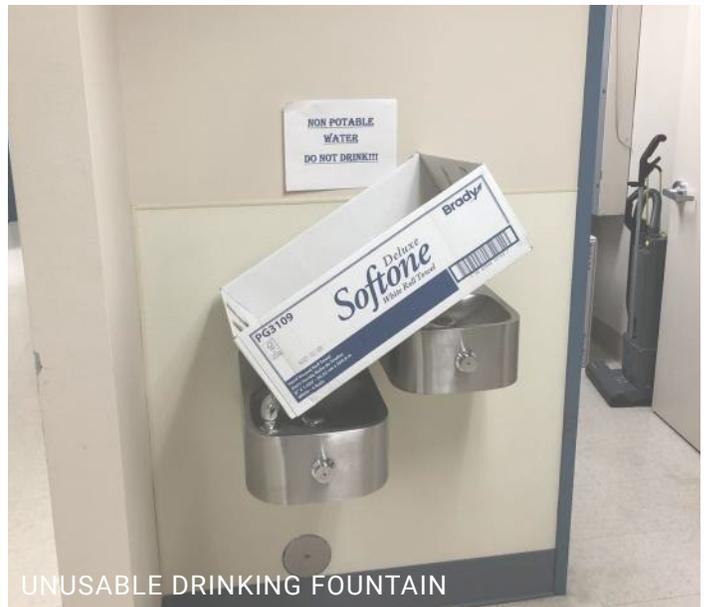
UNUSABLE DRINKING FOUNTAIN

The water supply to the building was tested and contains high arsenic levels. This health risk means that all drinking water must be purchased in bottle form and no shower facilities are available onsite. In addition to the arsenic levels, the water supply is crystallized. These crystals lead to build-up in the pumping system which has caused sewage backups in the facility.

This facility presents multiple immediate health concerns for staff. There is arsenic present in the water serving the site, so there is no potable water or showers available to staff within the building. The water is also crystallized, which accumulates in sanitary pipes and causes sewage backups in the building.

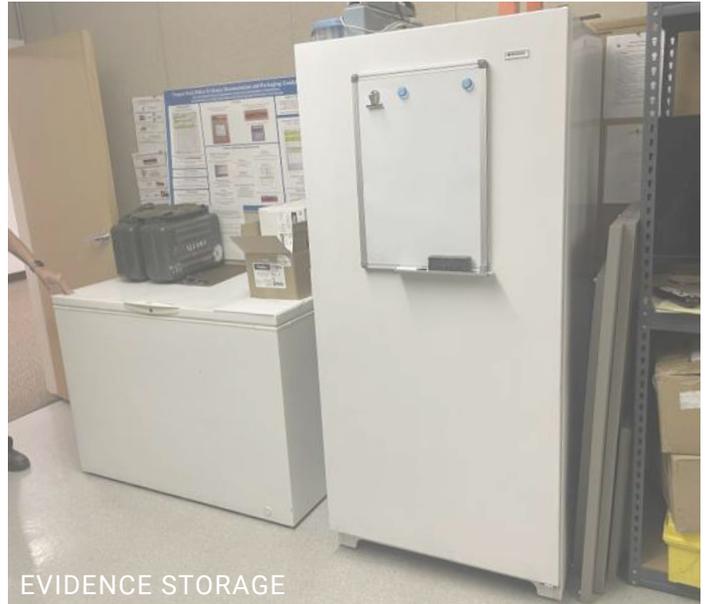
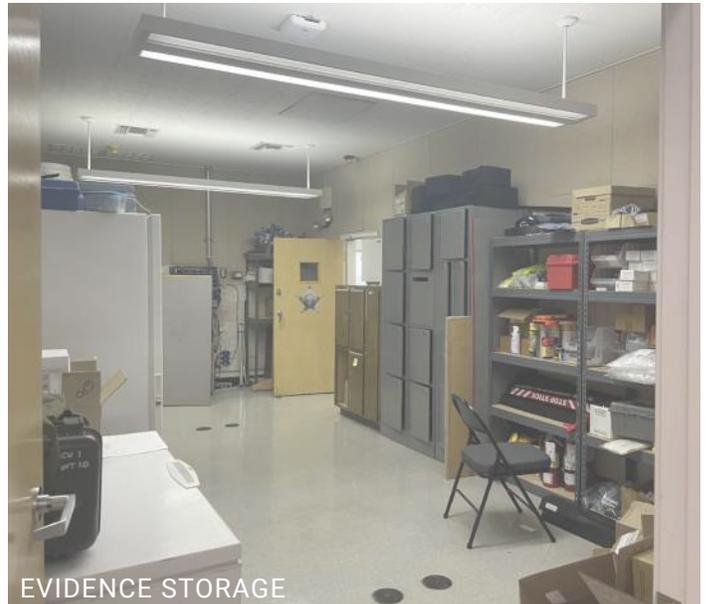
EVIDENCE STORAGE

There is no generator onsite at this location. During a loss of power, the facility is not functional and has to shift operations to other Area Command facilities. In a prolonged power outage, critical evidence can be lost in evidence storage freezers and refrigerators.

The evidence storage room lacks proper ventilation. In addition, the storage space is shared with other building functions rather than having its own space. One of these shared uses is the IT server. Both evidence storage and the IT server need their own secure space to limit access.

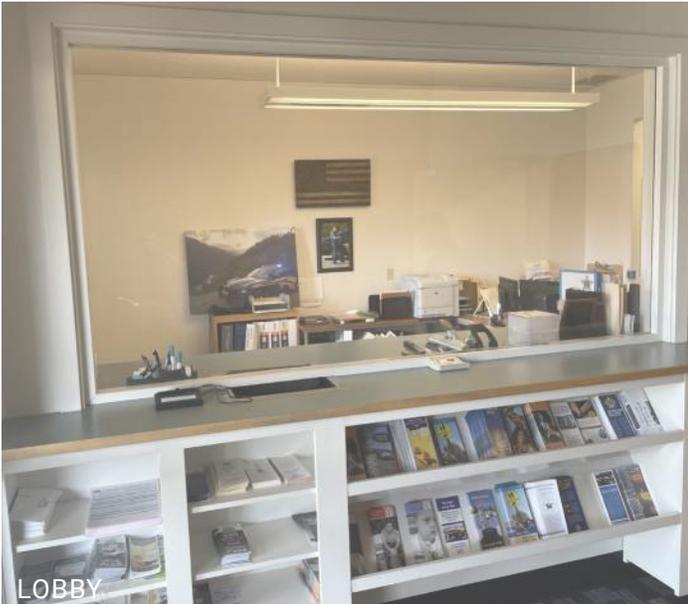
LOBBY

The lobby at Grants Pass Area Command is small and does not provide a separate registrant vestibule. Additionally, there is no restroom available for public use. Currently the interview room is only accessible through the meeting room, which causes functional problems when both are in use. A purpose-built report-taking room and fingerprinting room directly off the lobby would provide increased security and a better operational flow, as documented in the compliance category section of this report.

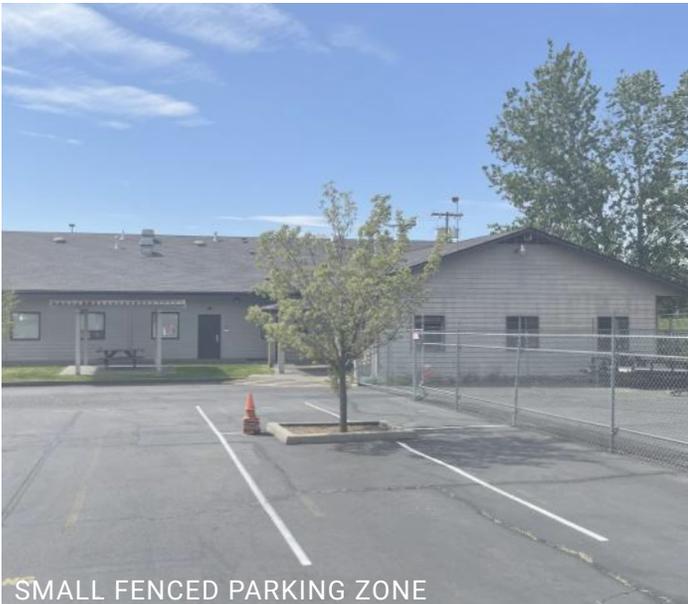
SMALL FENCED PARKING ZONE

There is a small area of fenced secure parking area that is not used for daily patrol operations. This area provides limited space for a small number of vehicles or trailers. The available parking area is poorly illuminated. Without a secure parking area, this lack of lighting is especially a concern for officers at night accessing their vehicles or responding to a call.

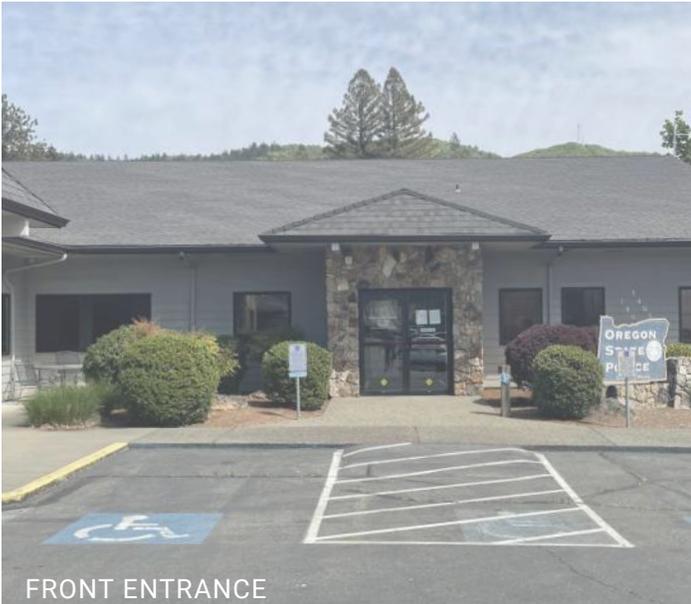
FRONT ENTRANCE

The windows have a reflective film that makes the interior of the building fully visible when lit at night, but occupants cannot see out. The blinds have to be drawn, which limits observation of the parking area. The building exterior does not have ballistic protection or vehicle deterrents. With public roads around the majority of the exterior, the building is vulnerable vehicular attacks on all sides.

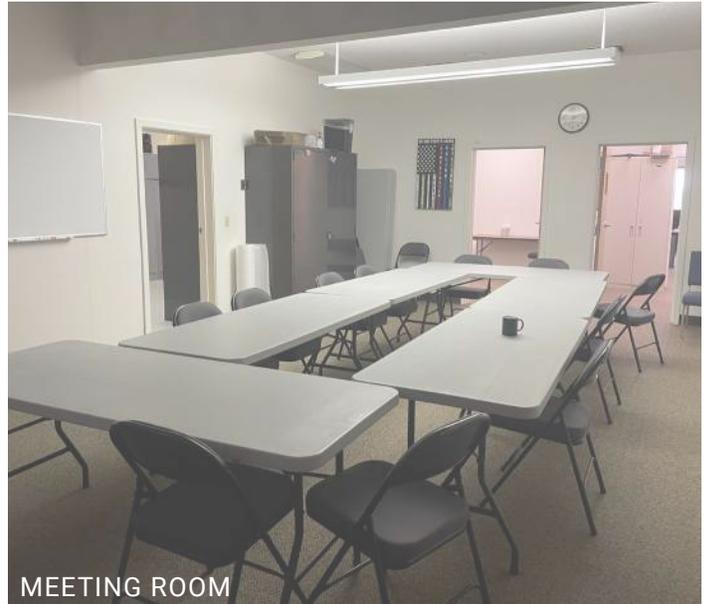
MEETING ROOM

Two different office spaces were combined to make the current OSP space at this location. As a result, the space has several electrical and HVAC issues. For example, there is no light switch for the conference room, so lights are controlled with the breaker panel. Heating and cooling are also an issue throughout the building. Some offices are too hot while others are too cold. This is inefficient for energy use and makes for an uncomfortable work environment. Along with the mechanical and electrical concerns, lizards and rats are a consistent problem inside the building.

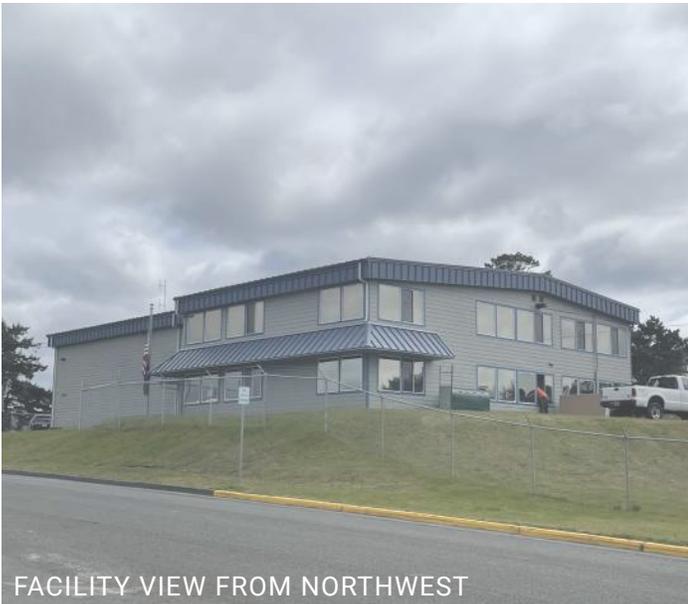
FACILITY VIEW FROM NORTHWEST

The facility is located adjacent to the Southwest Oregon Regional Airport and two runways. This location is typically not advised for an Essential Facility due to its proximity to low-flying aircraft and related potential hazards. In addition, the building is not sprinklered and long term evidence storage is at risk in the event of a building fire.

The building does not have vehicle deterrents or ballistic protection. The only ballistic glazing observed was at the transaction window at the public lobby. The exterior windows are mirror tinted, but such a mirror tint only functions in daylight. When it is dark outside, one can see into the building, which can create security concerns.

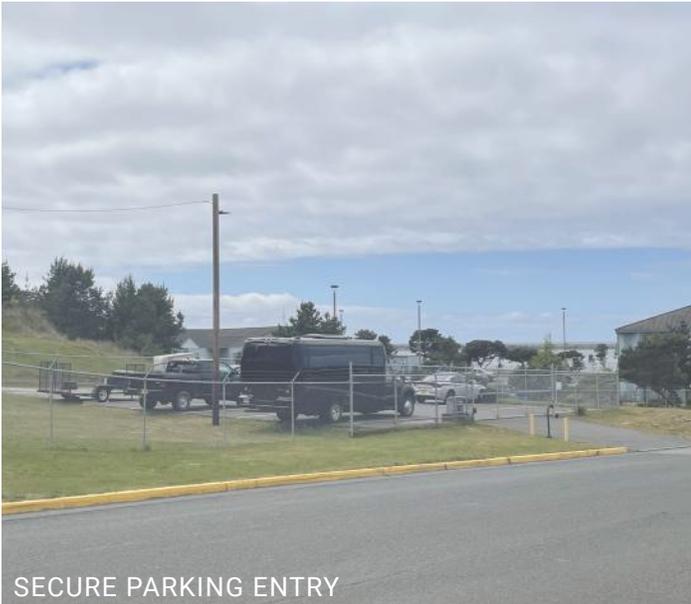
SECURE PARKING ENTRY

There is only one response route from the patrol parking area behind the building. If the security gate is blocked or there is an active threat in the area, officers do not have a secondary pathway to respond to calls or escape to safety. Secure parking is provided but is limited in size and does not meet the staffing demands for the facility. There are no security cameras on site and no visual security or exterior surveillance measures in place to protect building occupants.

The site is very limited and constrained. There is not enough secure parking for staff, resulting in a portion of the staffing parking in the unsecure area. Maneuvering is also a challenge with a dead end parking configuration, requiring patrol vehicles to make a U-turn in a tight space. This can cause delays in response times.

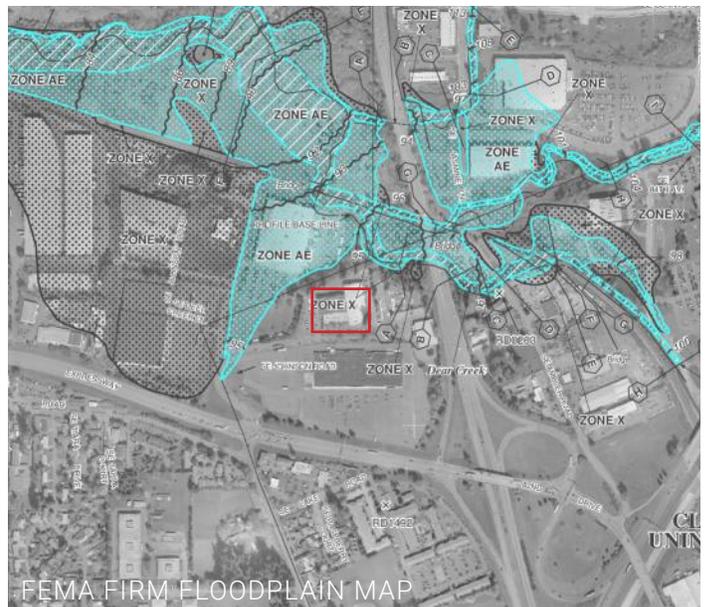
Located in the Cascadia subduction zone, the facility is in a moderate seismic risk zone. The facility is not constructed to meet Essential Facility standards. In addition, there are noticeable cracks in the roof beams and foundation issues apparent in the facility. The building is unlikely to survive a Cascadia earthquake, which severely limits OSP's ability to operate, respond, and support the Portland Area in a Cascadia event.

The facility also has flooding and wildfire concerns. The building location is adjacent to a river 100-year flood zone. This special flood hazard zone extends across the building access road SE Deer Creek Lane. Given that the road is a dead-end, flooding would cut-off car access to the site, limiting OSP's response pathways. With regards to wildfires, the facility itself is low risk, but parts of the surrounding areas are high risk. The area command was under evacuation orders during 2020's wildfires.

In the event of a power outage, the generator is too small to provide enough back-up power for OSP emergency operations. Currently the generator only serves minimal outlets and does not provide heat to the facility. This is a concern in ice storms where temperatures can drop below freezing and power outages are common.

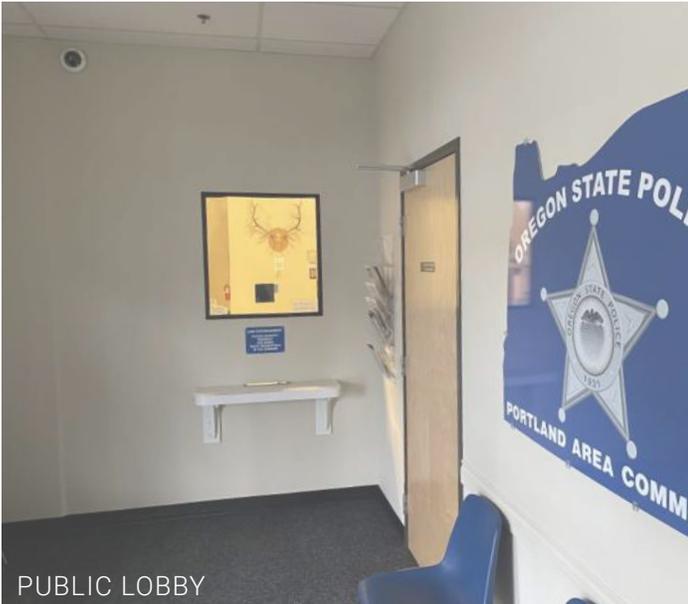
PUBLIC LOBBY

In the public lobby, the security walls are not continuous up to the roof structure and allow access to secure portions of the facility through the ceiling tiles. There is a report taking room directly off the lobby but no public toilet available and the public needs to be escorted in the secure zone of the facility to use the restroom. The only roof access for the entire building is in the Area Command, which also requires an escort in this secure zone during maintenance visits. This has been a constant issue to monitor and maintain security due to the extent of roof leaks and constant maintenance all tenants in shared building require.

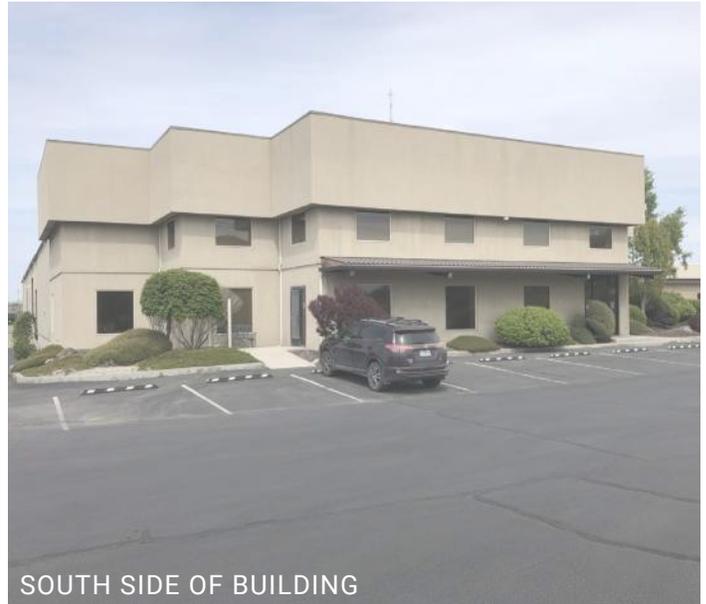
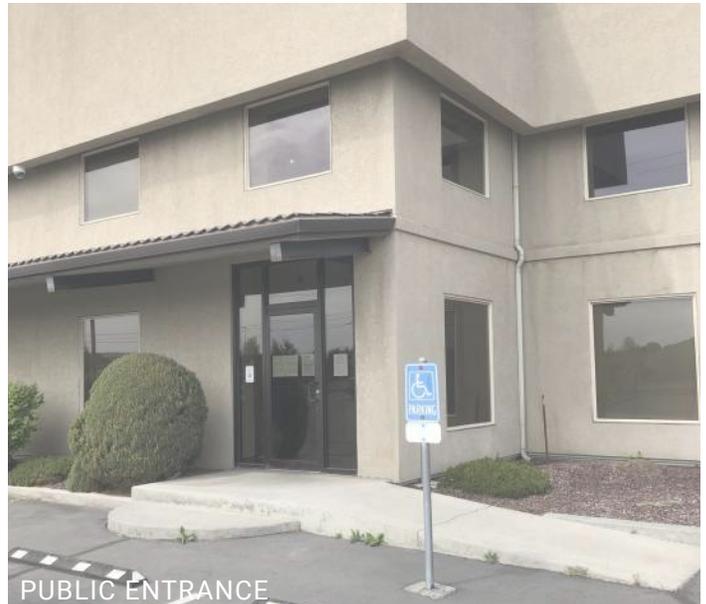
In terms of resiliency compliance, the Hermiston Worksite does not have a backup power generator for the building. In the event of a power outage, the facility could not sustain or support OSP operations. This is a critical issue since the location of this facility maximizes OSP response times along the highways.

The facility is also not constructed to Essential Facility standards. In a seismic event, the facility would not be occupiable immediately afterwards when OSP plays a critical role in the regional emergency response.

The building does not have fire sprinklers. This lack of fire suppression creates a potential hazard for the temporary stored evidence, equipment, and staff onsite.

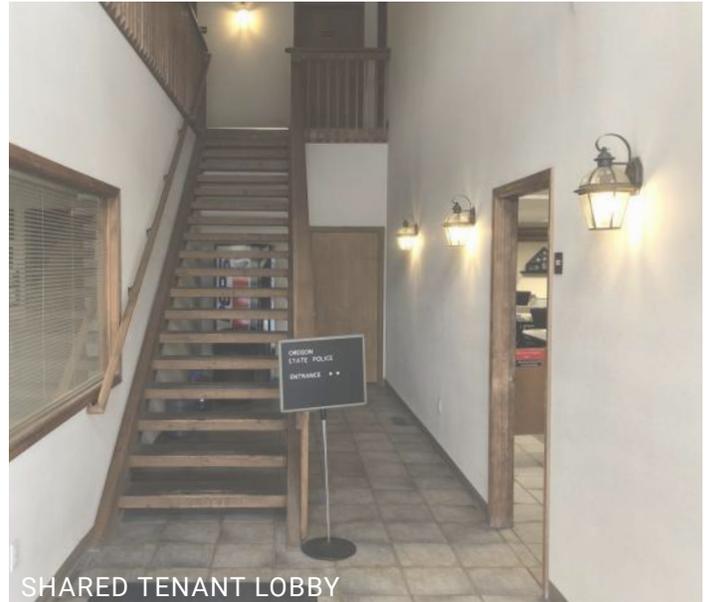
SHARED TENANT LOBBY

The shared tenant arrangement of the facility is also a security risk since officers travel outside the secure zone when moving between the multiple floors, as well as using the shared building restrooms. The building exterior is constructed with stucco siding and single pane windows, and neither element is ballistically rated.

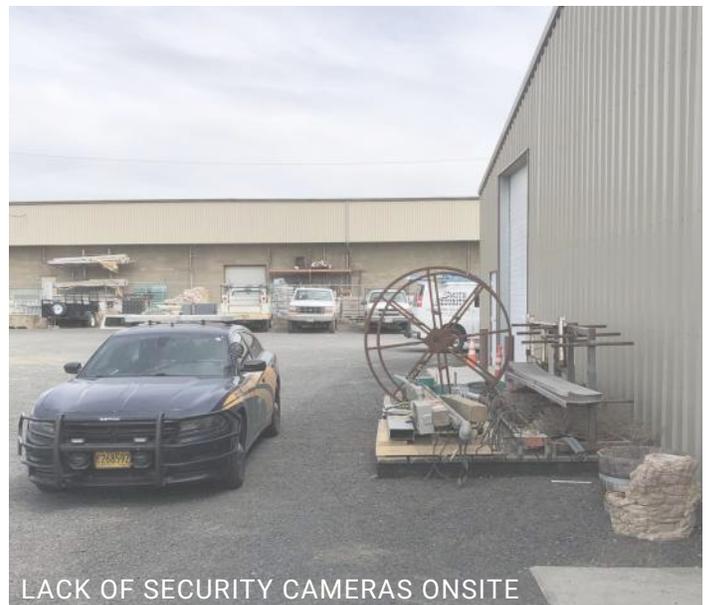
LACK OF SECURITY CAMERAS ONSITE

Without any security measures in place, officers keep the blinds down to limit visibility into the facility. With the blinds down and no security cameras to monitor the site, officers have limited ability to identify threats or assess situations when an issue arises.

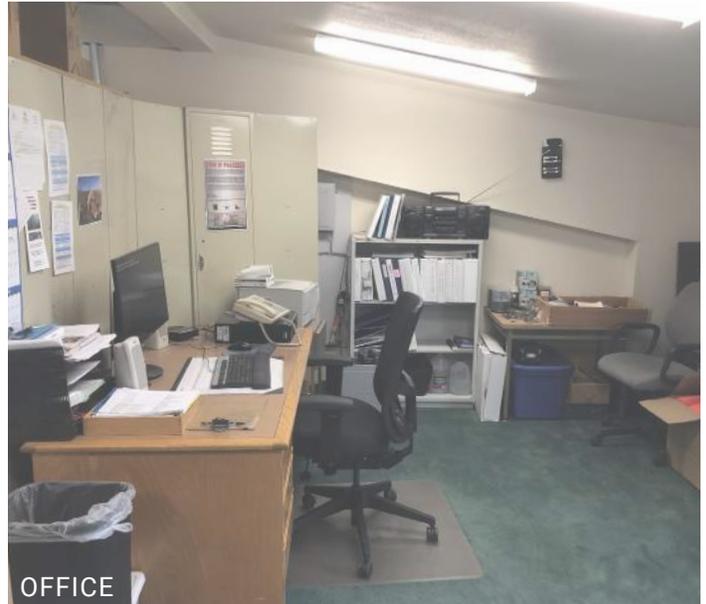
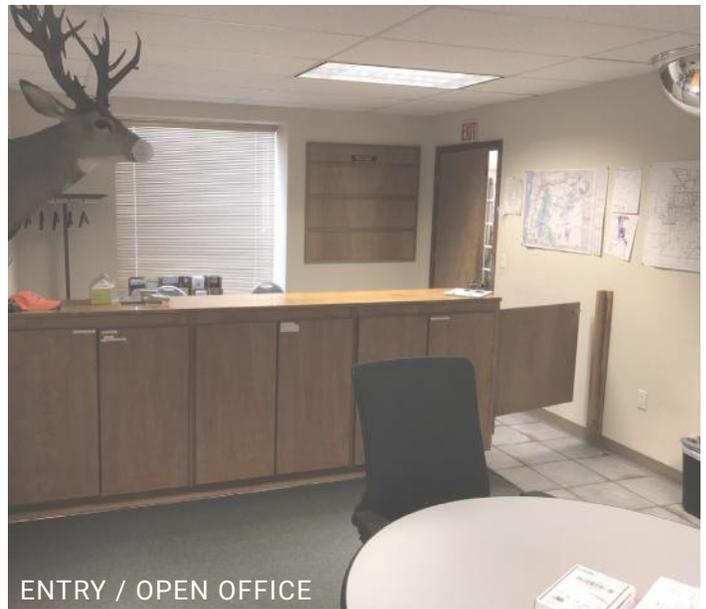
Within the facility, there is significant distance between the spaces that officers use everyday. Evidence processing is located on the second floor while report writing is on the first floor. Equipment, which is accessed daily, is stored in the support building at the back of the site. Since this facility does not have dedicated support staff to facilitate conversation with the public, the officer onsite is responsible for monitoring public access. Without any cameras onsite and the separated layout of the facility, the officer's ability to be responsive is limited. These various separations create an inefficient flow that requires an officer to spend more time at the facility and less time on patrol performing their duties.

The facility also lacks many critical spaces to support officers' daily tasks. There are no interview rooms for detectives, so interviews occur in the open office area. This significantly limits privacy for victims as well as lacks any acoustical separation for recording. Another key set of missing spaces are a sally port and impairment processing. An officer must take a DUI suspect back to the Area Command in Pendleton or another alternate facility to access an intoxilizer or equipment for a breath or blood test, which is notably more time-consuming and less efficient. There is also no dedicated evidence processing area, no weapons maintenance counter, no locker rooms, and no break room in the building.

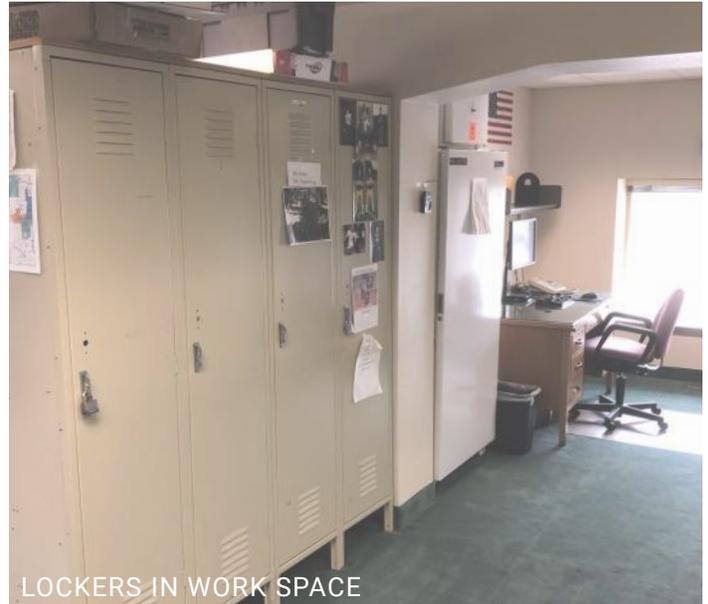
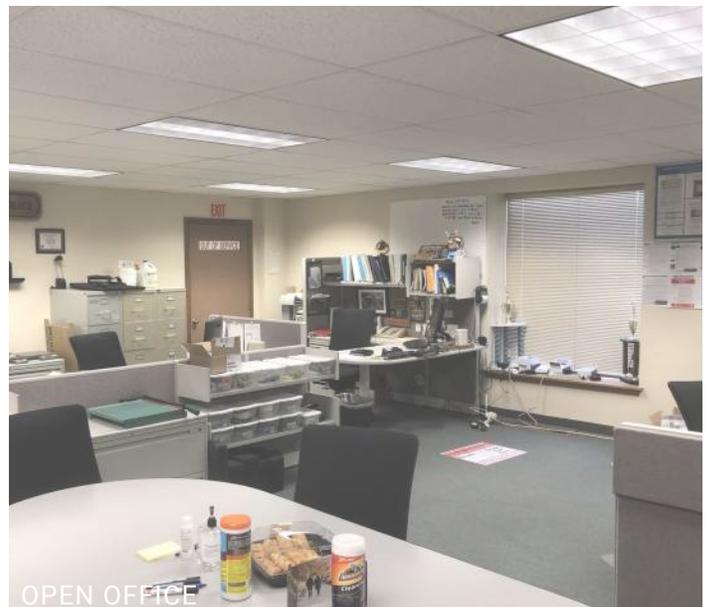
There is no elevator in this two-story building so several spaces are not ADA-accessible to both the public and staff. There is also no dedicated staff locker space or changing rooms. Staff lockers are located in the middle of the open office area on the second floor. This location is disruptive to the surrounding workspace and lacks privacy for staff.

The building is notably old and has not received a recent update to materials and finishes on the interior. Its systems, such as lighting and HVAC, as well as general infrastructure, are significantly outdated and inefficient.
