**Willamette River Newberg Pool
Towed Water Sport Zone and
Wake Surfing and Water Skiing Zone
River Bank Erosion Documentation and Evaluation**

David Gorman, PE
Ecological Engineering, LLC
2016 SE Henkle Road
Corbett, Oregon 97019

September 10, 2021

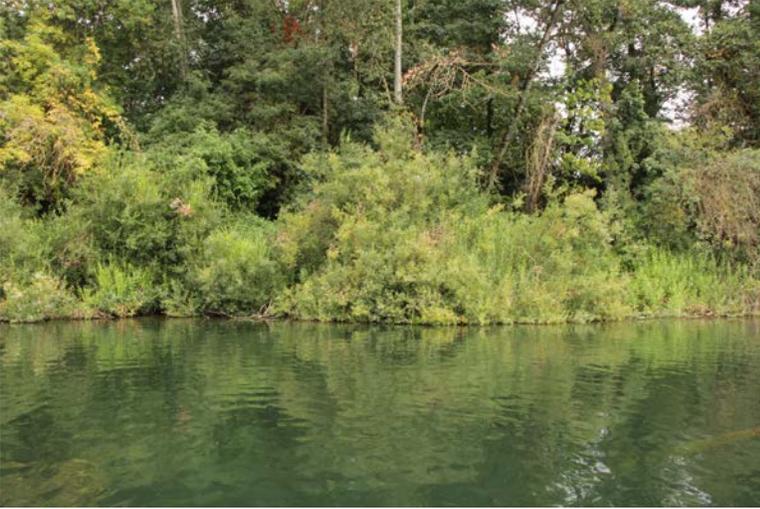
Photo WR-1B

Photos WR-1A through WR-1D were taken at Photo Point WR-1 (see map above) just downstream of the Newberg Bridge within the Oregon Marine Board designated Towed Water Sport Zone (Towed Zone) and approximately one river mile upstream of the upper limit of the Oregon Marine Board designated Wake Surfing and Water Skiing Zone #1 (Surf Zone 1). The river bank in this area was used as a reference for bank conditions inside of the Towed Zone but outside of Surf Zone 1.

There is a thick growth of willows (*Salix* sp.) along the lower and wetter portion of the bank with native trees higher up on the bank. There is no sign of bank erosion or failure.

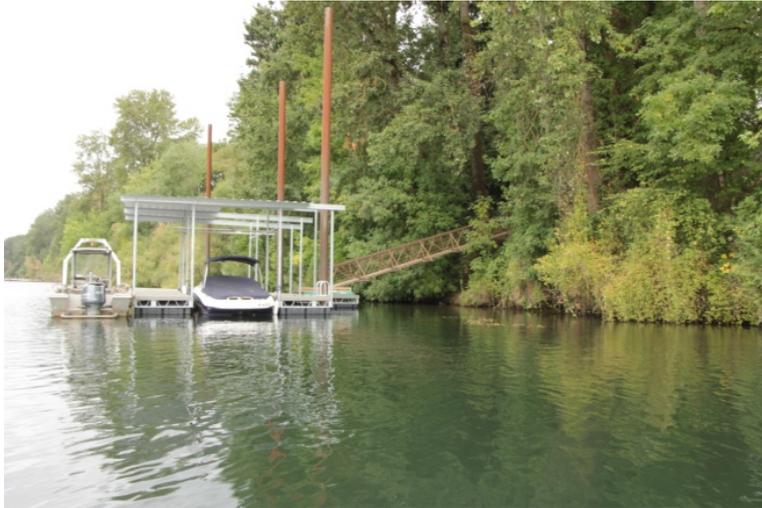
Photo WR-2B

development. The dock and ramp are on agricultural land with no housing nearby. The river bank has some areas with non-native invasive Himalayan blackberry (*Rubus ameniacus*) and some areas that have sparse vegetation, but there is little or no erosion or bank failure.

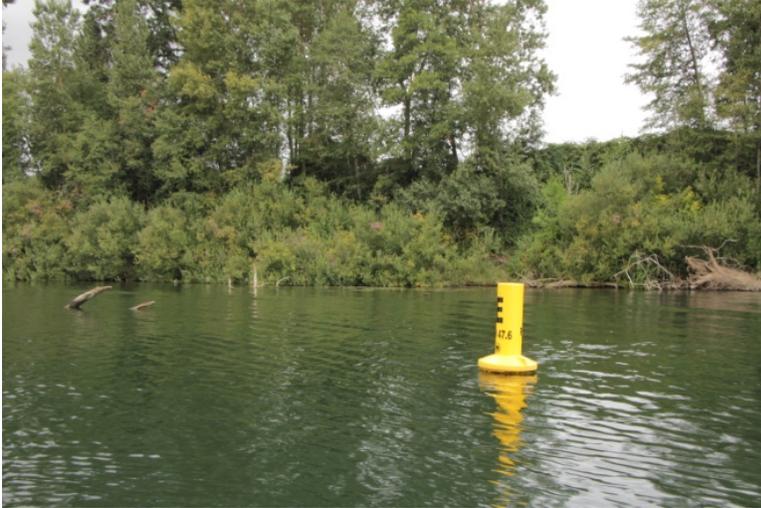
Photo WR-3B

Photos WR-3A through WR-3D were taken at Photo Point WR-3 located at the upper end of Surf Zone 1 located at RM 47.6 (see map above and zone marking bouys in photos). These photos represent bank conditions at the upper end of the Surf Zone. The river bank is well vegetated with willow and native dogwood (*Cornus sericea*) lower on the bank with no sign of erosion or

bank failure. The upper end of Surf Zone 1 is located in an agricultural area with no urban development of land uses.

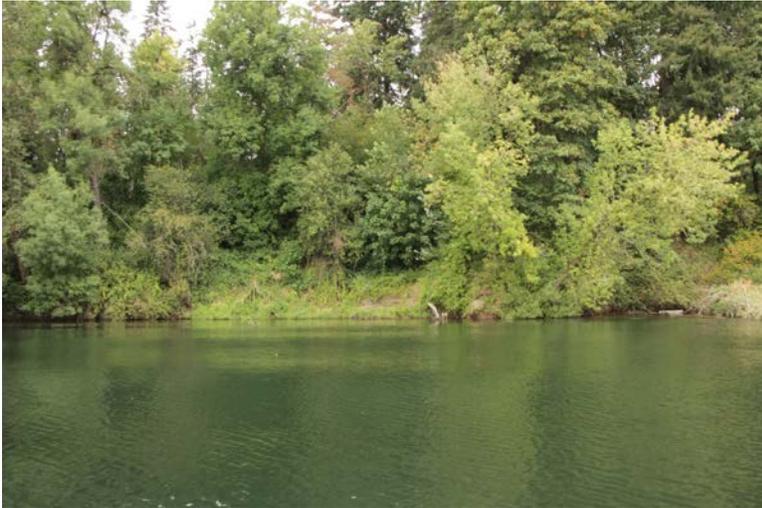
Photo WR-7C

Photos WR-7a through WR-7C were taken from Photo Point WR-7 in the lower one third of Surf Zone 1 (see map above). Land use in this portion of the Surf Zone is exclusively agricultural. The river bank has a minor amount of erosion in an area where willow and dogwood shrubs are lacking and vegetation is sparse. The predominant vegetation lower on the bank is non-native invasive Himalayan Blackberry. The cause of the erosion may be boat wakes

in the absence of other human activity, but there is no obvious cause.

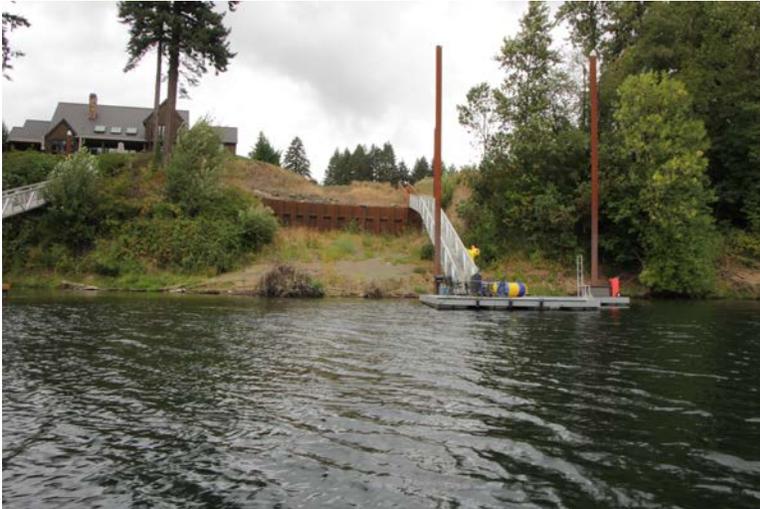
Photo WR-11A

Photos WR-11A and WR-11B were taken at Photo Point 11 (see map above) approximately RM 45, 1 river mile downstream from the lower end of the Wake Surfing and Water Skiing Zone 1 (Surf Zone 1) and within the Towed Water Sport Zone (Towed Zone). These photos were taken of the left bank in an area where the land use is residential. All, or nearly all, of the river bank residential properties in this reach of the river have boat docks and ramps. At this location

the property owner has placed steel sheet pile with riprap behind it in an apparent attempt to stabilize the land behind the sheet pile. It appears that the bank has been excavated in this location based on the steep slope to the right of the sheet pile. The lack of vegetation and the presence an “alcove” or indentation in the bank may result in the formation of flow eddies at higher flows that will increase the erosional pressure on the steep bank.

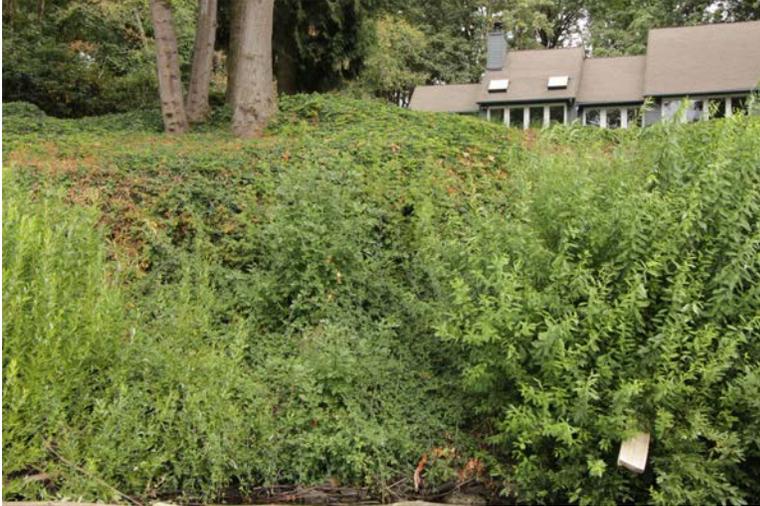
Photo WR-14A was taken at Photo Point 14 very close to Photos WR-13A through WR-13C within the Towed Water Sport Zone but not within the Wake Surfing and Water Skiing Zone (see map above). This photo shows healthy riparian vegetation lower on the river bank and a ground cover of ivy on the upper bank. Bank stability could be improved by removal of the ivy and replacing it with native shrubs such as willow and dogwood.

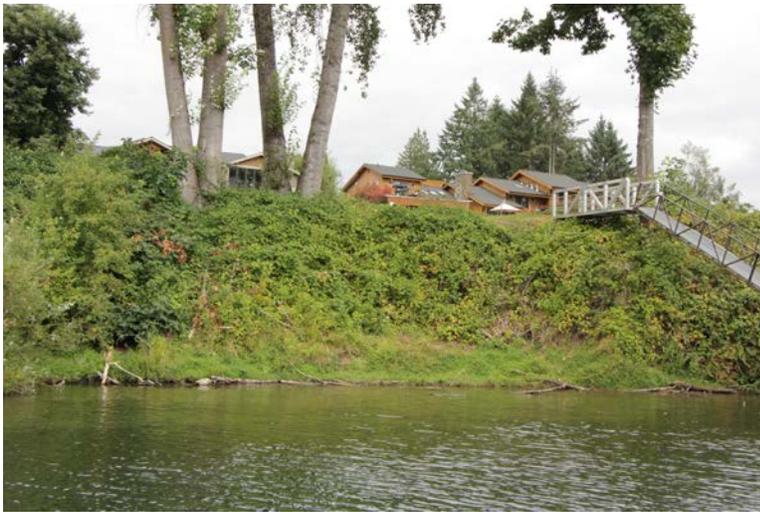
Photo WR-22A

Photos WR-22A through WR-22C were taken at Photo Site 22 within the Towed Water Sport Zone but outside of the Wake Surfing and Water Skiing Zone (see map above). Most of the river bank of this property is covered with Himalayan blackberry. Bank erosion can be seen underneath the blackberry bushes and above the boat wake zone. This is especially evident in Photo WR-22C. Long term stability of the bank will require removal of all of

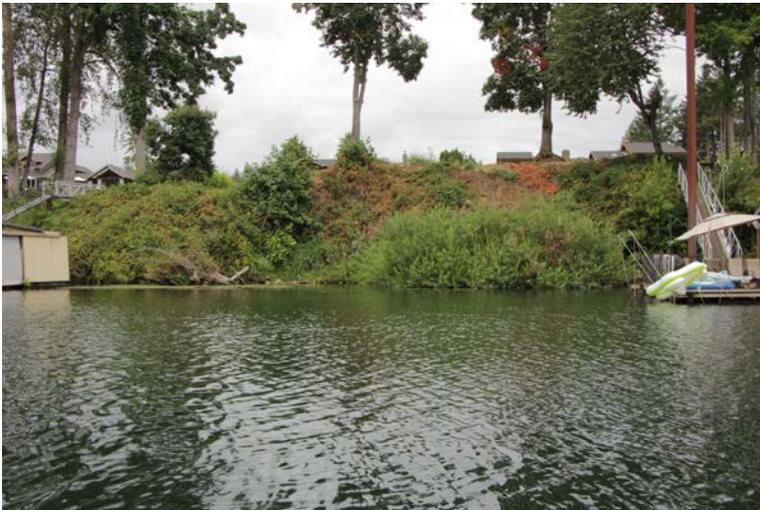
Photo WR-23B

growing and keep the soil mostly exposed to high river flows and potential scour.

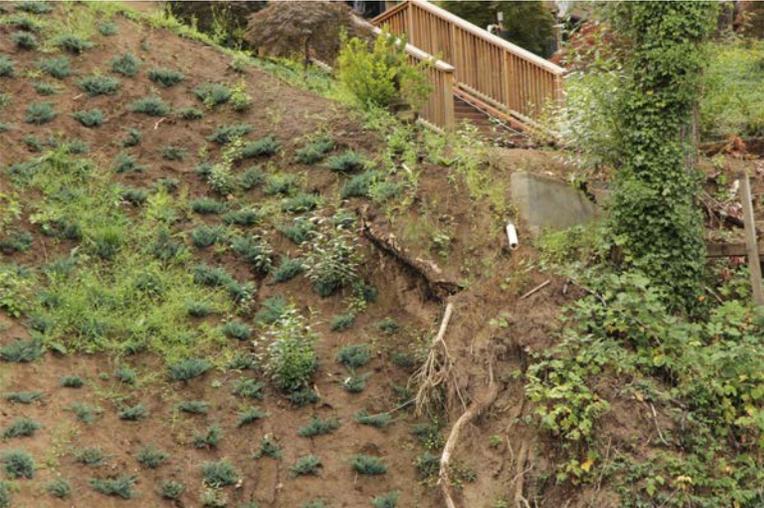
Photo WR-24C

Photos WR-24A through WR-24D were taken at Photo Point 24 within the Towed Water Sport Zone but outside of the Wake Surfing and Water Skiing Zone (see map above). This mass failure appears to be the result of the discharge of water at the top of the slope. A white PVC pipe can be seen in the upper right hand corner of Photo WR-24B and is one source of water. Photos WR-24D and WR-24E show erosion rilling down the face of the slope from a

water source that is still discharging and keeping the bank soil moist. The toe of the slope is completely exposed bare soil and shows some signs of wave erosion. However, the greatest threat to the river bank is the discharge of water at the top of bank and the nearly complete lack of riparian vegetation. The placement of landscaping plants on the slope is not likely to protect the slope from bank scour in the short or long term.

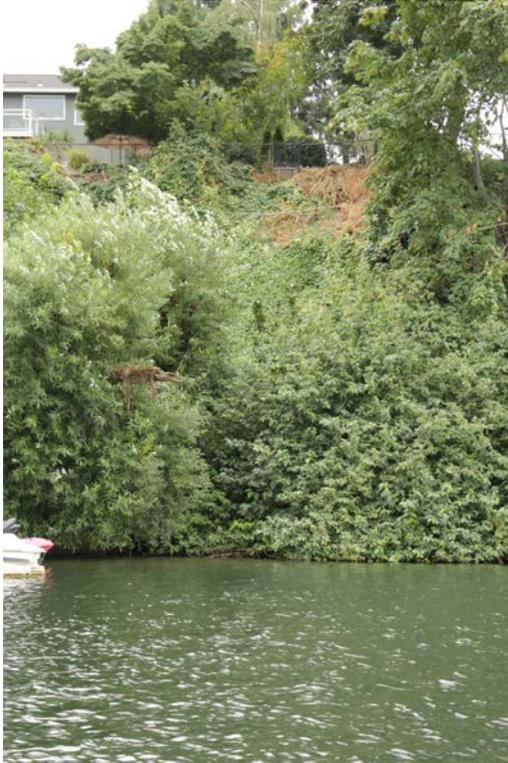
Photo WR-25C

Photos WR-25A through QWR-25D were taken at Photo Point 25 within the Towed Water Sport Zone but outside of the Wake Surfing and Water Skiing Zone (see map above). These photos are of the property just downstream of the property described above. They have been included here as a contrast to the river bank conditions shown in photos WR-24. The river bank on this property has dense riparian vegetation of willow and dogwood on the lower

half of the bank. There is no sign of bank scour, mass failure, or boat wake erosion.

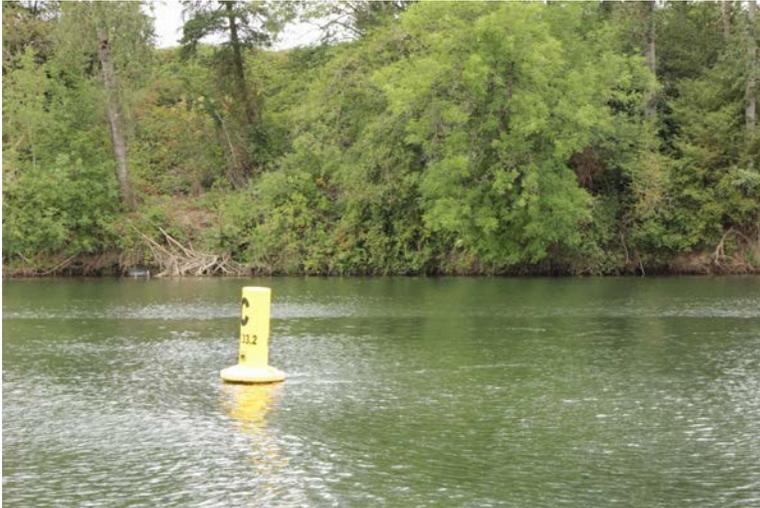
Photo WR-26B

Photos WR-26A through WR26C were taken at Photo Site 26 within the Towed Water Sport Zone and within the Wake Surfing and Water Skiing Zone (see map above). Photo site 26 is located at the upper end of the Surf Zone 2 at RM 33.2. Landuse on the left bank is agricultural and on the right bank is a combination of recreational (a golf course) and agricultural. Neither bank shows noticeable erosion or bank failure.

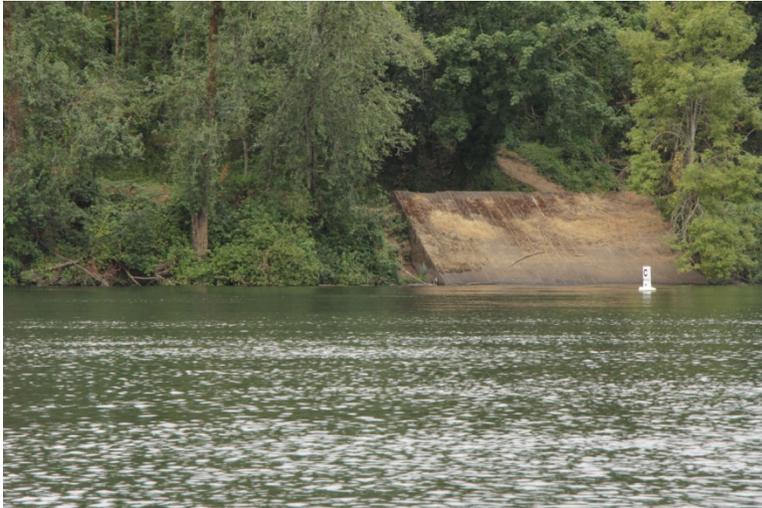
Photo WR-27B

Photos WR-27A through WR27C were taken at Photo Site 27 within the Towed Water Sport Zone and within the Wake Surfing and Water Skiing Zone (see map above). Photo site 27 is located at the upper end of the Surf Zone 2 at RM 33.2. Landuse on the left bank is agricultural and on the right bank is a combination of recreational (a golf course) and agricultural. Neither bank shows noticeable erosion or bank failure. There are some areas of the bank

that are lacking riparian vegetation due to land based human activity.

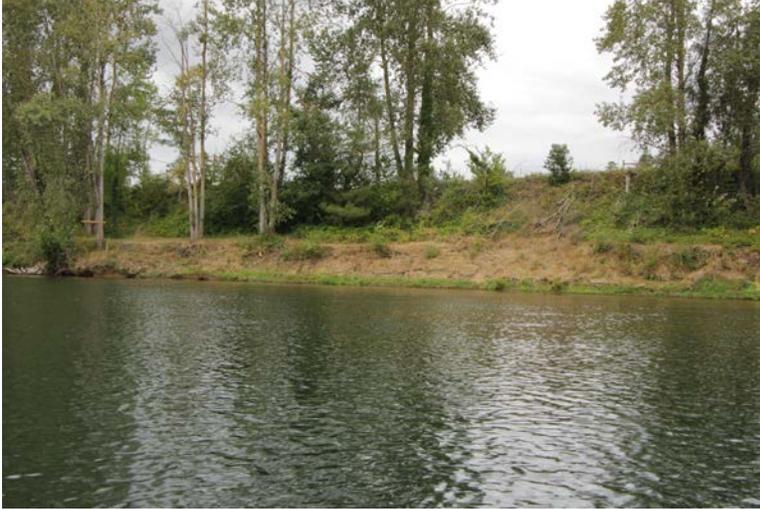
Photos WR-28A and WR-28B were taken at Photo Site 28 within the Towed Water Sport Zone and within the Wake Surfing and Water Skiing Zone (see map above). Landuse on the left bank adjacent to the photo site is intense agriculture with a significant amount of structures and activity. The river bank has been cleared of nearly all native riparian vegetation and there is evidence of frequent human activity on the bank. Some minor

bank erosion is present. It is possible that boat wakes contributed to the erosion, but no erosion is evident at the far left side of Photo WR-28A where riparian vegetation is still intact. The existing bank erosion would very likely not exist except for the vegetation removal.

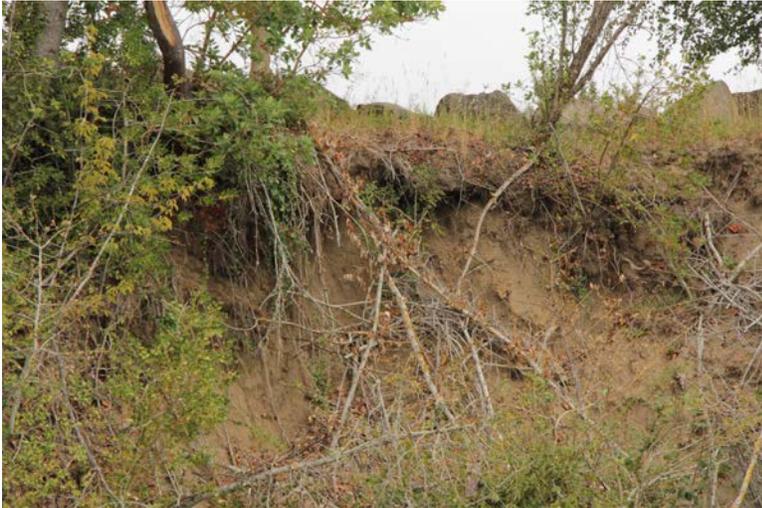
Photos WR-29A through WR-29D were taken at Photo Site 29 within the Towed Water Sport Zone and within the Wake Surfing and Water Skiing Zone (see map above). These photos show a combination of mass failure and bank scour. Potential contributing factors to the mass failure include the existence of a construction road at the top of the river bank and the associated placement of boulders at the top of bank. The added weight of the boulders and

construction vehicles plus the vibration of the traveling construction vehicles are likely contributors to the mass failure. Multiple dump trucks traveled this road to haul in sand to create an artificial beach for the unfinished resident at the end of the road. The bank scour may have been caused by boat wakes or higher river flows. Bank scour shown in Photo WR-29C appears to be caused by high river flows.

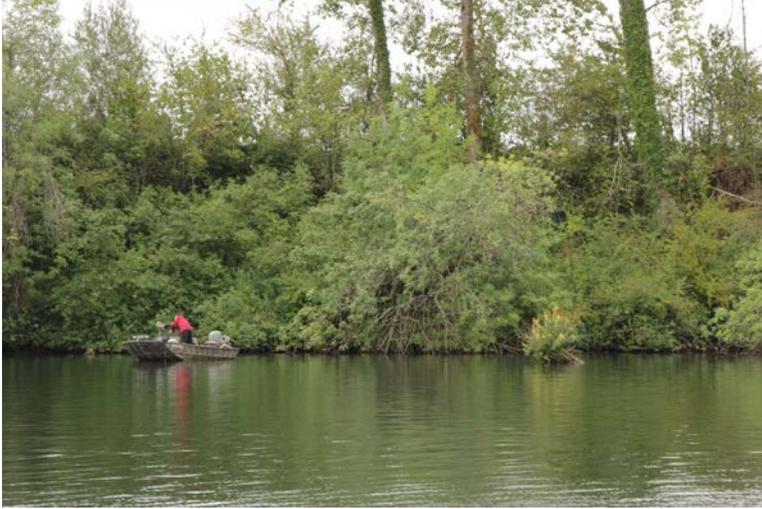
Photo WR-30C

boat wake erosion, bank scour from high river flows, or mass failure. If boat wakes were the cause of bank erosion within the the Towed Water Sport Zone and within the Wake Surfing and Water Skiing Zone it should be evident at this location, but it is not.

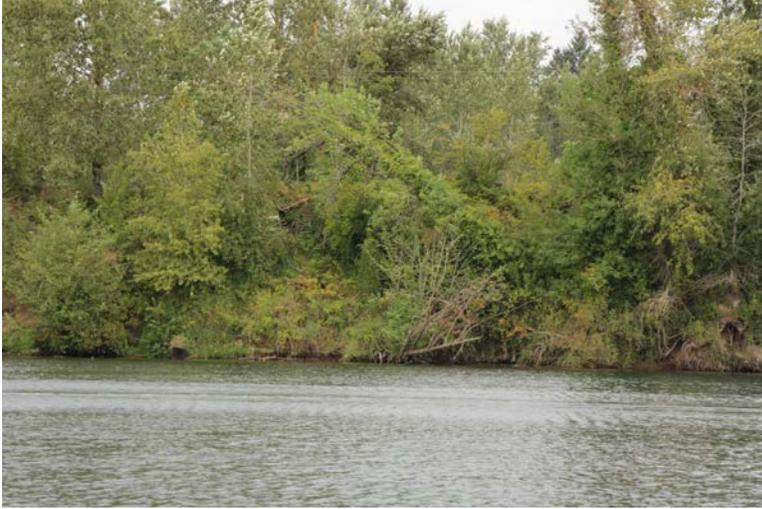
Photo WR-31C

riparian vegetation is lacking. Most of the erosion is above the boat wake zone and is likely caused by high river flows against poorly vegetated banks.

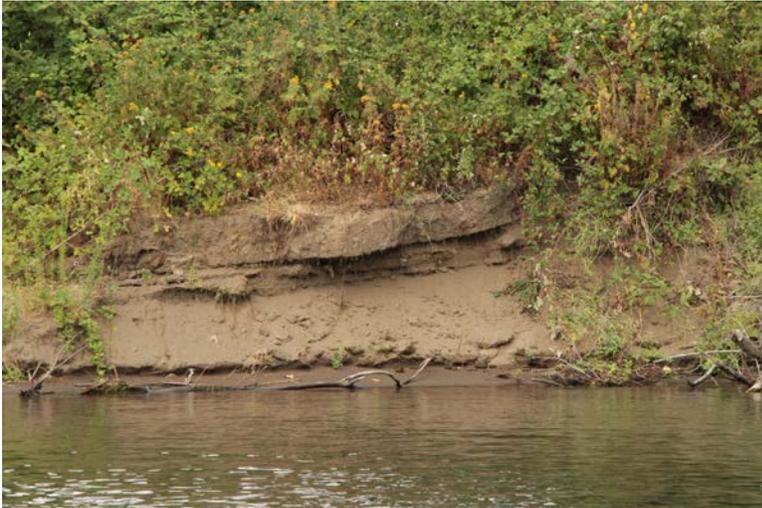
Photo WR-31G

Bank erosion shown in Photos WR-31F through WR-31H may have been caused by boat wakes. However, the bank erosion is only prevalent in those areas of the bank that have had the riparian vegetation removed. See Photos WR-30A through WR-30F taken across the river from Photo Point 31 for comparison with these photos.

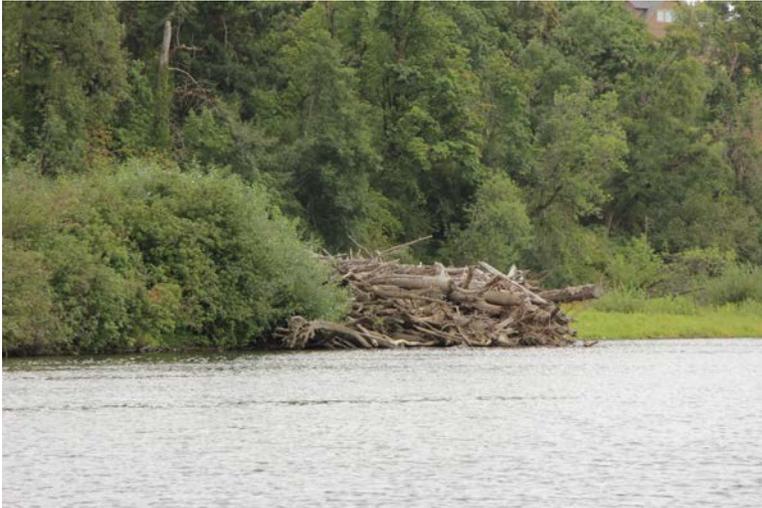
Photo WR-32B

Photos WR-32A through WR-32C were taken at Photo Point 32 within the Towed Water Sport Zone and within the Wake Surfing and Water Skiing Zone (see map above). This series of photos is of the relatively undisturbed right bank at the lower end of Surf Zone 2. Land use along the right bank is a mix of agricultural, residential, and industrial. None of these uses has caused significant disturbance to the riparian zone. The right bank is subjected to the same boat

wakes as the left but there is no evidence of erosion or bank failure from boat wakes, high flow bank scour, or mass wasting. The river bank looks healthy and stable.

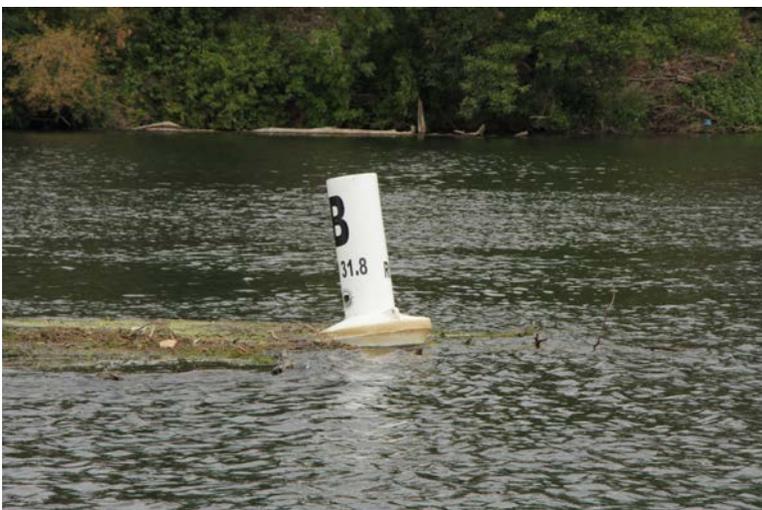
Photo WR-33A

Photos WR-33A and WR-33B were taken at Photo Point 33 at the lower boundary of Surf Zone 2 and represent the downstream extent of this survey.
