# **WILLAMETTE HERITAGE CENTER**

## **EXTERIOR SITE AND BUILDING OBSERVATIONS**

NOVEMBER 2024

**CBTWO**  
ARCHITECTS<sub>LLC</sub>

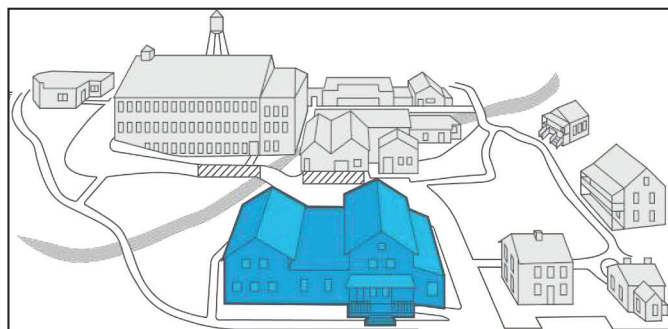
There were many instances of damage to siding and window trim, leading to water intrusion and eventual wood rot. In some areas, siding has chipped or broken away, leaving exposed nailheads and an unknown plastic substrate (Figure 5.2). At window and door trim heads, there appears to be no caulk, waterproofing, or flashing used to deflect water away, which is allowing for water intrusion behind the trim and moss growth (Figure 6.3). A electrical panel was observed splitting away from wooden mounting plate on the east wall of the building (Figure 5.4).

Finally, masonry foundations appear to be in generally good condition, but appear to include some temporary solutions. Wood shims and other material have been placed on top of masonry piers, which are exposed to weather (Figure 7.1). Flashing is observed at piers which are slightly proud of exterior siding, but the flashing in some cases do not extend the full length of the pier, allowing for water intrusion (Figure 7.2).

Observation	Figure	Priority
Uneven boardwalk surfaces, and a mix of historic and non-historic boards used from previous repairs	5.1	Low
Chipped/rotting siding, allowing for water intrusion	5.2, 6.1, 6.4,	High
Siding reveal type changes occur on front elevation	5.3	Low
Panel breaking away from siding	5.4	Low
After-hours exit not accessible due to gravel path	5.5	Mid
Doorway/window trims are rotting, exhibiting moss growth and likely contributing to water intrusion	6.2, 6.3	High
Masonry foundations are flashed inappropriately and built up with improper materials, many of which do not appear historically accurate	7.1, 7.2	Mid
West door missing flashing and trim	7.3	Low
Siding nails are rusting/deteriorating	7.4	Mid

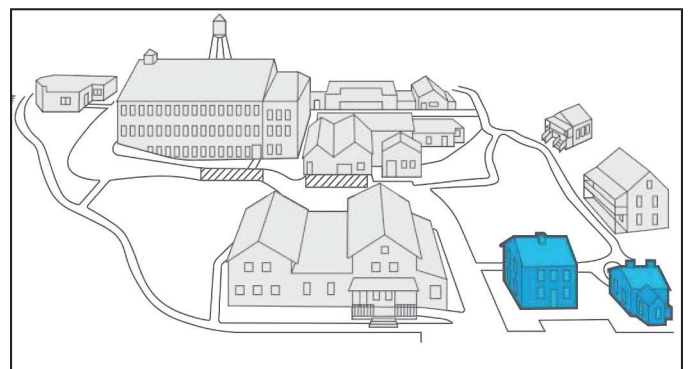
The Parsonage exterior displays some of the heaviest weathering and damage observed among the buildings on campus, especially in regard to the category of buildings that were relocated to the WHC campus.

Primary weathering damage occurs at transitions at first floor building corners (Figure 9.1), walls against roof shingles due to lack of step flashing (Figure 9.3), and exposed doors and window trim (Figure 9.5). A column supporting the east edge of the front porch roof is showing signs of significant structural damage, with the wood base splitting apart and wind-driven water intrusion evident. The wood boards on the second floor stairway landing are showing significant weathering, with the railing supports and joints beginning to split away.

The Boon House has very similar issues as the Parsonage, though to a lesser degree of damage. The trim at the southeast corner wall base has significant damage (Figure 10.4), and the siding against the roofing is rotting at the end grain of the wood (Figure 10.5). The roof shingles appear to be nearing their end of life, with significant moss growth across the entire surface (Figure 10.1). Siding on the east elevation in particular is warping and bowing, creating an uneven surface where water can intrude behind the siding.

Observation	Figure	Priority
Corner trims at base of siding heavily deteriorating at Parsonage and Boon House	9.1, 10.4	Mid
Structural damage at Parsonage porch column	9.2	High
Siding against roofing rotting, heavy water intrusion at Parsonage and Boon House	9.3, 10.5	High
Upper stair landing deteriorating at Parsonage	9.4	Low
Chips in siding and trim causing water intrusion at Parsonage and Boon House	9.5, 10.2, 10.3	Mid
Boon House roof sagging	10.1	Mid

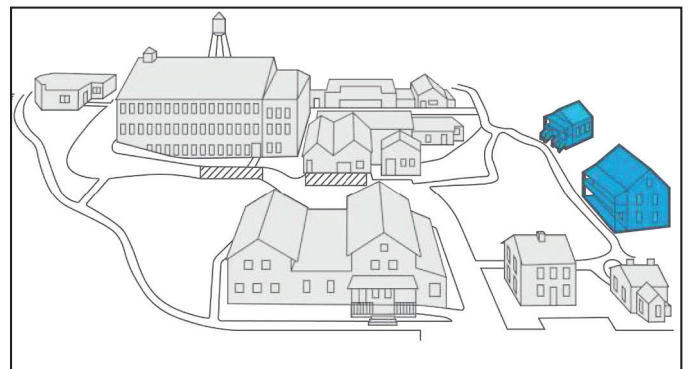
The Jason Lee House is displaying many of the same issues as the Parsonage and Boon House, with several deferred maintenance items that require remediation. In several instances, we observed Bondo or a similar wood filler substance used on window trim and window sashes (Figures 12.3 and 13.1), but further treatment (sanding and painting) was not performed to match the adjacent finish. Most of the other observations on the following pages highlight issues with aging exterior envelope items. Mold growth was visible on siding on the rear elevation (Figure 13.2). Balcony decking on the front elevation is weathering and/or rotting, resulting in chipping and cracking in the wood boards (Figure 12.1 and 12.2). Elsewhere, paint is chipping from siding and door/window trim (12.4, 13.3, 13.4), as well as window mullions (13.5).

The Church includes many of the same issues as the Jason Lee House, including mold growth on exterior walls (Figures 14.4 and 14.5) and paint chipping and cracking (Figure 14.3). Some unique issues observed on the Church exterior were gaps in the porch roof soffit and structure (Figure 14.1), and a couple instances of bubbling water pockets in the siding, which is being caused by water intrusion from the window sills (14.2).

Observation	Figure	Priority
Balcony decking deteriorating at Jason Lee House	12.1, 12.2	Low
Wood filler not properly finished at Jason Lee House	12.3, 13.1	Low
Wood trim and thresholds at end of life on Jason Lee House	12.4, 13.4	Mid
Corner base trim at Lee House heavily deteriorating or missing entirely	12.5, 13.3	Mid
Mold growth on siding at Jason Lee House and Church	13.2, 14.4, 14.5	Mid
Paint chipping from window mullions at Jason Lee House	13.5	Low
Church siding bubbling due to water intrusion	14.2	Mid
Paint chipping on Church siding	14.3	Low

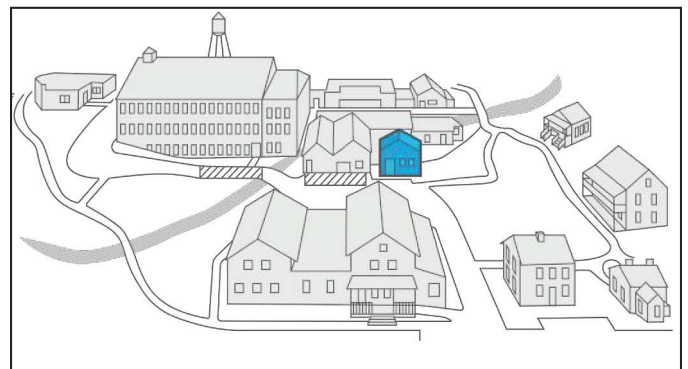
The PGE Power Exhibit building, as the newest building on campus, appears to be in suitable condition, with no critical repairs appearing necessary. To the north side of the PGE building, the top of the wooden guardrail is beginning to split and warp (Figure 16.2).

The south portion of the Scouring Room, included on the following page, shows signs of foundation erosion on the south elevation (Figure 16.3), along with siding damage that requires further remediation from what has been done previously (Figure 16.4).

Observation	Figure	Priority
Railing against creek splitting	16.2	Low
Foundation eroding beneath Scouring Room	16.3	High
Paint finish on wall is inconsistent	16.4	Low
Plywood siding on upper wall of Scouring Room deteriorating, and does not match typical siding on lower walls	16.5	Mid

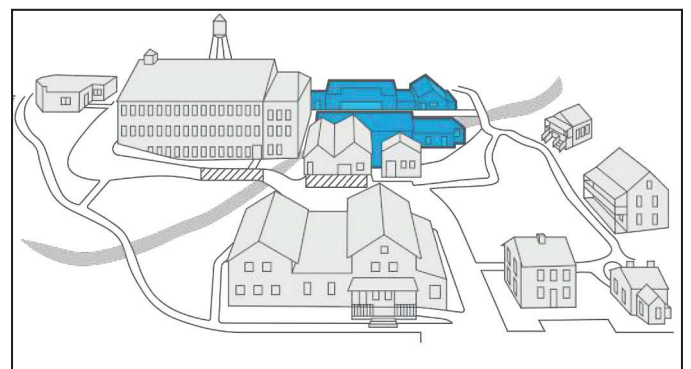
The Mentzner Machine Shop was observed to be in better exterior condition than most of the other buildings on campus. The major concern is the east roof, which is directly underneath a willow tree. The roof shows heavy debris from the tree, which provides potential to trap water and erode the roof surface (Figure 18.1).

At the Picker House deck, there is a vast layering of historical interventions and changes that make it difficult to discern what is historically significant, and thus determine priority in making repairs. A large panel of plywood is covering a large hole that appears to be temporary (Figure 19.3). In addition, there are several holes or missing pieces of cladding that are providing ample space for water intrusion, including a missing panel of lap siding above the tunnel (Figure 18.3) and missing brick veneer where a pipe penetrates into the Picker House (18.5). A circular hole in the concrete wall contains a mesh screen, but it does not fully cover the hole (19.4). Most importantly, dripping water was visible underneath the concrete creek run, suggesting structural damage or cracking that should be rectified immediately to prevent further damage or leaking (19.5).

Observation	Figure	Priority
Moss and debris on Machine Shop roof, from overhanging tree	18.1	Low
Moss on Scouring Room roof	18.2	Low
Several instances of holes in exterior causing water/insect intrusion	18.3, 18.5, 19.3, 19.4	High
Rusting flashing on Picker House deck	18.4	Low
Water intrusion at base of window at masonry	19.1	Mid
Vertical slats on Picker House deck guard pulled apart, resulting in gap	19.2	Low
Dripping water beneath concrete creek run suggests failing structure	19.5	High

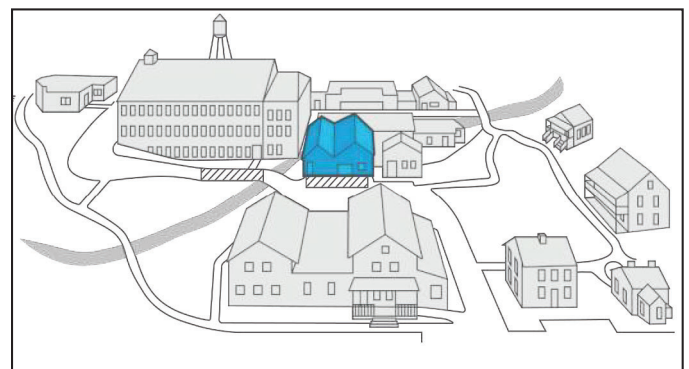
The exterior area between the mill building, picker house, and scouring room shows a variety of structures, most of which are clearly showing age but not pointing to any major issues. The one critical item observed at this location is a wood beam sitting on the ground that serves as part of the support for a bridge structure above. The base beam is showing severe water/insect damage, hollowing out from the center, which could compromise the column support (Figure 21.2). Siding on one of the equipment bridges is rotting at the bottom, allowing for water to penetrate inside (Figure 21.3). We also observed a unique area of masonry efflorescence on the west edge of the Picker House, which points to years of water intrusion behind the brick (Figure 21.1). The efflorescence itself is not a major issue, but remediation of the brick may be required to prevent future intrusion of water. Water damage to the brick is also evident above the arched doorway on the west elevation of the Picker House (Figure 21.4).

Lastly, significant mold growth was observed on the west elevation of the Scouring Room/Dye House, caused by a large crack in the siding (Figure 21.5).

Observation	Figure	Priority
Masonry efflorescence on west side of Picker House	21.1	Low
Floor beams supporting mill turbine structure are rotting/hollowing out	21.2	High
Siding deterioration and incorrect installation of roof flashing	21.3	Mid
Heavy masonry weathering at west side of Picker House	21.4	Low
Moss growth on siding	21.5	Mid

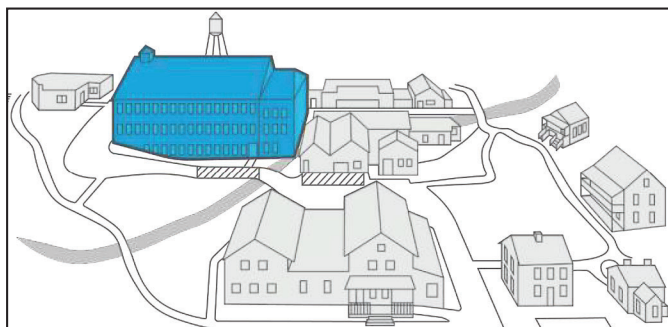
The Thomas Kay Woolen Mill Building is the crown jewel of the Willamette Heritage Center campus. On the main building volume, we observed a large amount of surfaces requiring cosmetic repair due to weathering. Paint was beginning to chip away on the arched stone window headers (Figure 23.1), as well as most of the window sills, sashes, and window trim (Figure 23.2). There were localized pockets of damage on the roof cornice, which appears to be resulting from wind and water damage (Figure 23.3). Recessed doorways and other outside corners of masonry are eroding, causing small lips that allow for standing water and further water damage (Figure 23.4). Weeds and moss are growing on the repurposed stone used from the original mill building, but based on our review of the exterior, it is unclear if any remediation is needed beyond weed control (Figure 23.5).

The rear (north) side of the Mill Building would require extensive work in building repair and safety upgrades. Ventilation grates at the ground level were filled with insulation in recent history, but batts are now breaking away and hanging down in front of the grate (Figure 24.2). The roof of the submerged maintenance shop is approaching end of life, with moss growth and other debris scattered across the surface (Figure 24.3). The stairs down to the lower portion of the Boiler Room have been removed, leaving an open hole that is overgrown with weeds and grasses (Figure 24.4). On this portion of the campus, the grounds were overgrown, with debris scattered across pathways and unsafe stair conditions.

Observation	Figure	Priority
Paint chipping and deterioration on window trim and door/window headers	23.1, 23.2, 23.4	Low
Roof cornice damage, dutch gutter joints failing	23.3, 25.2	High
Original stone provides areas for water intrusion and weed growth	23.5	Low
Electrical outlet on west exterior wall is not protected nor appears to be historically significant	24.1	Low
Insulation damage in foundation vents	24.2	Low
Maintenance roof nearing end of life	24.3	Mid
Unsafe stairwell to lower Boiler Room	24.4	Mid
Water damage near maintenance shop door	24.5	Mid
Masonry wall buckling under weight of turbine structure	25.1	High
Retaining wall against creek settling due to damage against bank	25.3	High
