**GEOMORPHIC, HYDROLOGIC AND ECOLOGICAL
EFFECTS OF THE BEAR CREEK MEADOW
RESTORATION PROJECT: A LAYMAN'S REVIEW**

**PREPARED BY:
CHRISTOPHER T. HAMMERSMARK
&
JEFFREY F. MOUNT**

NOVEMBER 15, 2005

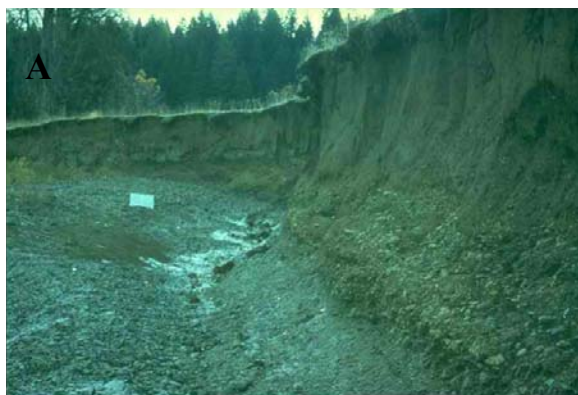
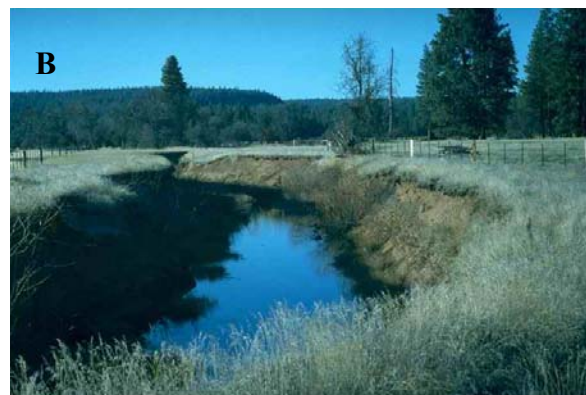
Figure 2 – **A)** Tall, near vertical unvegetated banks of the pre-restored Bear Creek channel. **B)** Prior to restoration, Bear Creek was best described as a gully (Photos: Rick Poore).

As the stream channel incised and lowered the ground water table, the stream banks progressively grew very tall and steep, and unable to support much vegetation which lead to increased instability of the stream banks (Figure 2). This instability initiated a cycle of lateral erosion of the banks, widening the channel. This lateral channel enlargement confined more water within the channel and contributed even more sediment to the Fall River. Bear Creek’s once numerous shallow, vegetated, and meandering channels had degraded into what are best described as two unstable, erosive gullies (Figure 2).

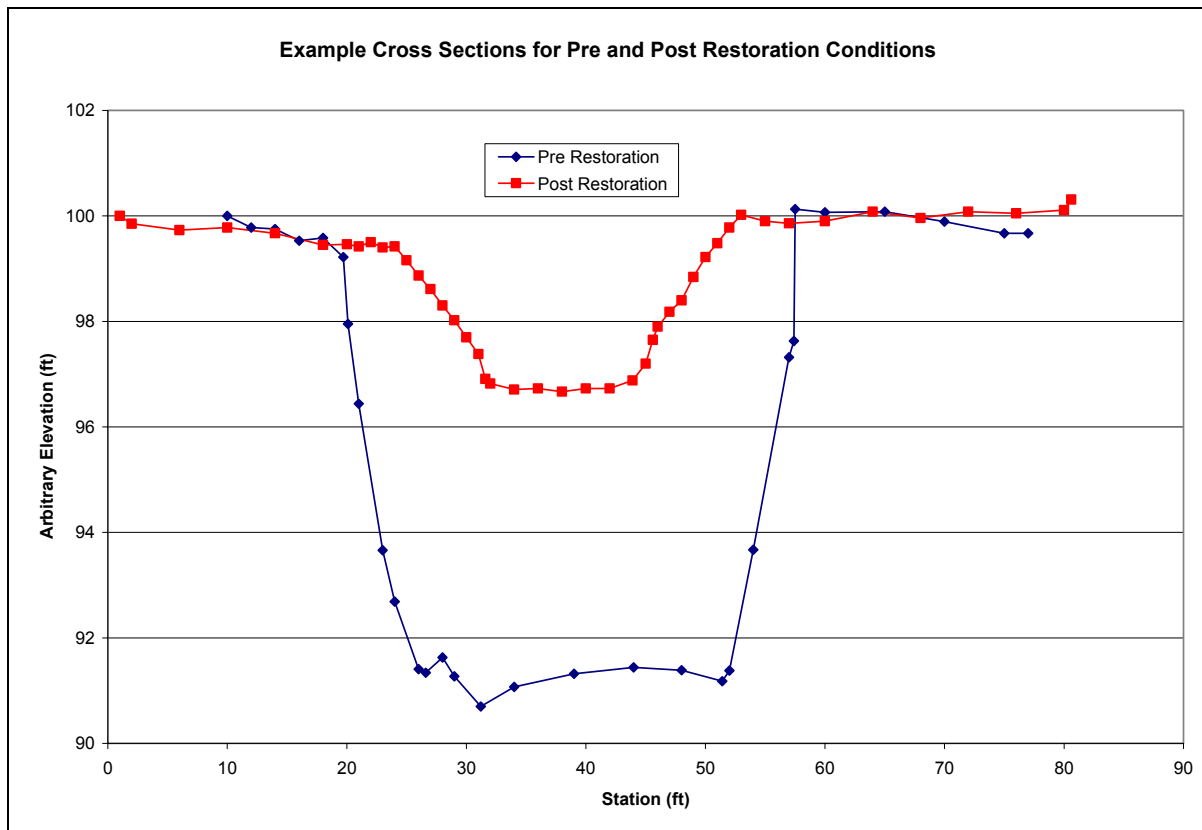
Figure 5 – Representative cross sections of Bear Creek in the pre restoration (blue with diamonds) and post restoration (red with squares) project conditions. Notice how much larger (deeper and wider) the pre restoration channel is when compared to the restored channel.

The plugging of the old, over-sized channel and creation of the new, small main channel for Bear Creek re-established the geomorphic processes typical of a meadow. Based on annual surveys of more than 20 channel cross sections (Figure 5), the sinuous, shallow channel has remained relatively stable in the period since completion of the restoration project. Rapid channel adjustments involving incision or significant lateral migration have not been widespread although minor redistribution of sediment has been observed. The causes of this sediment redistribution are under investigation by UC Davis and Streamwise, Inc., but appear to involve local excessive slope or flow confinement. The few instabilities have been addressed by Streamwise, Inc. through a variety of bank stabilization techniques.
