# **THE POND-AND-PLUG TREATMENT FOR STREAM AND MEADOW RESTORATION: RESOURCE EFFECTS AND DESIGN CONSIDERATIONS**

**A Briefing Paper for Plumas National Forest  
Resource Specialists and Managers**

**Version 1.0  
May 2010**

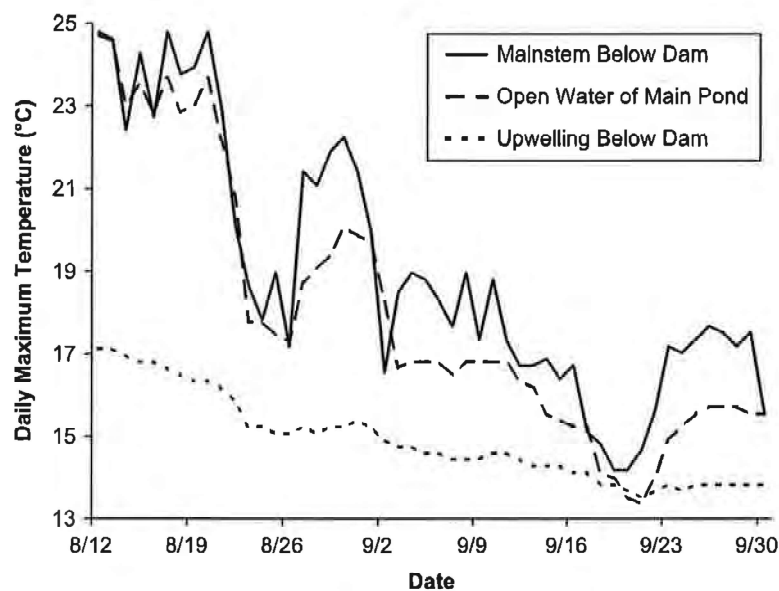
**Figure 8.** Temperature profiles of lower Bridge Creek in late summer 2005, showing that relatively cool pockets of water with mild temperature fluctuations exist below beaver dams, presumably the result of accumulated pond water above the dams downwelling through the alluvium and then upwelling below the dam (see White, 1990).
